RE: 190-14-CA (708 Dorothea Drive)

Property Address: 708 Dorothea Drive

Window Survey

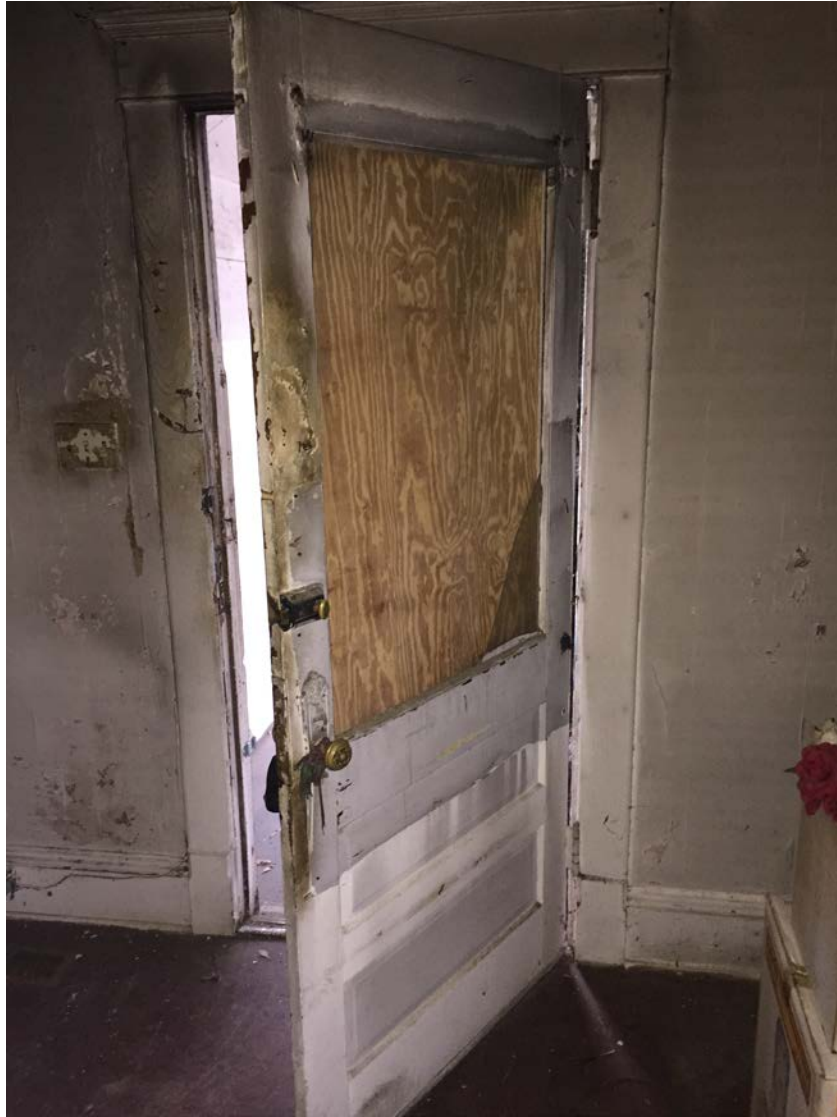
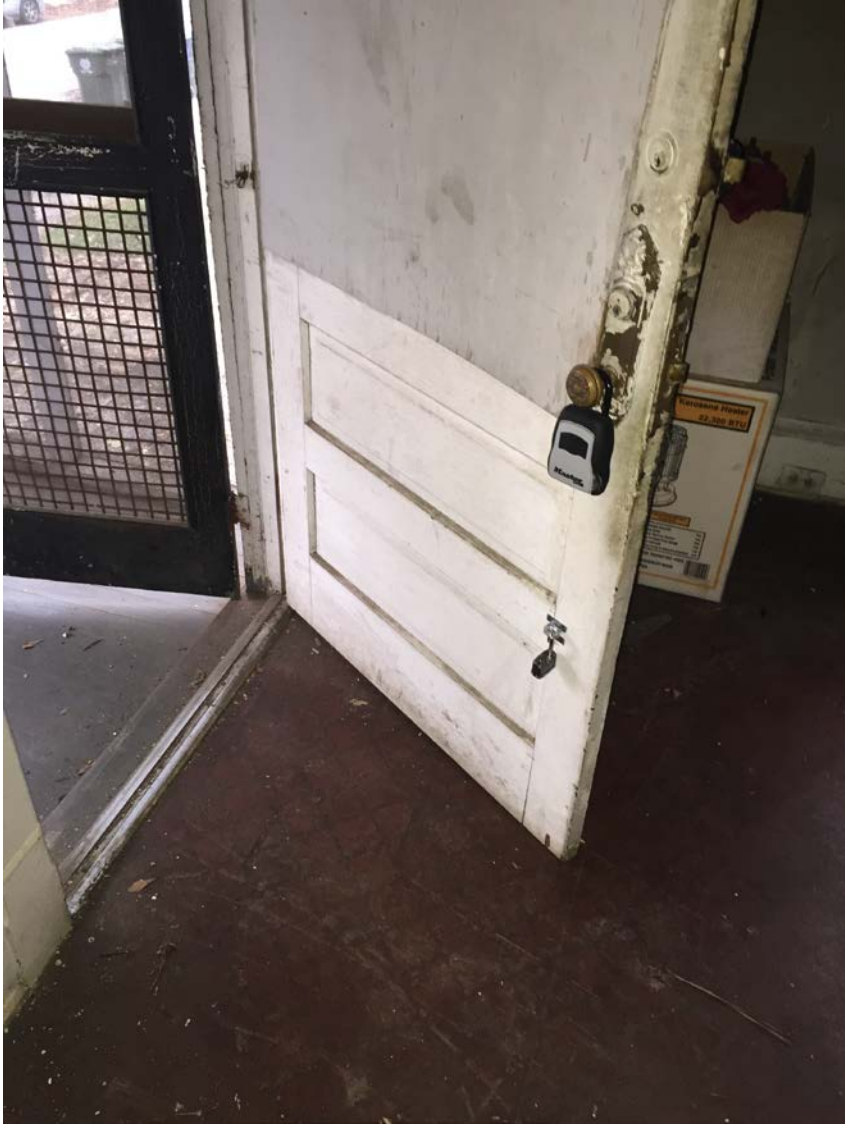
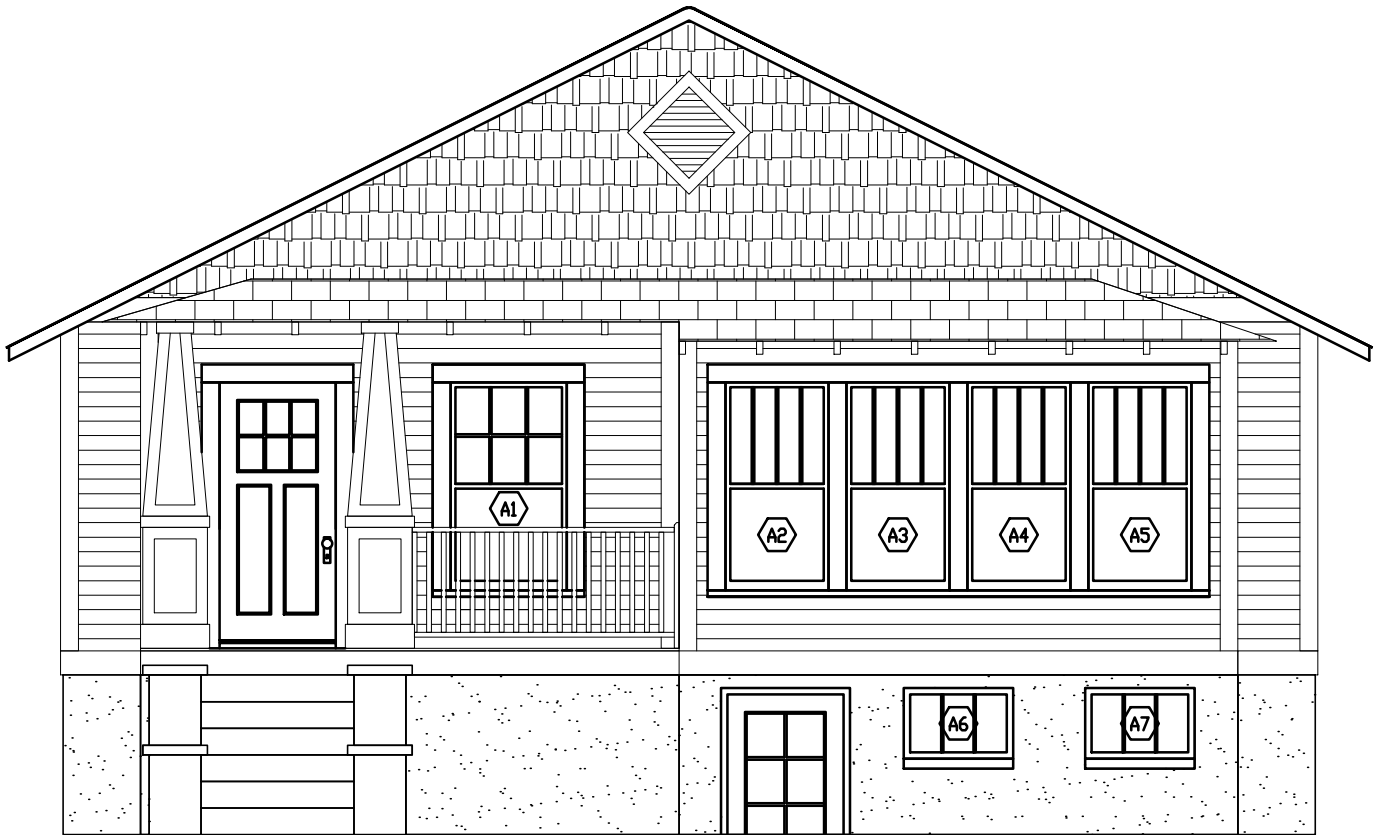
Existing front door damage:

In regards to the front door, I would still like to replace this. The historic preservationists I talked with would not give me a quote for fixing the door; therefore I would still like to replace it. I've included some additional pictures that show the extensive damage to the door. Previously a door was submitted for approval and I ask this be re-reviewed based on the information provided.

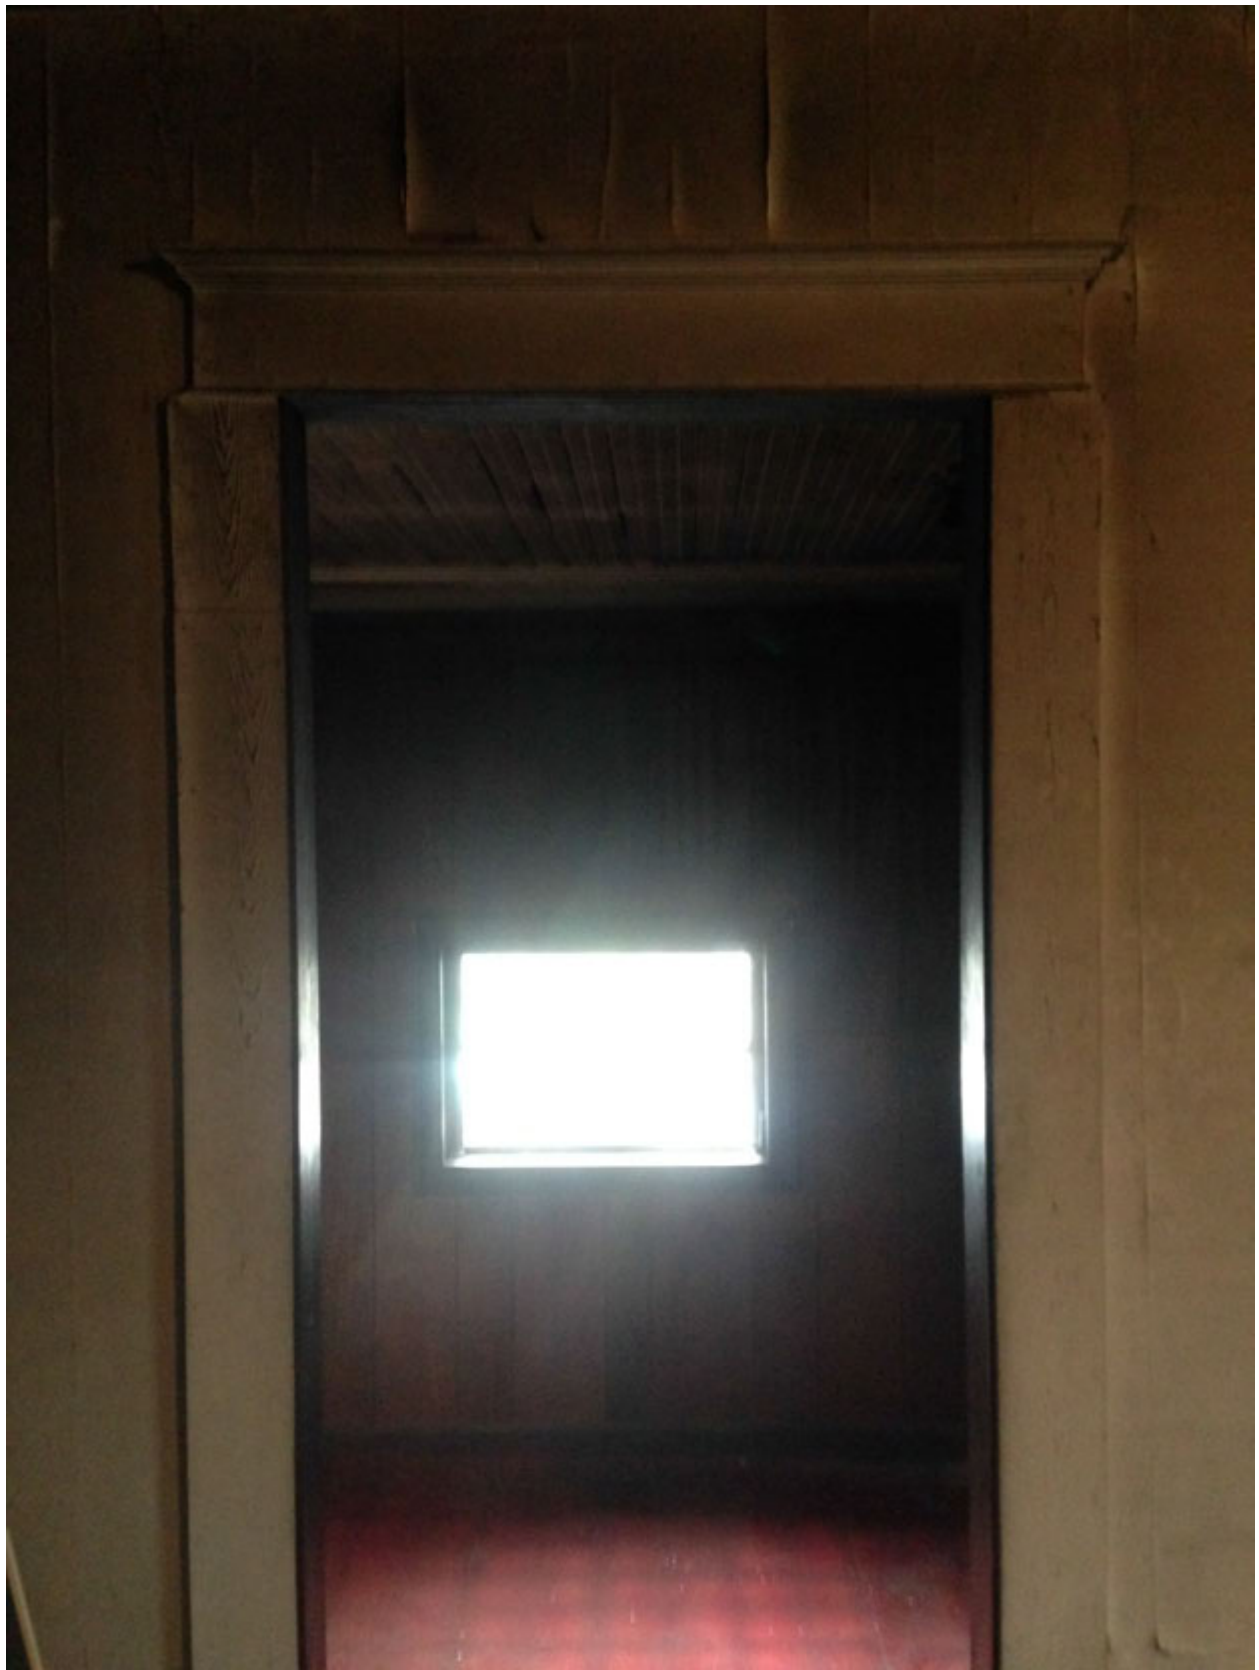
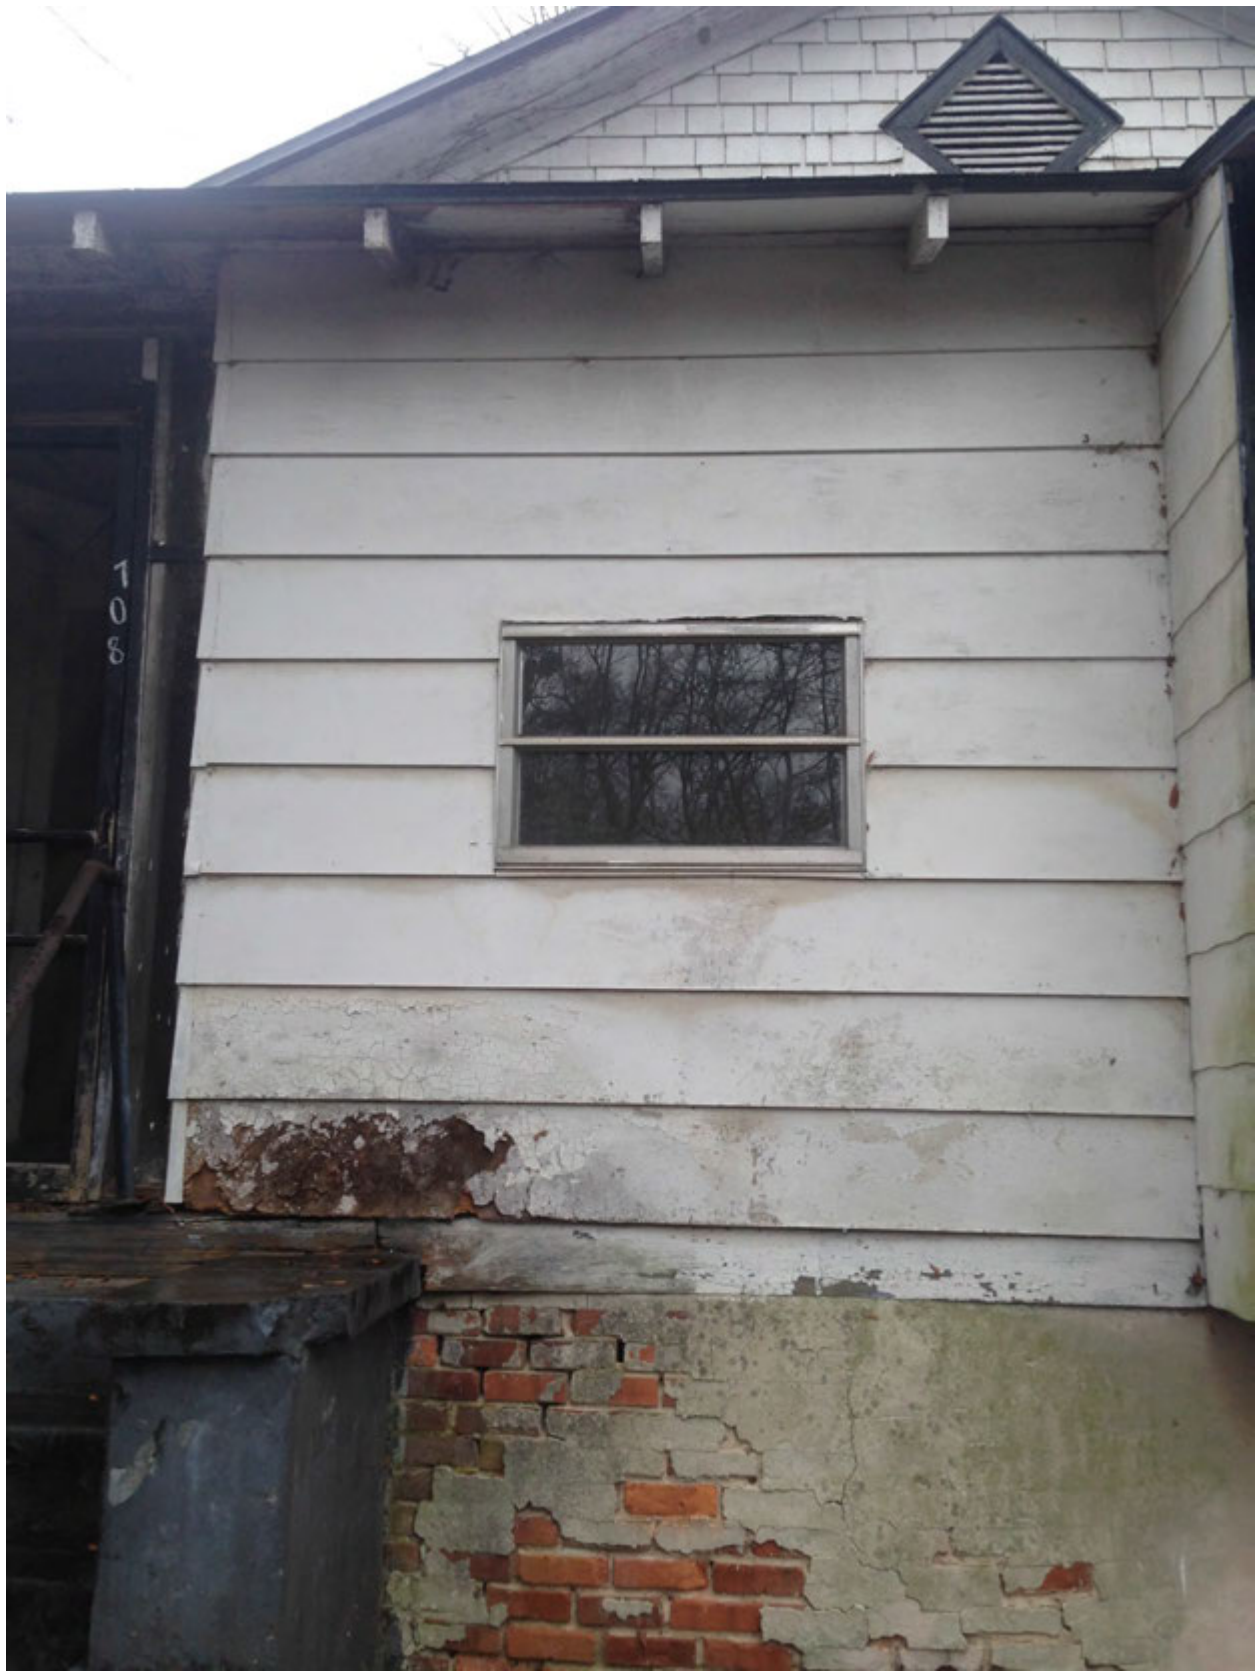
Window #: A1

Window #	Existing Type	Configuration	Existing Conditions						Proposed Window Type	Configuration	Remarks
			Repair Class			Sash					
			Sash	Frame	Sill	Original	Replaced	Unknown			
A1	Missing	N/A	N/A	N/A	N/A	N/A	N/A	N/A	Double Hung	6/1	This window was previously removed in order to enclose a portion of the porch by a previous owner and a doorway cut into the previous window opening. I plan to open this portion of the porch back up and install a new window in the opening that has been converted into a doorway. I plan to match the exterior trim of all the other windows on the south elevation with matching materials and profiles. New window shall be sized to match the other larger windows on the home, such as window B4, and have same 6/1 muntin configuration.
A2	Double Hung	4 vertical / 1	IV	IV	IV	X			Double Hung	4 vertical / 1	This window is located on the south elevation and is one of four in a row. This portion of the enclosed porch does not appear to be original, but was enclosed long ago based on trim and window types and the window does not match the muntin style of the original windows in the house. This window has severe sash, sill, and muntin deterioration and is proposed to be replaced. The sash is in such bad condition that the profile details are completely gone due to deterioration. Sash cords are cut and missing as well as counterweights. Panes have visible cracks and window does not operate correctly. Exterior trim is deteriorating at the sill from what appears to be years of leaves and rotting yard debris stuck between the sash and window screen. I plan to salvage whatever possible from the exterior trim and replace trim as required with matching materials and profiles. New window shall be sized to match existing rough opening and muntin configuration.
