RE: 190-14-CA (708 Dorothea Drive)

Property Address: 708 Dorothea Drive

Window Survey

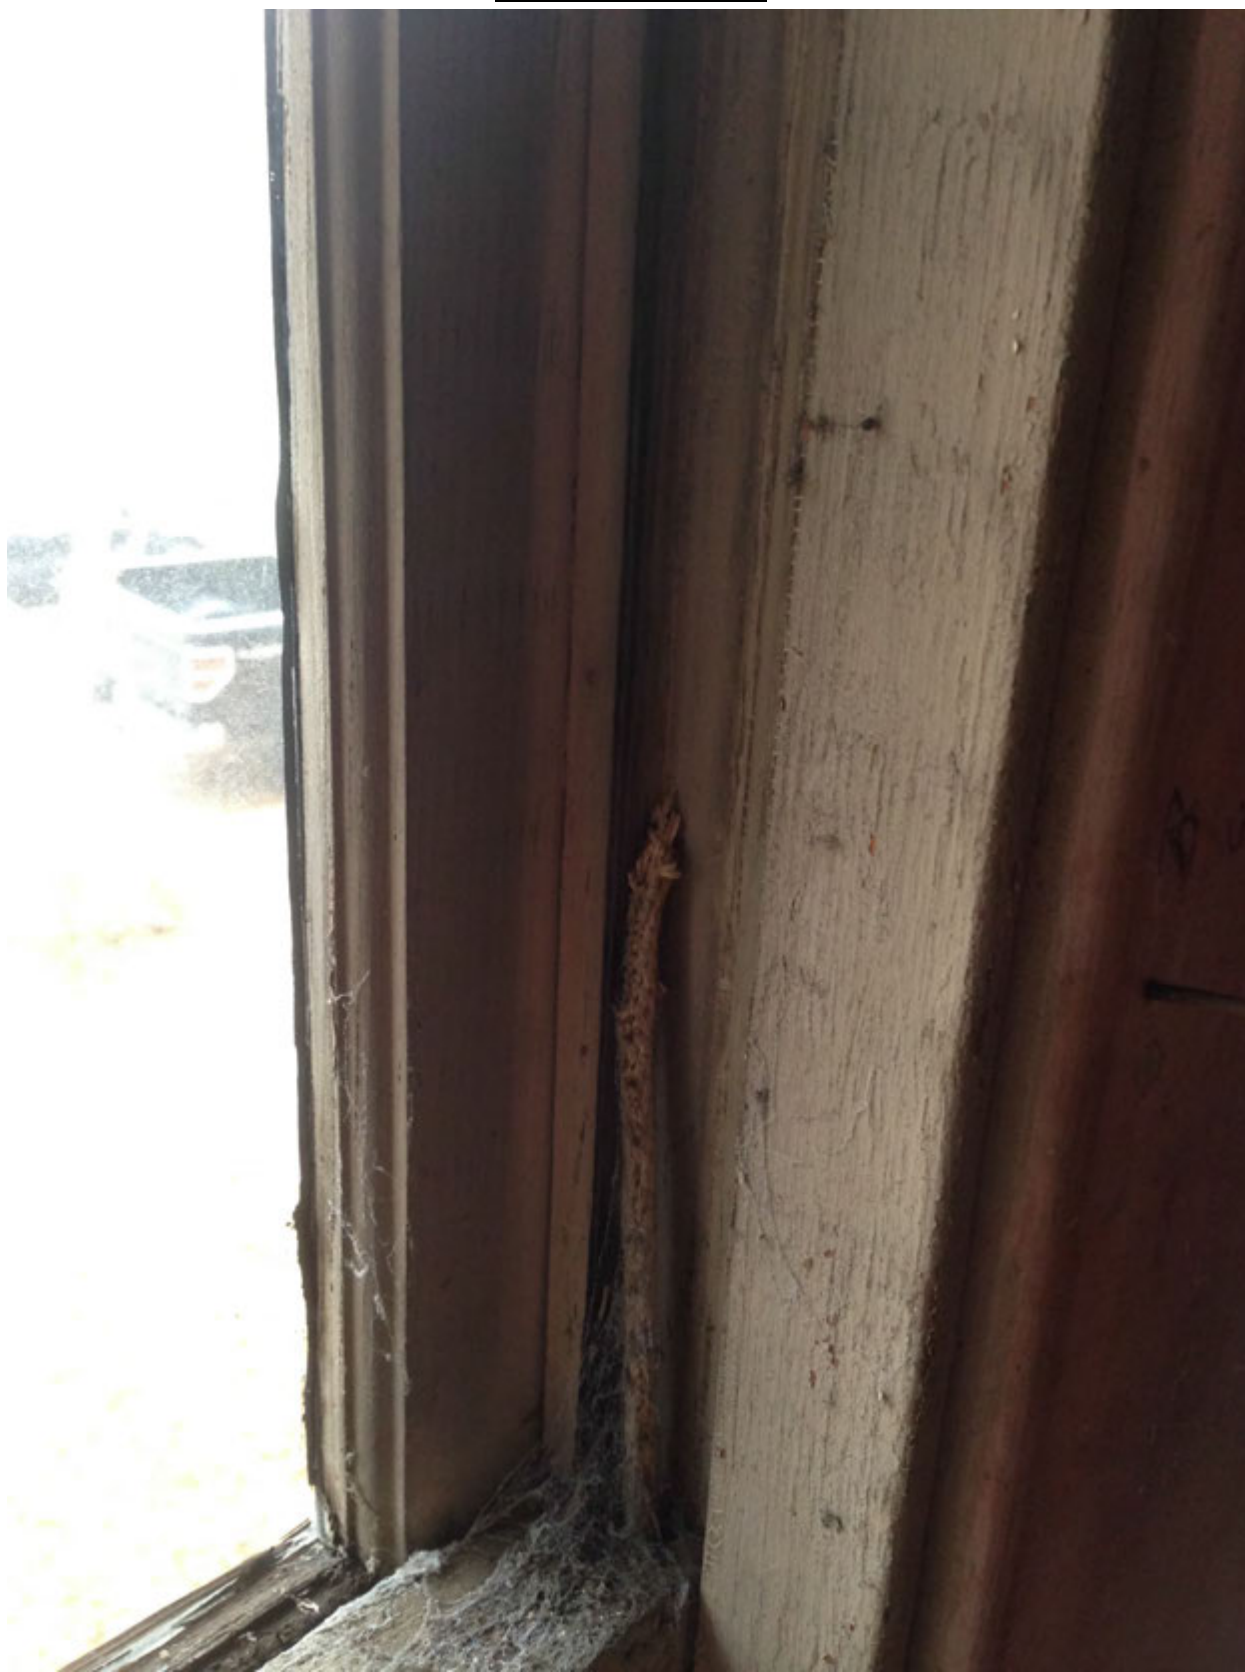
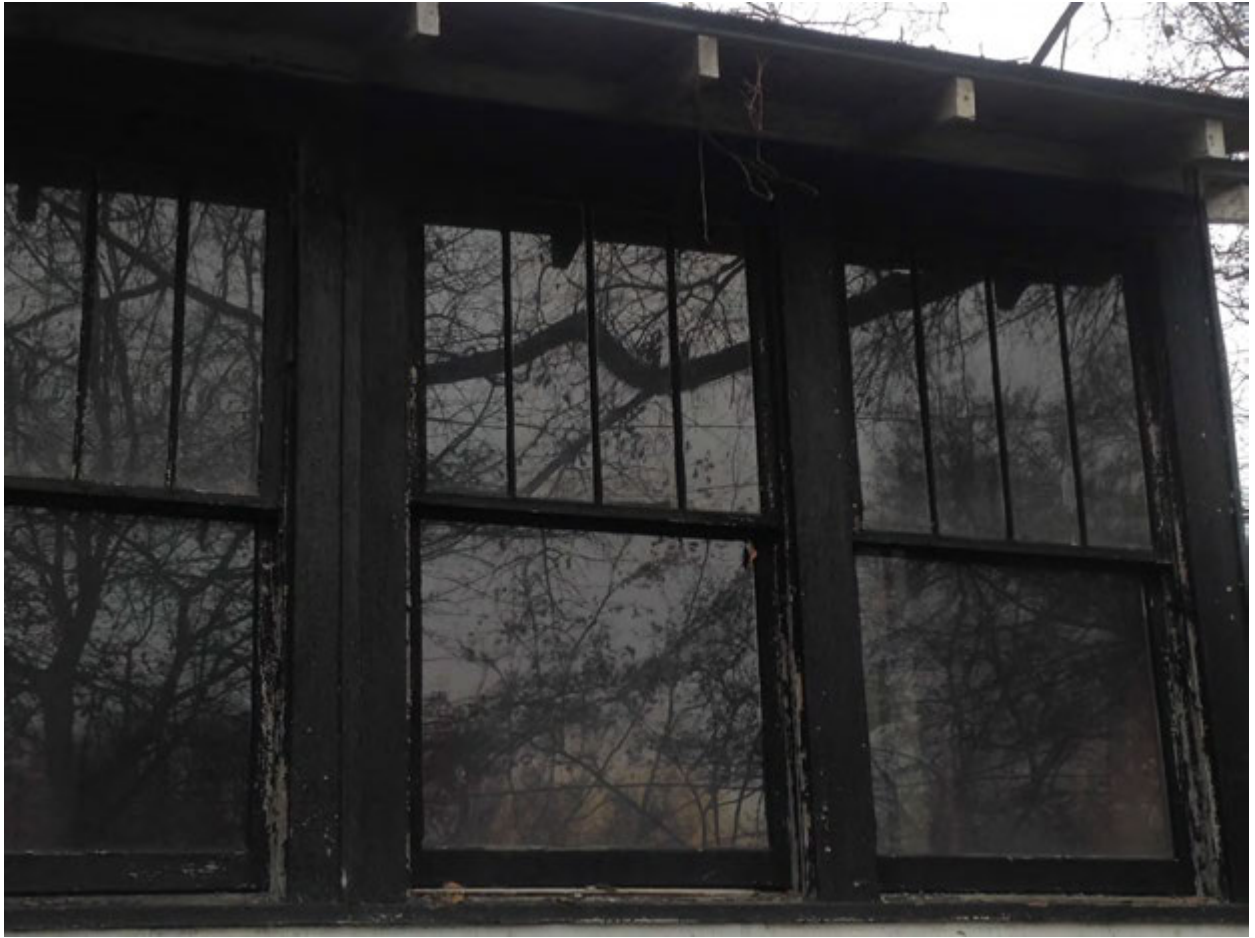
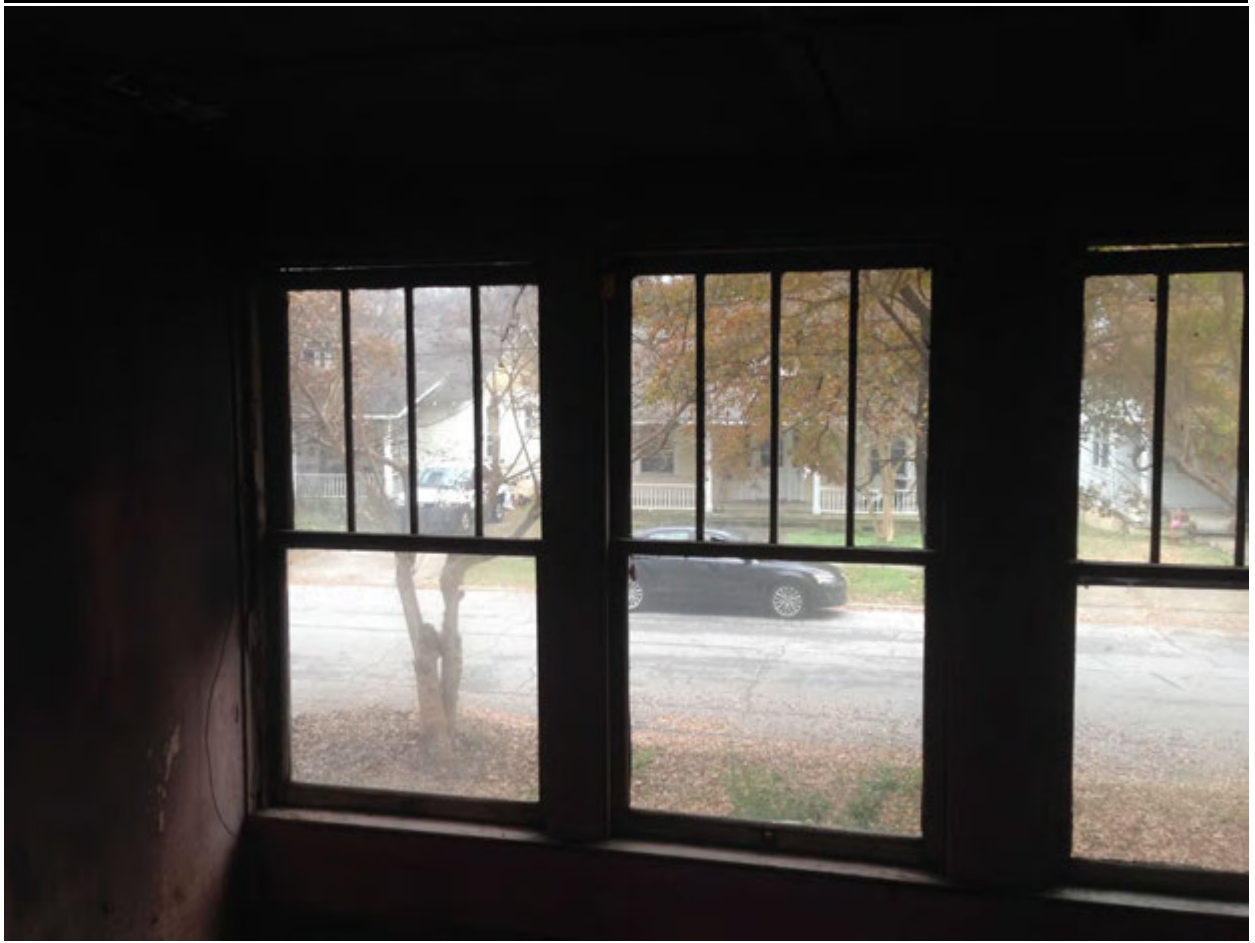
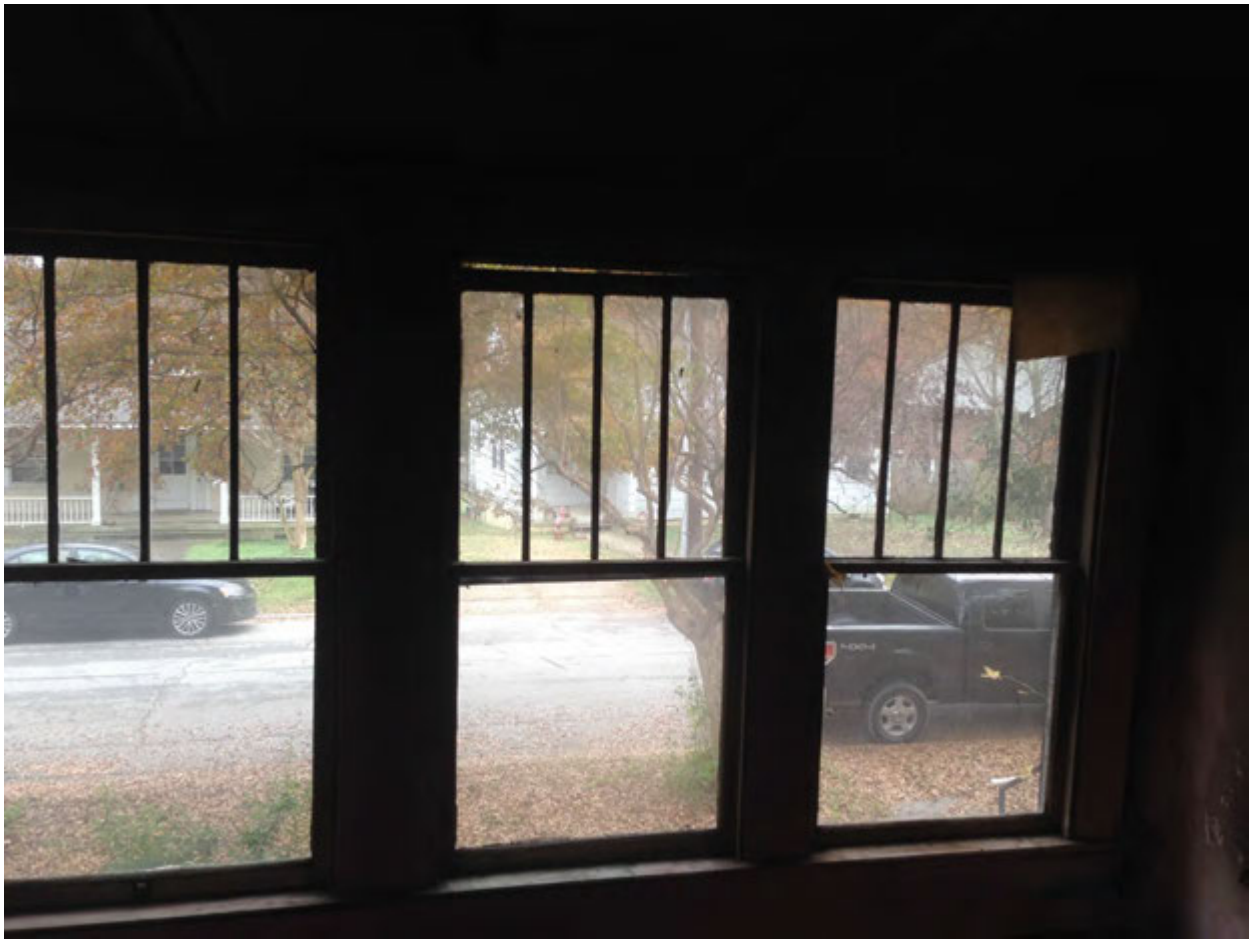
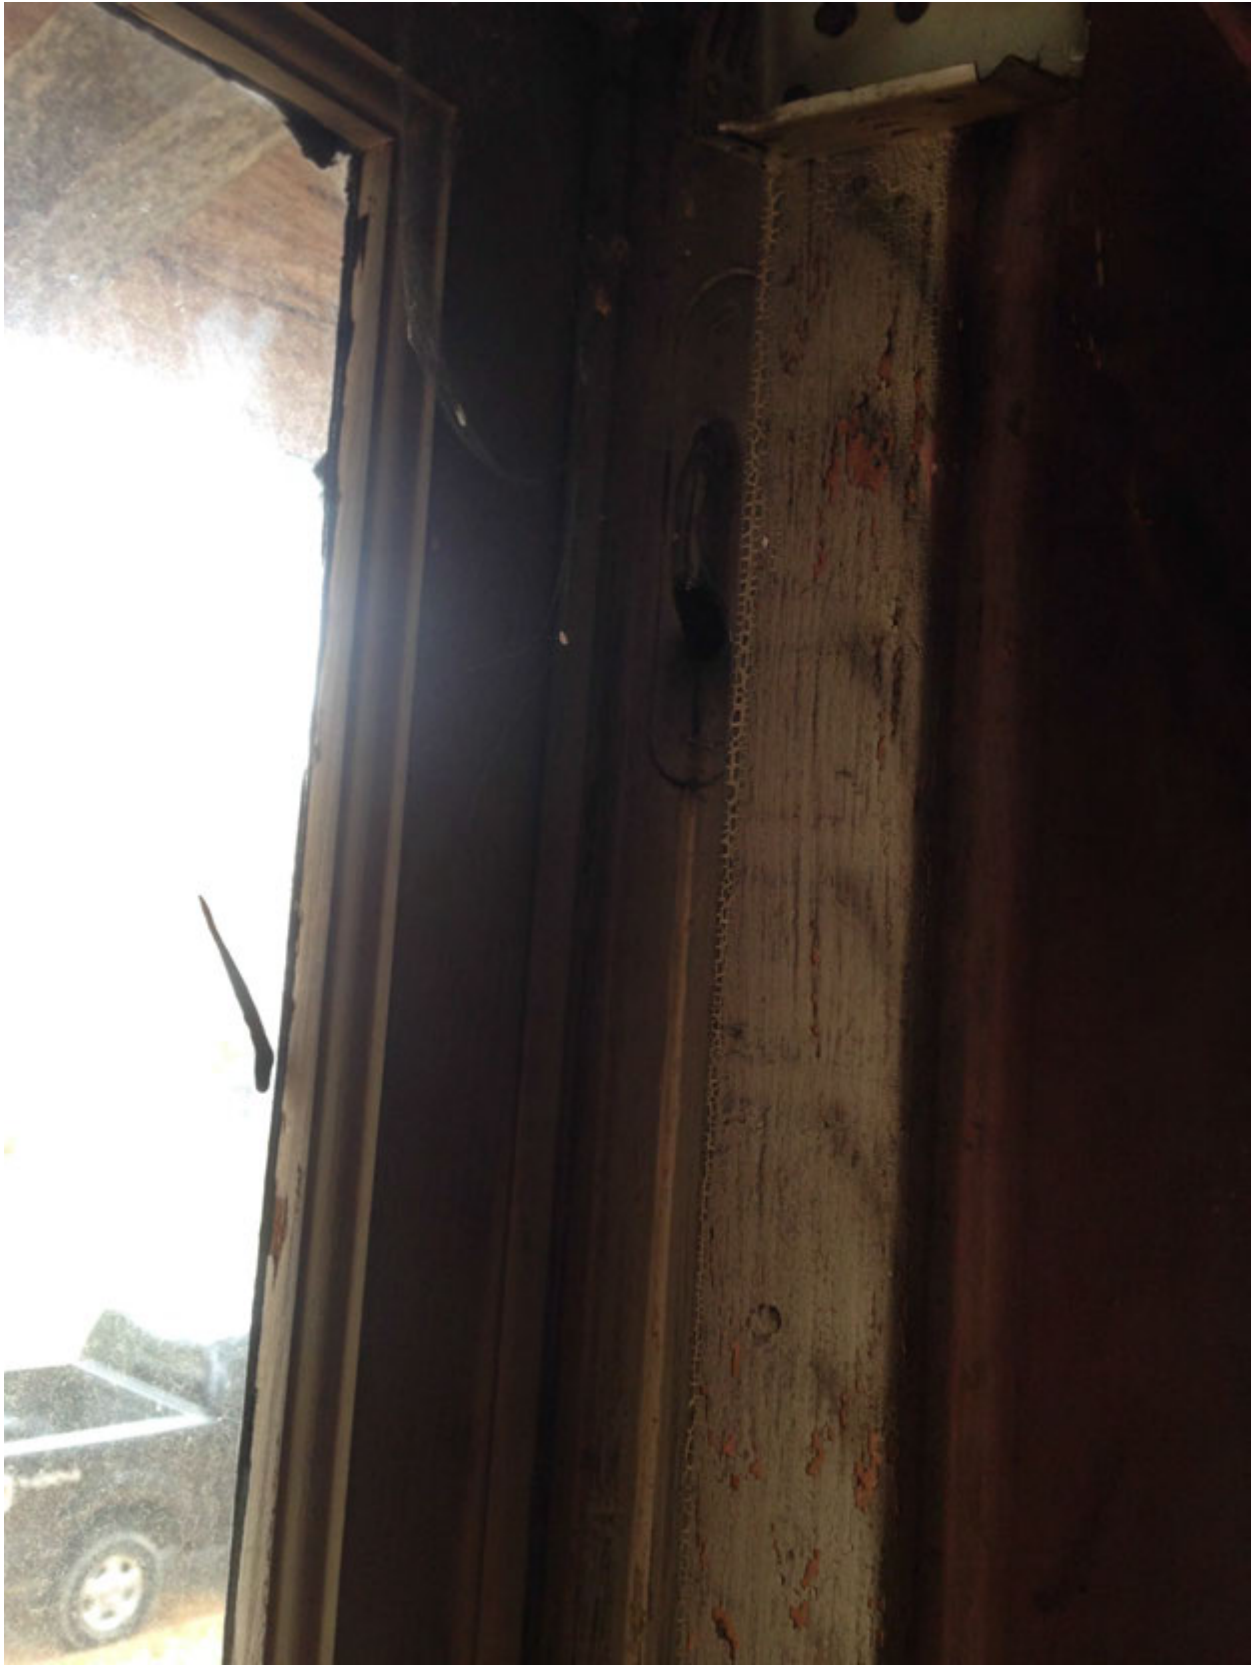
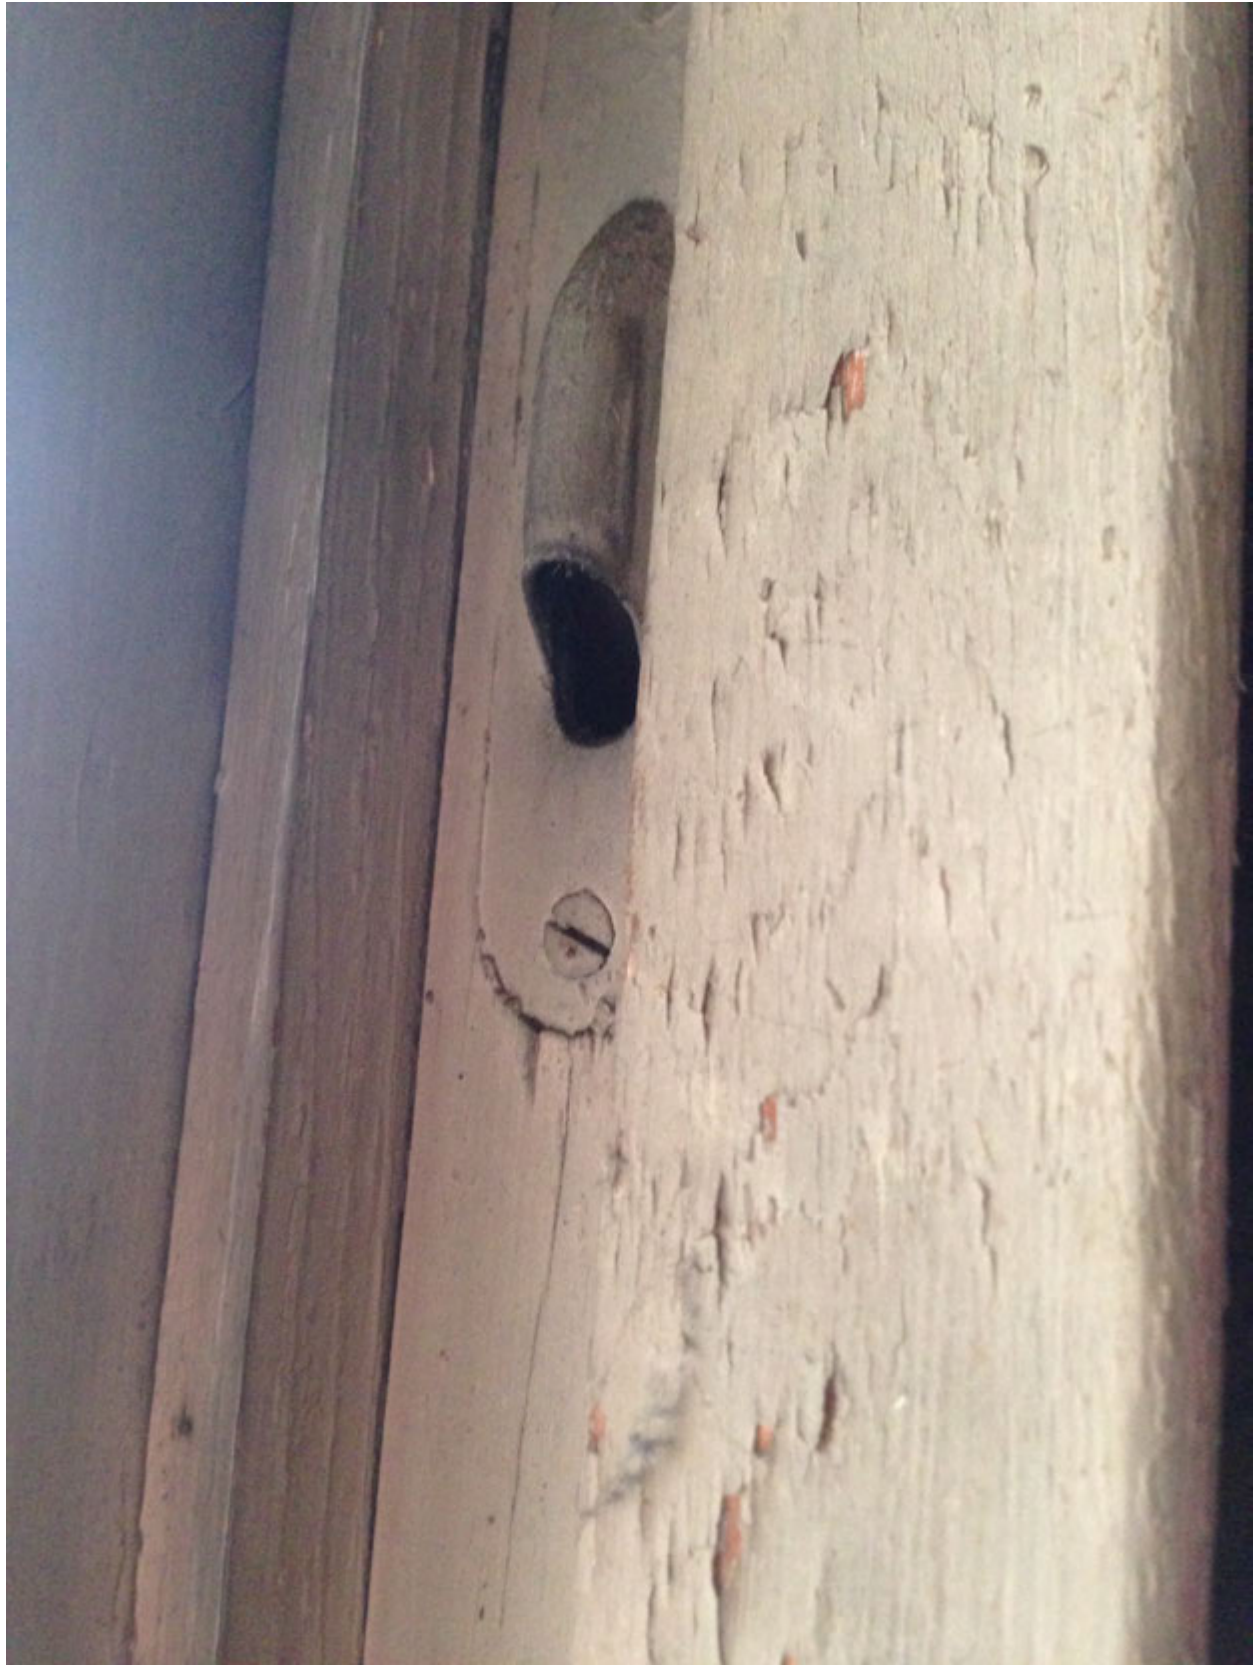
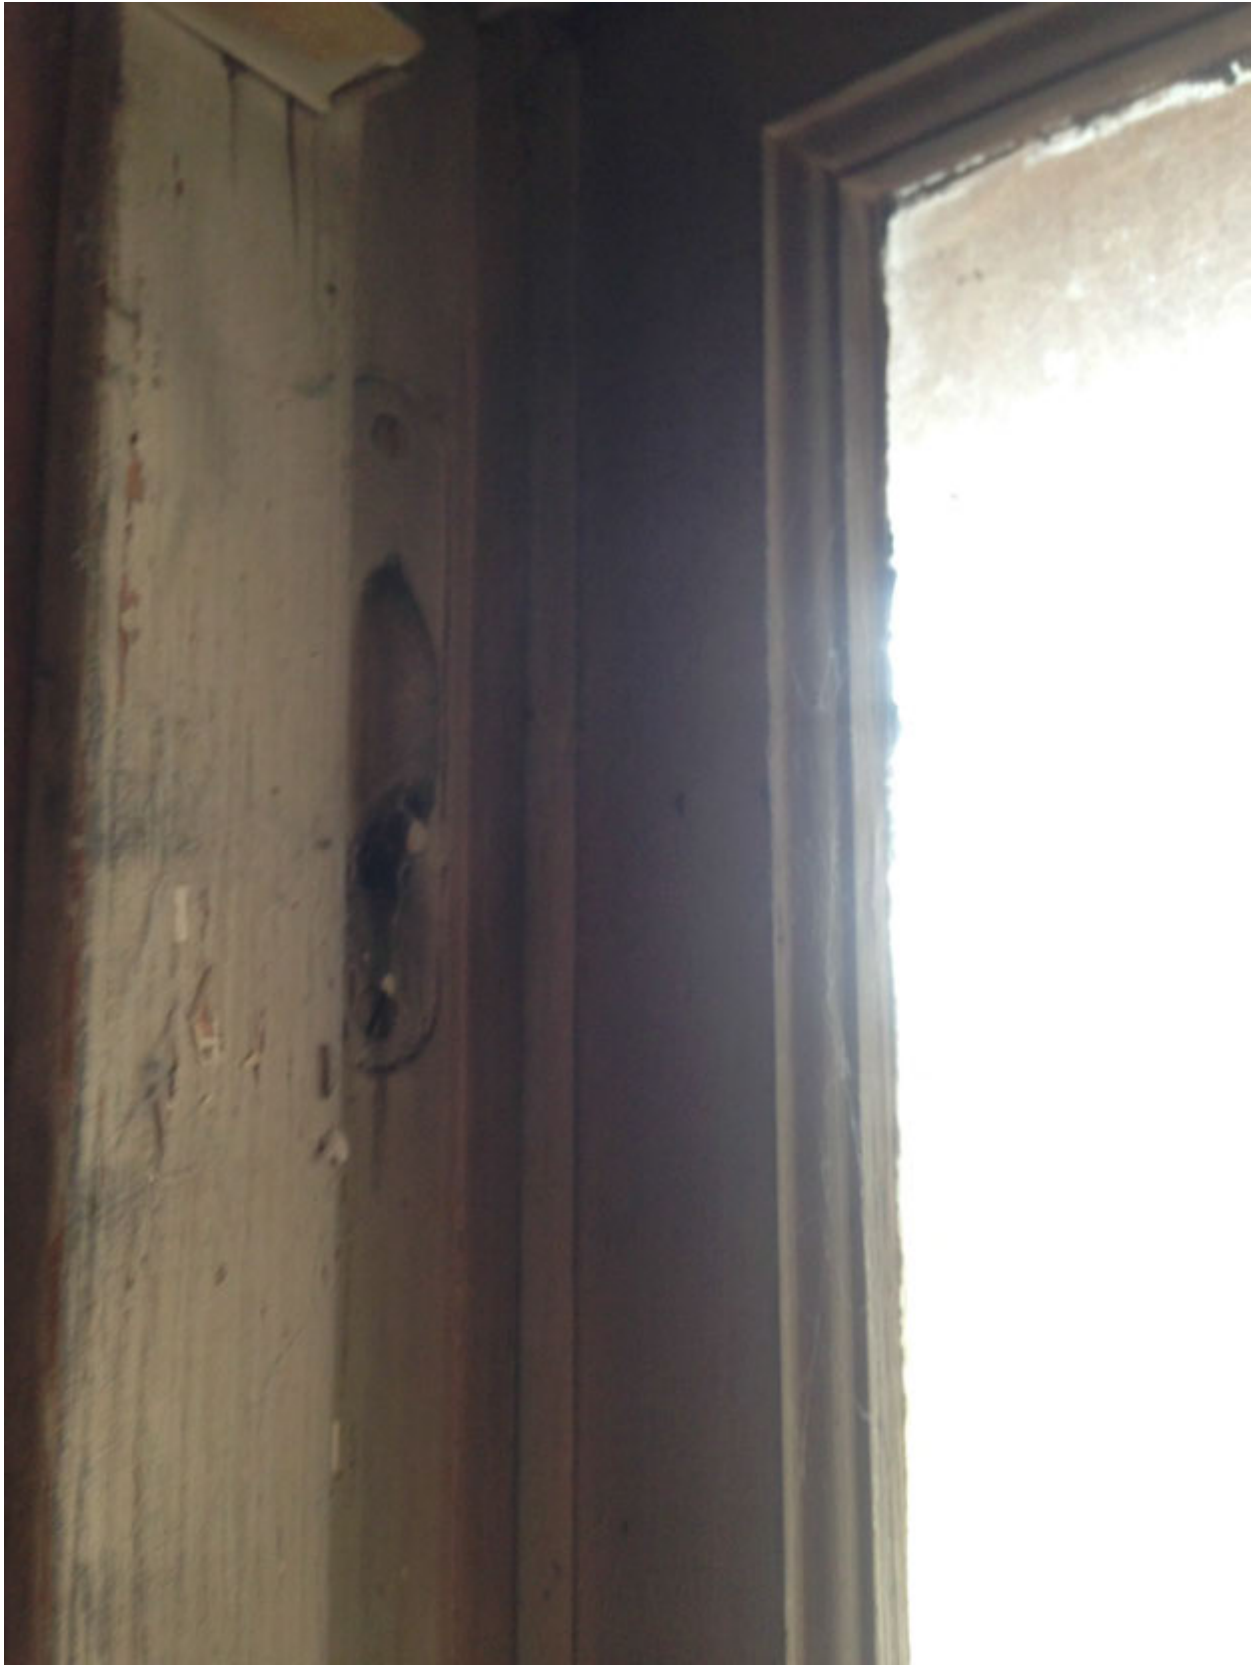
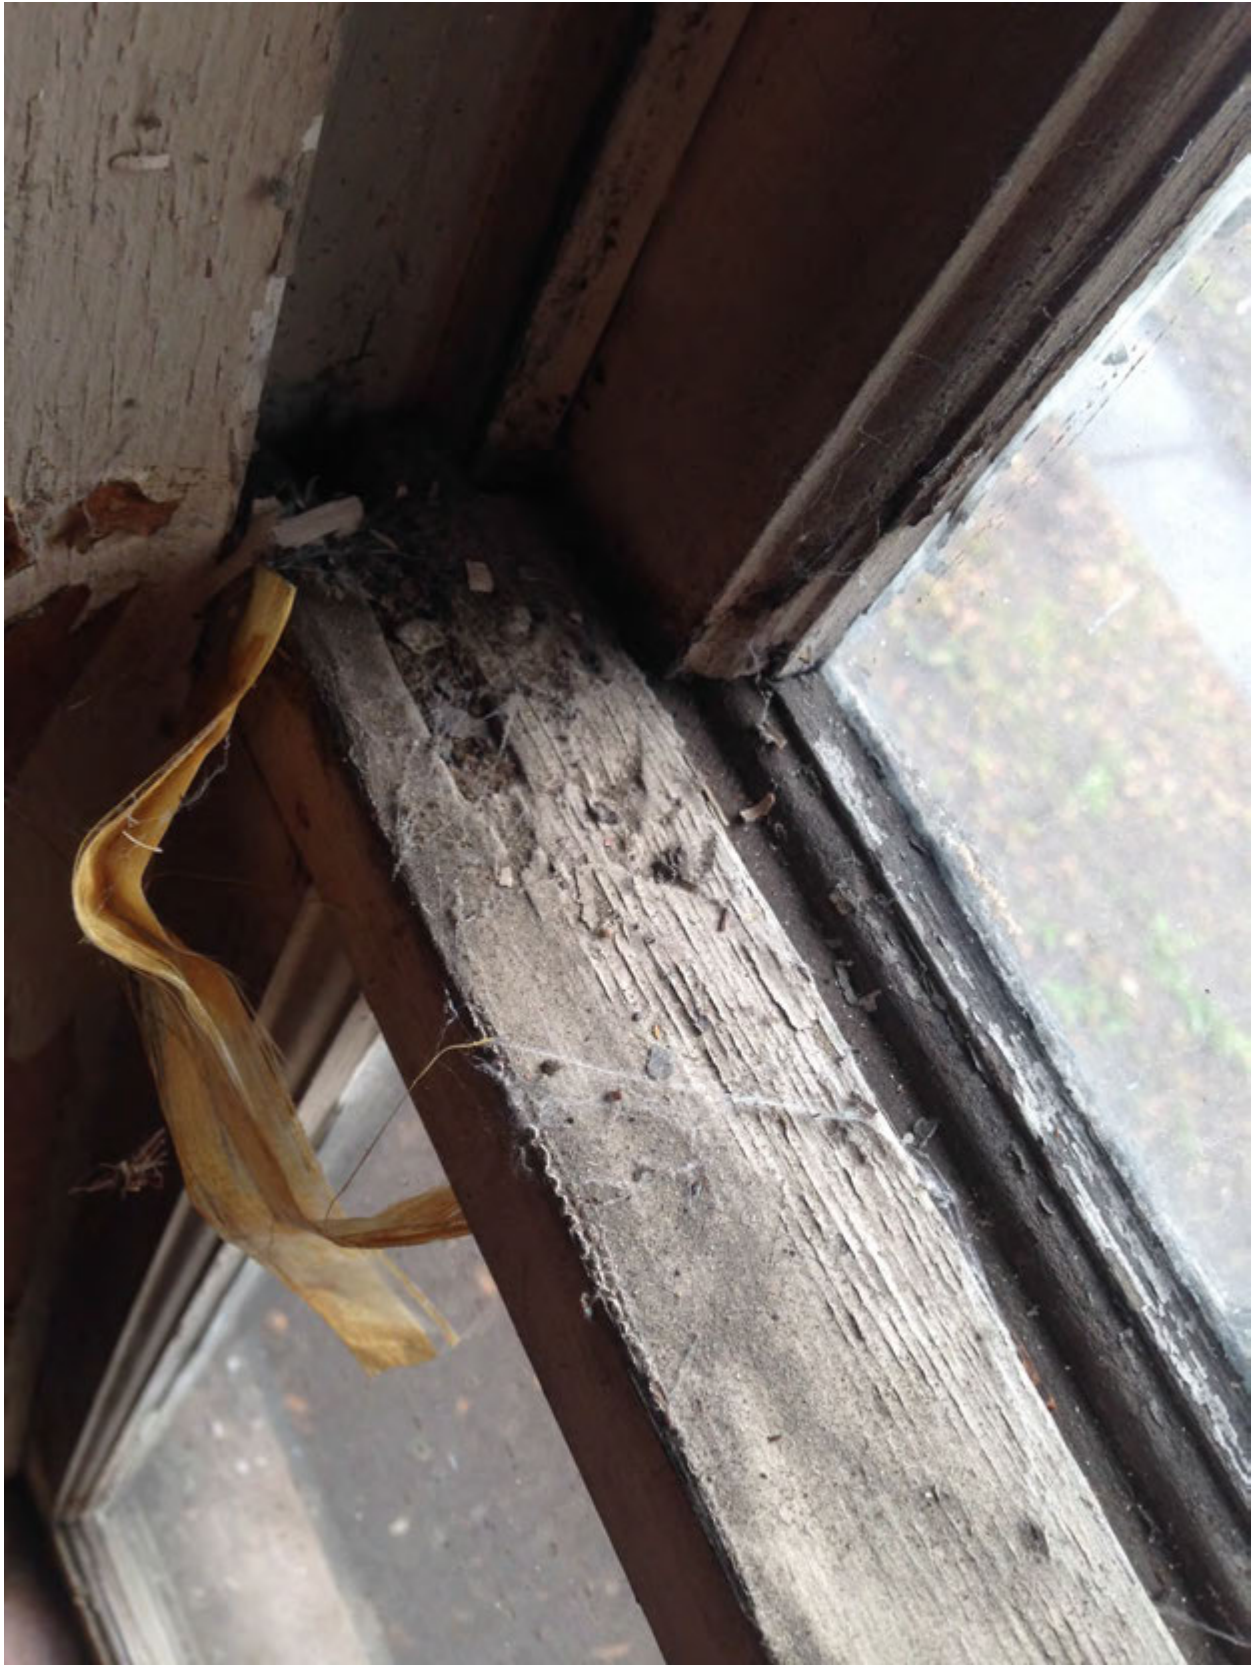
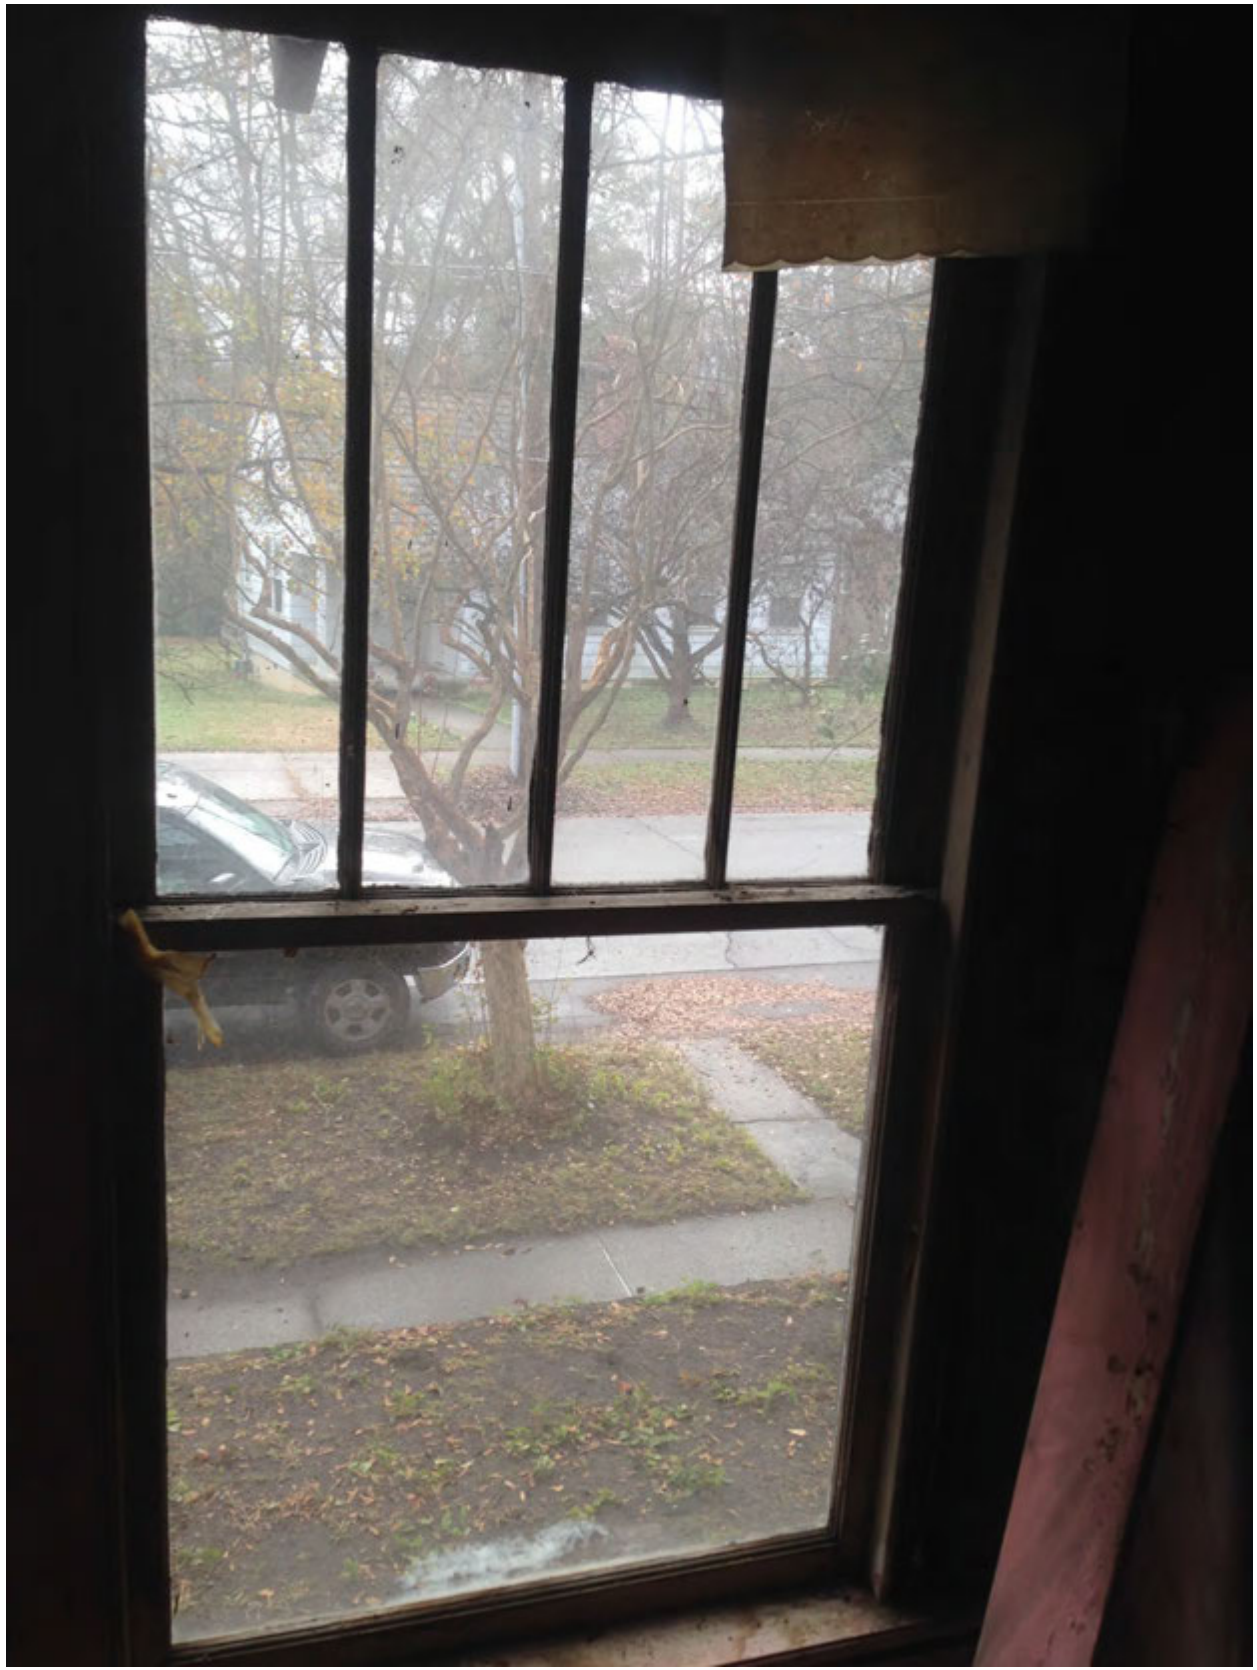
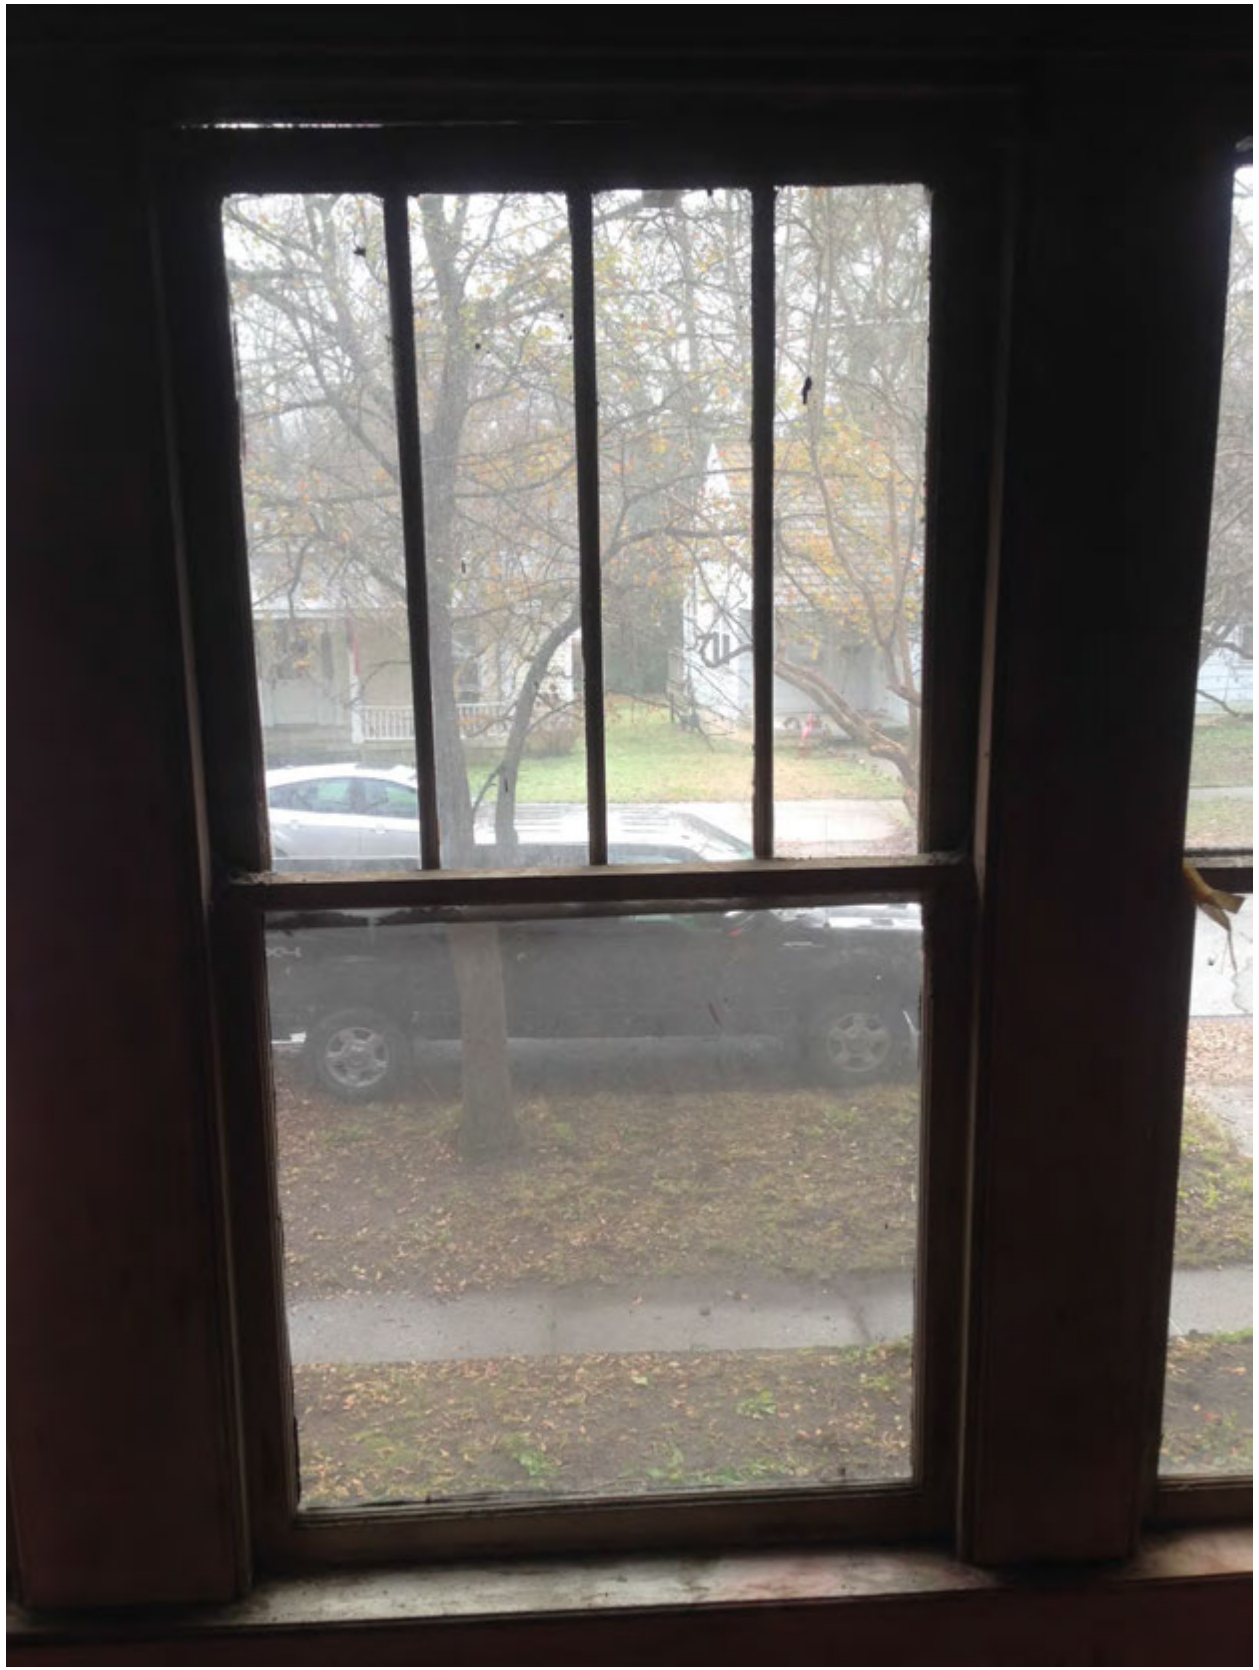
Window #: A2-A5

A3	Double Hung	4 vertical / 1	IV	IV	IV	X			Double Hung	4 vertical / 1	This window is located on the south elevation and is one of four in a row. This portion of the enclosed porch does not appear to be original, but was enclosed long ago based on trim and window types and the window does not match the muntin style of the original windows in the house. This window has severe sash, sill, and muntin deterioration and is proposed to be replaced. The sash is in such bad condition that the profile details are completely gone due to deterioration. Sash cords are cut and missing as well as counterweights. Panes have visible cracks and window does not operate correctly. Exterior trim is deteriorating at the sill from what appears to be years of leaves and rotting yard debris stuck between the sash and window screen. I plan to salvage whatever possible from the exterior trim and replace trim as required with matching materials and profiles. New window shall be sized to match existing rough opening and muntin configuration.

A4	Double Hung	4 vertical / 1	IV	IV	IV	X			Double Hung	4 vertical / 1	This window is located on the south elevation and is one of four in a row. This portion of the enclosed porch does not appear to be original, but was enclosed long ago based on trim and window types and the window does not match the muntin style of the original windows in the house. This window has severe sash, sill, and muntin deterioration and is proposed to be replaced. The sash is in such bad condition that the profile details are completely gone due to deterioration. Sash cords are cut and missing as well as counterweights. Panes have visible cracks and window does not operate correctly. Exterior trim is deteriorating at the sill from what appears to be years of leaves and rotting yard debris stuck between the sash and window screen. I plan to salvage whatever possible from the exterior trim and replace trim as required with matching materials and profiles. New window shall be sized to match existing rough opening and muntin configuration.

A5	Double Hung	4 vertical / 1	IV	IV	IV	X			Double Hung	4 vertical / 1	This window is located on the south elevation and is one of four in a row. This portion of the enclosed porch does not appear to be original, but was enclosed long ago based on trim and window types and the window does not match the muntin style of the original windows in the house. This window has severe sash, sill, and muntin deterioration and is proposed to be replaced. The sash is in such bad condition that the profile details are completely gone due to deterioration. Sash cords are cut and missing as well as counterweights. Panes have visible cracks and window does not operate correctly. Exterior trim is deteriorating at the sill from what appears to be years of leaves and rotting yard debris stuck between the sash and window screen. I plan to salvage whatever possible from the exterior trim and replace trim as required with matching materials and profiles. New window shall be sized to match existing rough opening and muntin configuration.

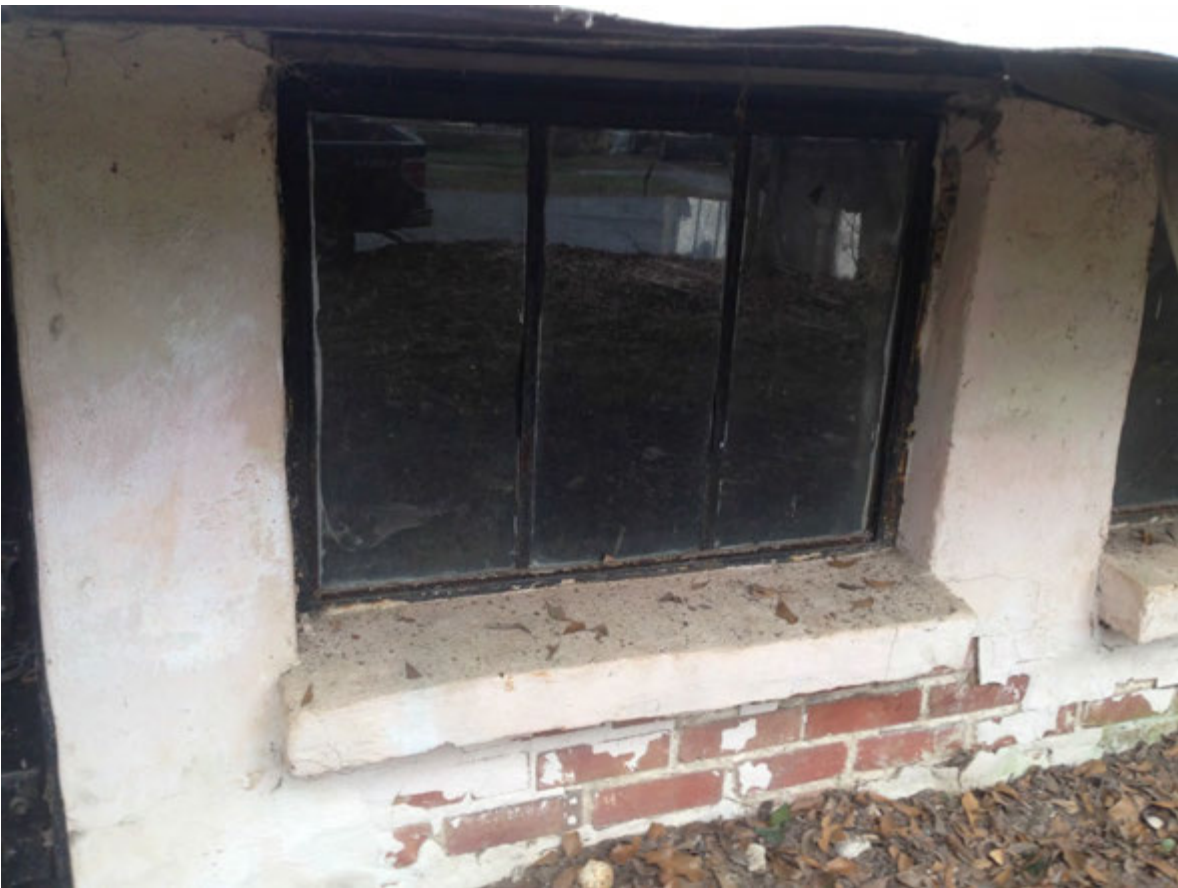
Window #: A6

A6	Fixed Frame	3 vertical	IV	IV	II	X			N/A	N/A	This window is located on the south elevation and is one of two on this elevation located in the foundation wall to provide natural light into the partial basement. The window has a steel frame with three vertical panes. I plan to repair the glass in this window as required, but overall there will be no changes.
A7	Fixed Frame	3 vertical	IV	IV	II	X			N/A	N/A	This window is located on the south elevation and is one of two on this elevation located in the foundation wall to provide natural light into the partial basement. The window has a steel frame with three vertical panes. I plan to repair the glass in this window as required, but overall there will be no changes.
