RE: 190-14-CA (708 Dorothea Drive)

Property Address: 708 Dorothea Drive

Window Survey

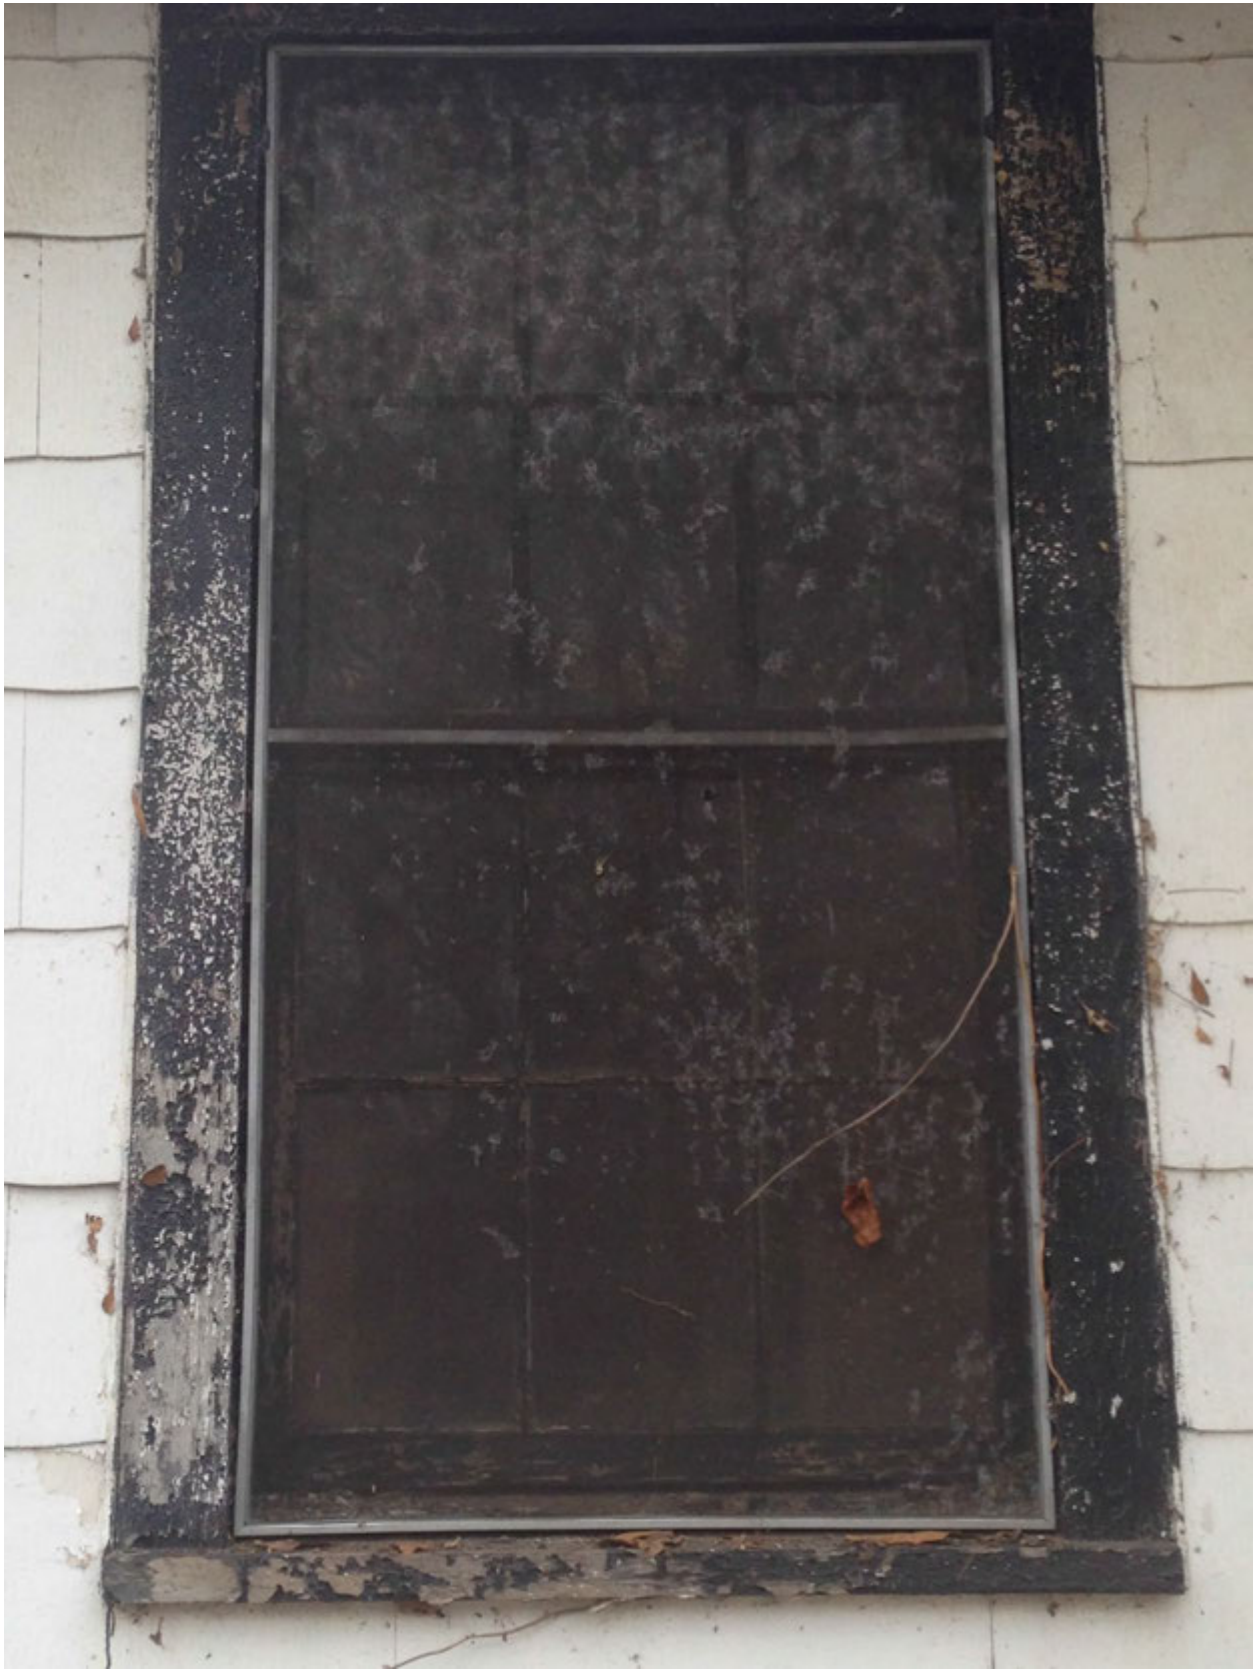
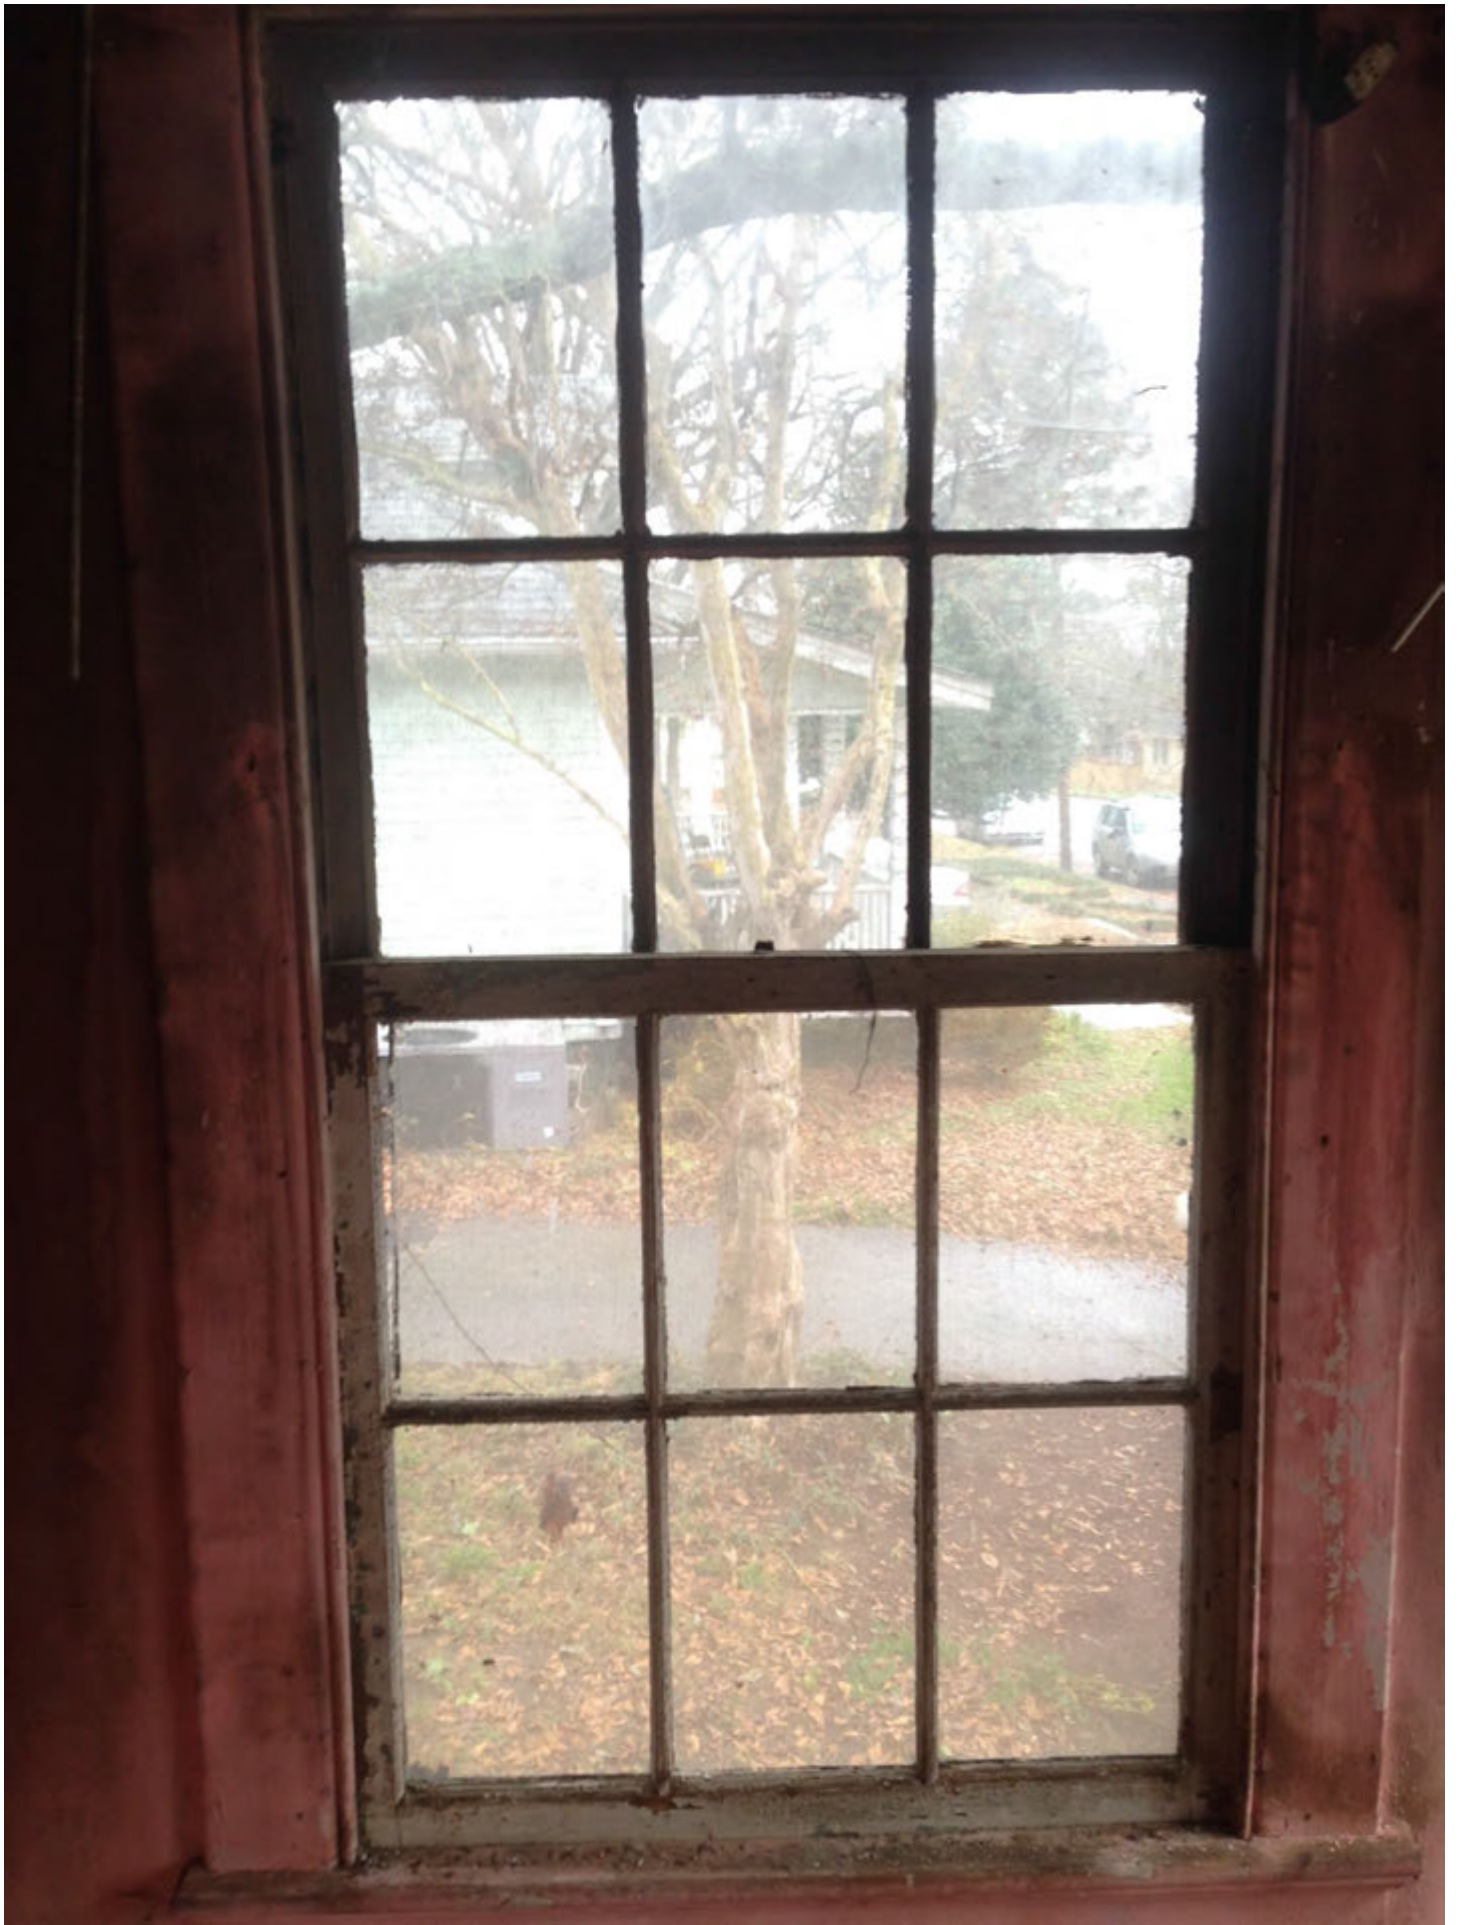
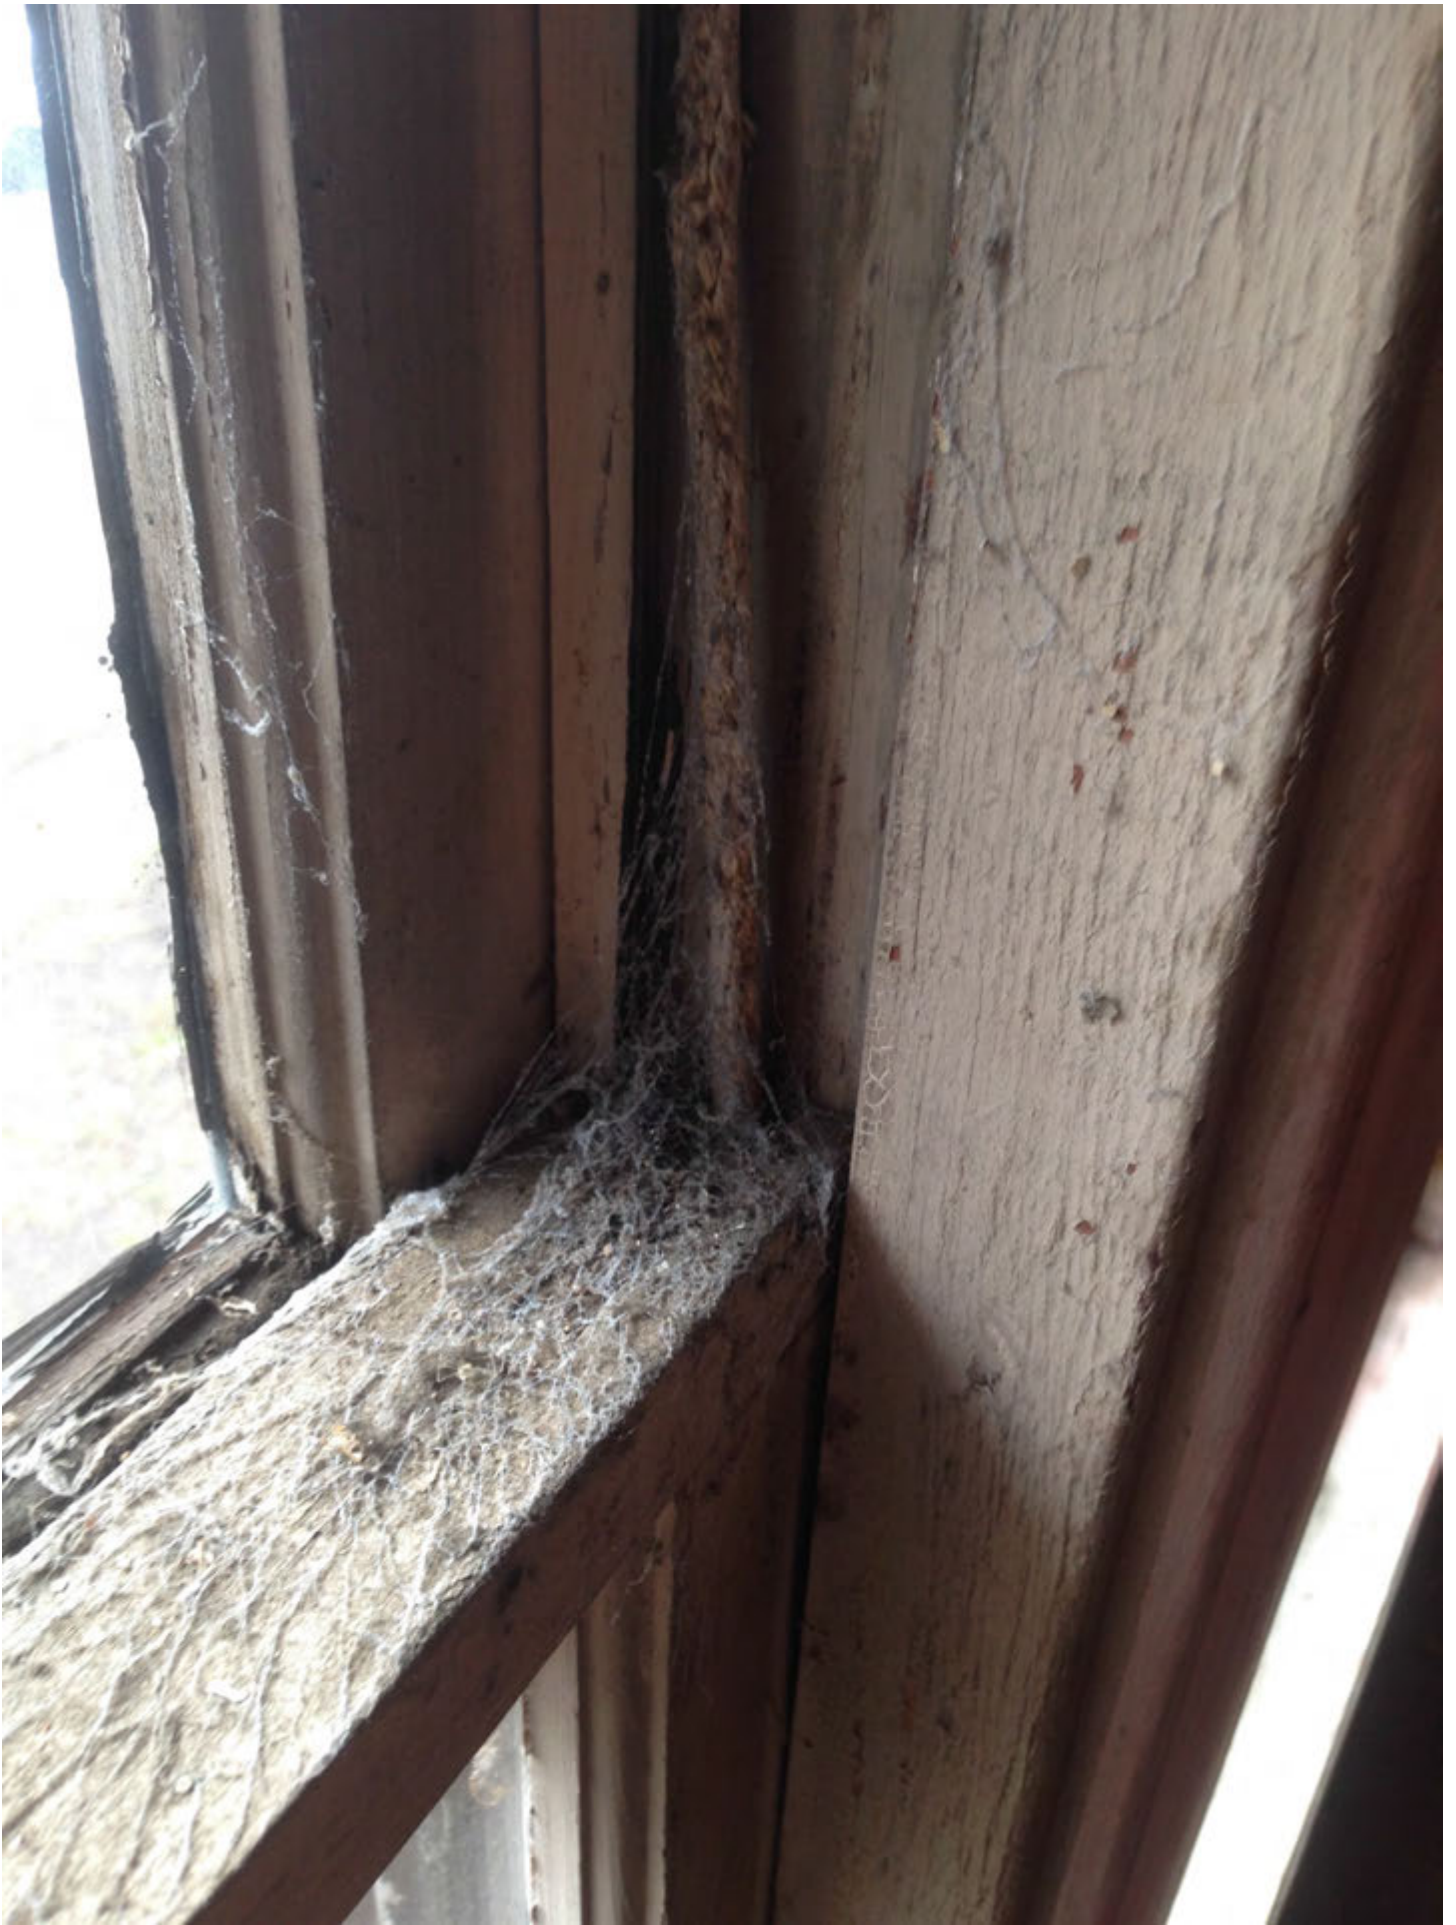
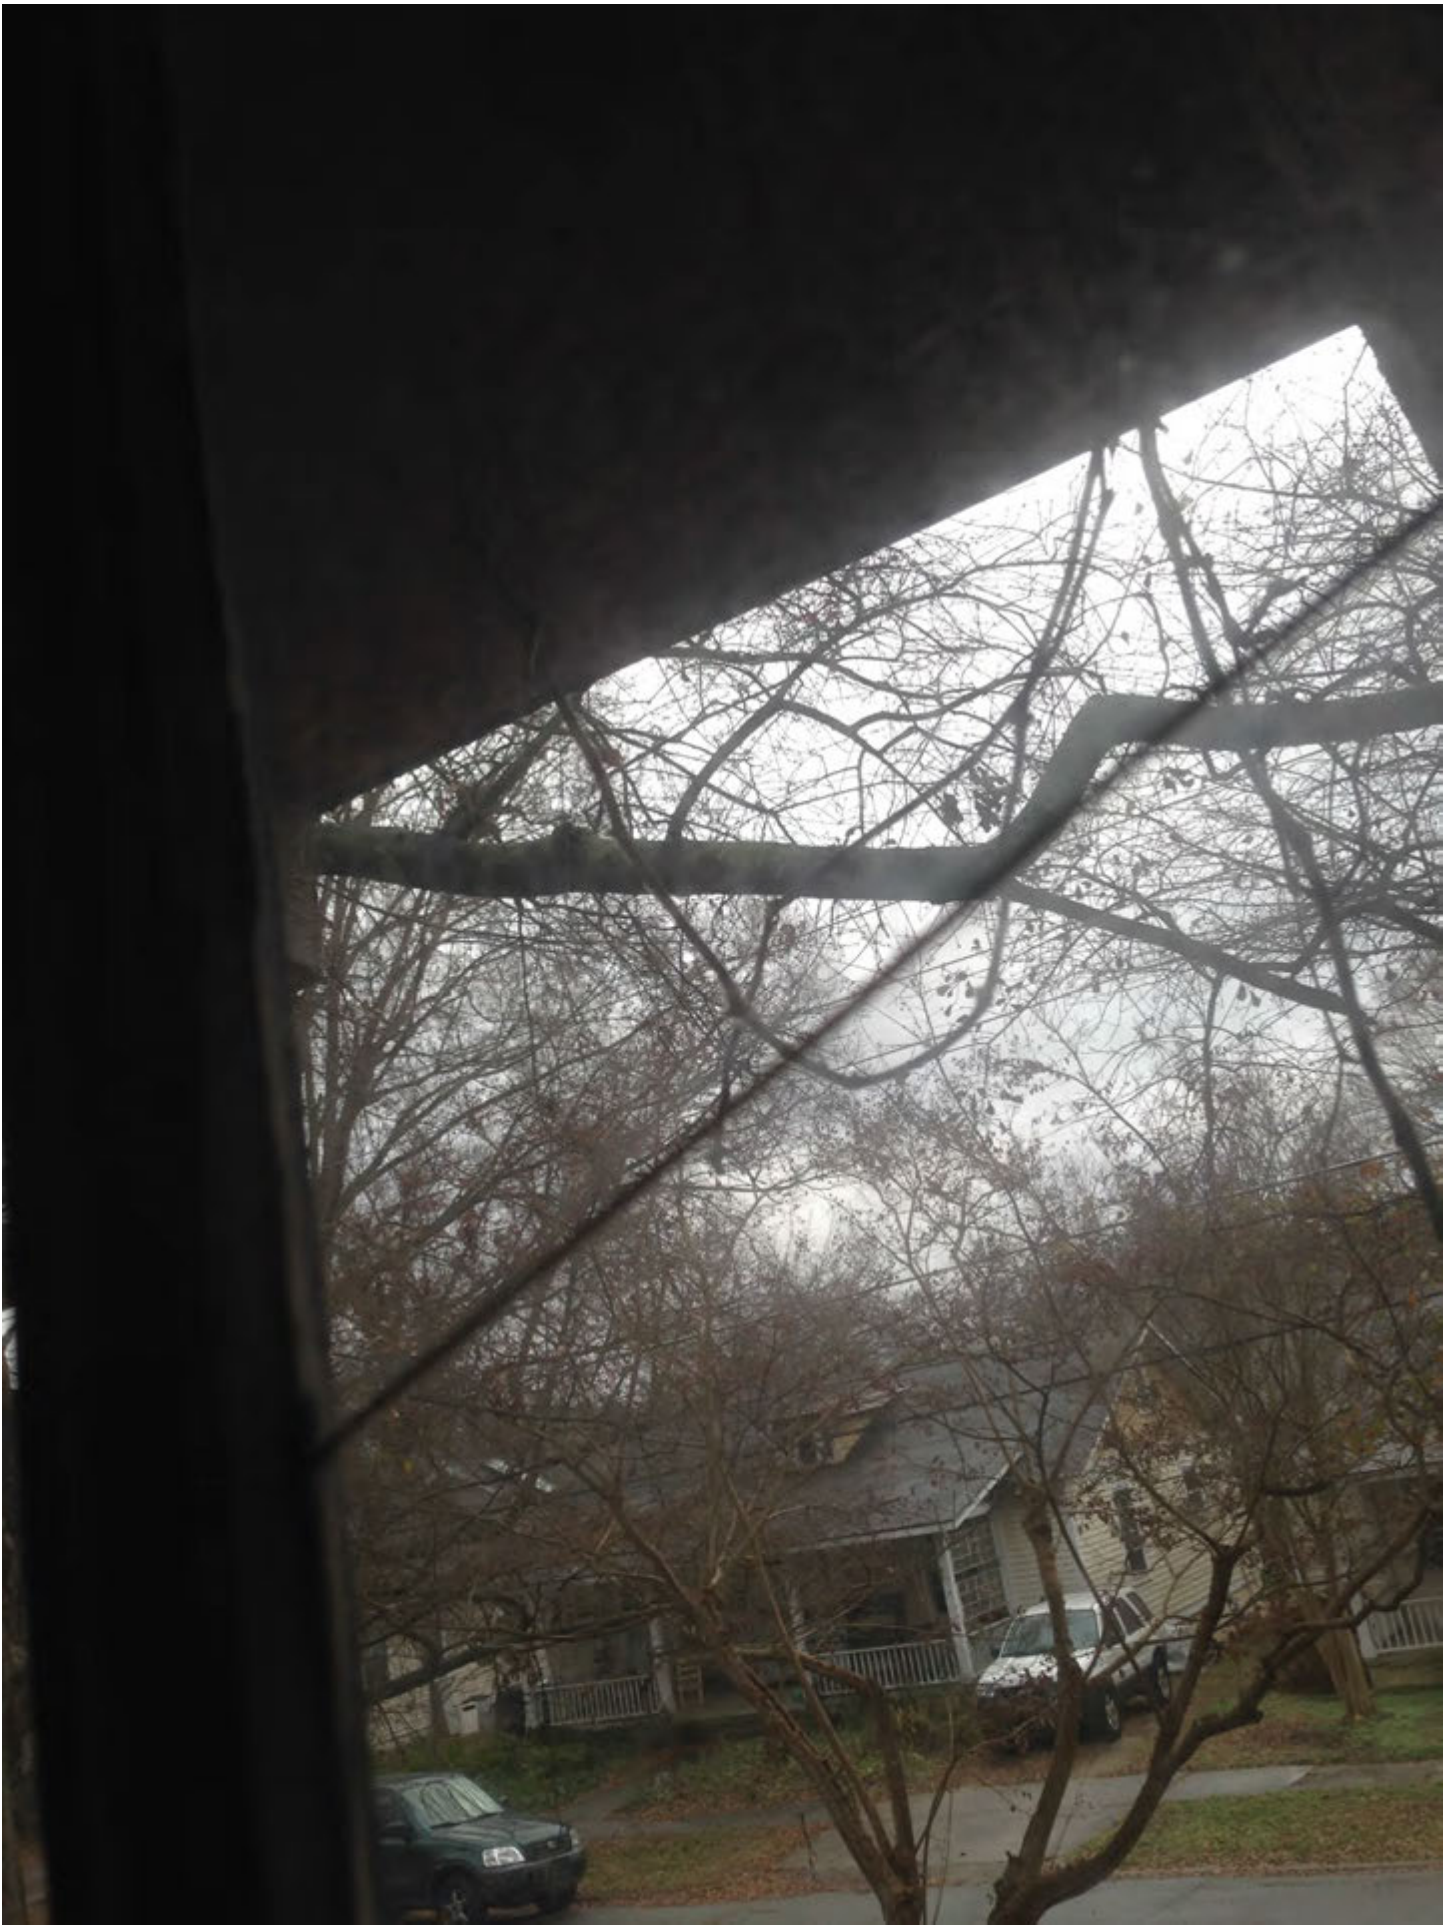
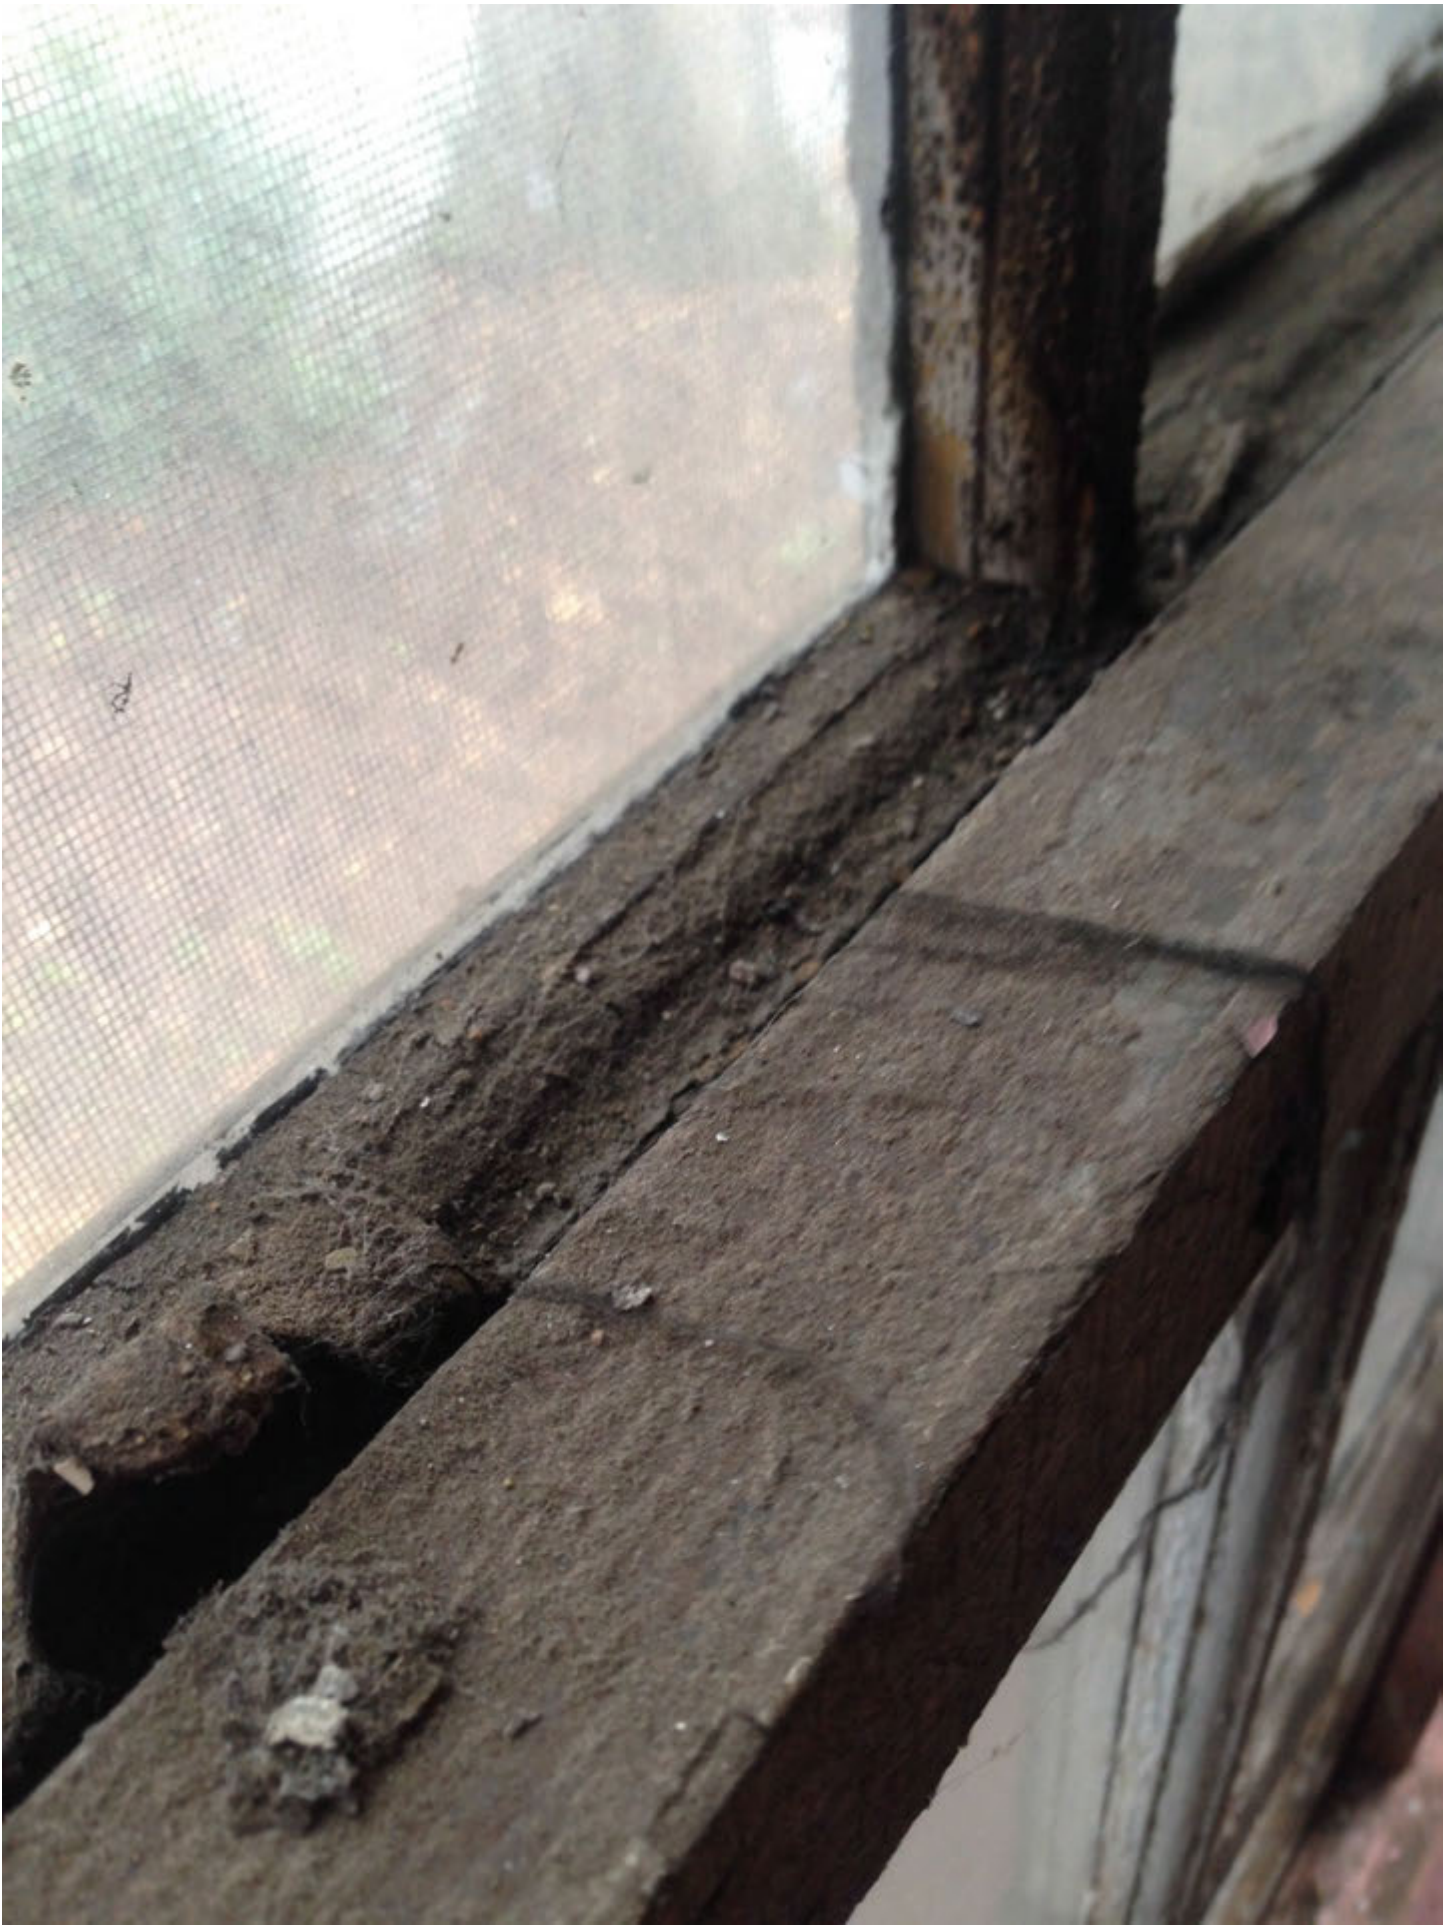
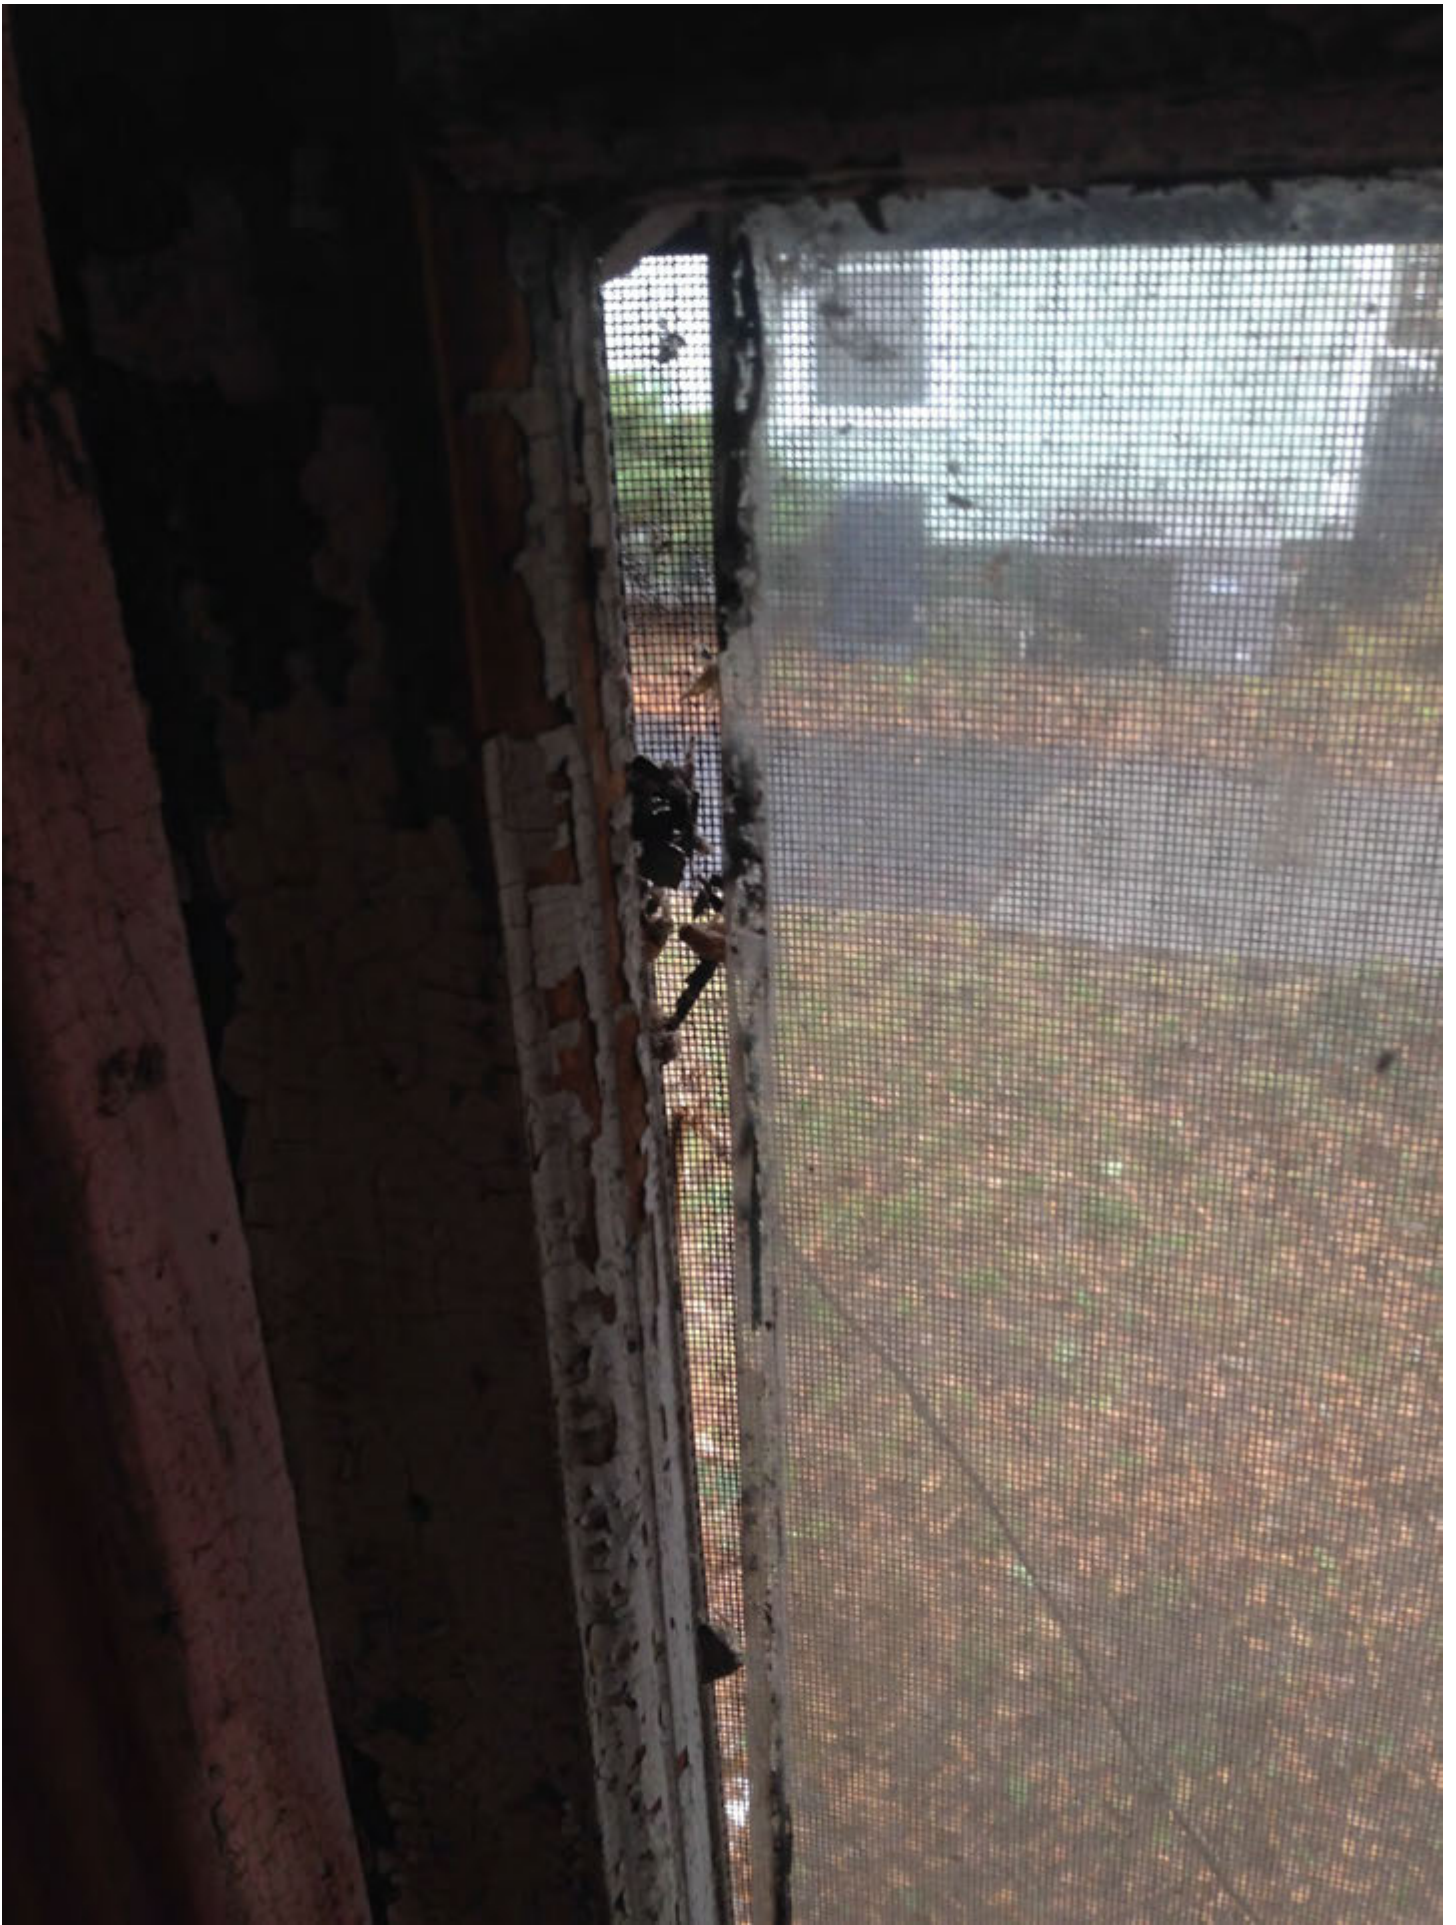
Window #: B1

B1	Double Hung	6/6	IV	IV	IV		X		Double Hung	6/6	This window is located on the east elevation. This portion of the enclosed porch does not appear to be original, but was enclosed long ago based on trim and window types. The bottom sash of this window appears to have been replaced with a newer six lite muntin configuration. Not only is one of sashes not original, but this window has severe sash, sill, and muntin deterioration and is therefore proposed to be replaced. The sash is in such bad condition that the profile details are completely gone due to deterioration. Sash cords are cut, therefore the window does not operate properly. Panes have visible cracks and holes. Exterior trim is deteriorating at the sill from what appears to be years of leaves and rotting yard debris stuck between the sash and window screen. I plan to salvage whatever possible from the exterior trim and replace trim as required with matching materials and profiles. New window shall be sized to match the existing rough opening and the muntin configuration changed back to what is assumed to be original (6/1). The reason I believe this window was originally 6/1 is due to the pulley system. The pulley hardware does not match the 4 vertical / 1 configuration, rather it matches the 6/1 window pulleys.

The only windows that would require replacement are the two picture windows on the western elevation (B8 & B9), the one picture window on the eastern elevation (B3), and the bottom sash of the porch window on the eastern elevation (B3). From talking with the preservationist, it appears the bottom sash of B1 was actually taken from B3; therefore I plan to reuse this sash in the location of B3 and replace the bottom sash of B1 with a salvaged single lite sash. In regards to B8 & B9 these need to be replaced. I plan to salvage 6 lite picture windows from Habitat Restore that match B3 to use in these locations.
