RE: 190-14-CA (708 Dorothea Drive)

Property Address: 708 Dorothea Drive

Window Survey

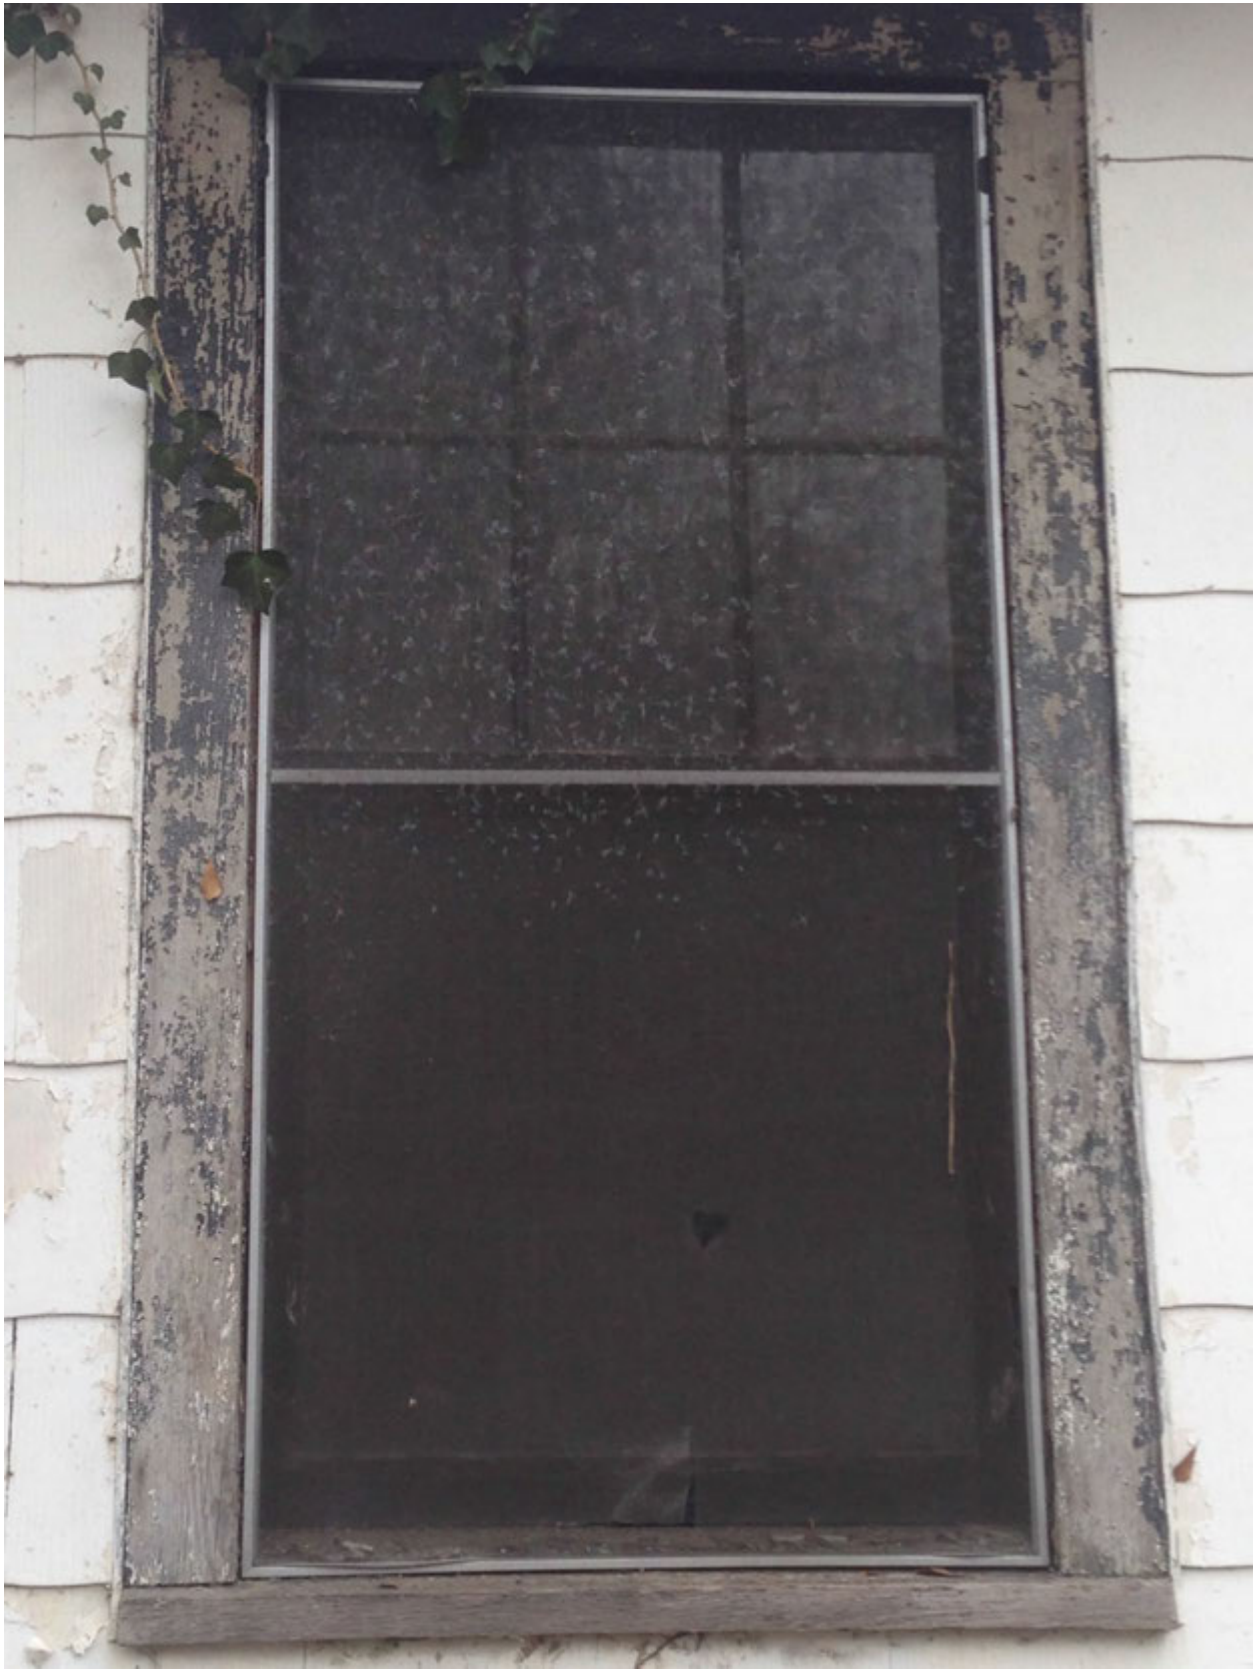
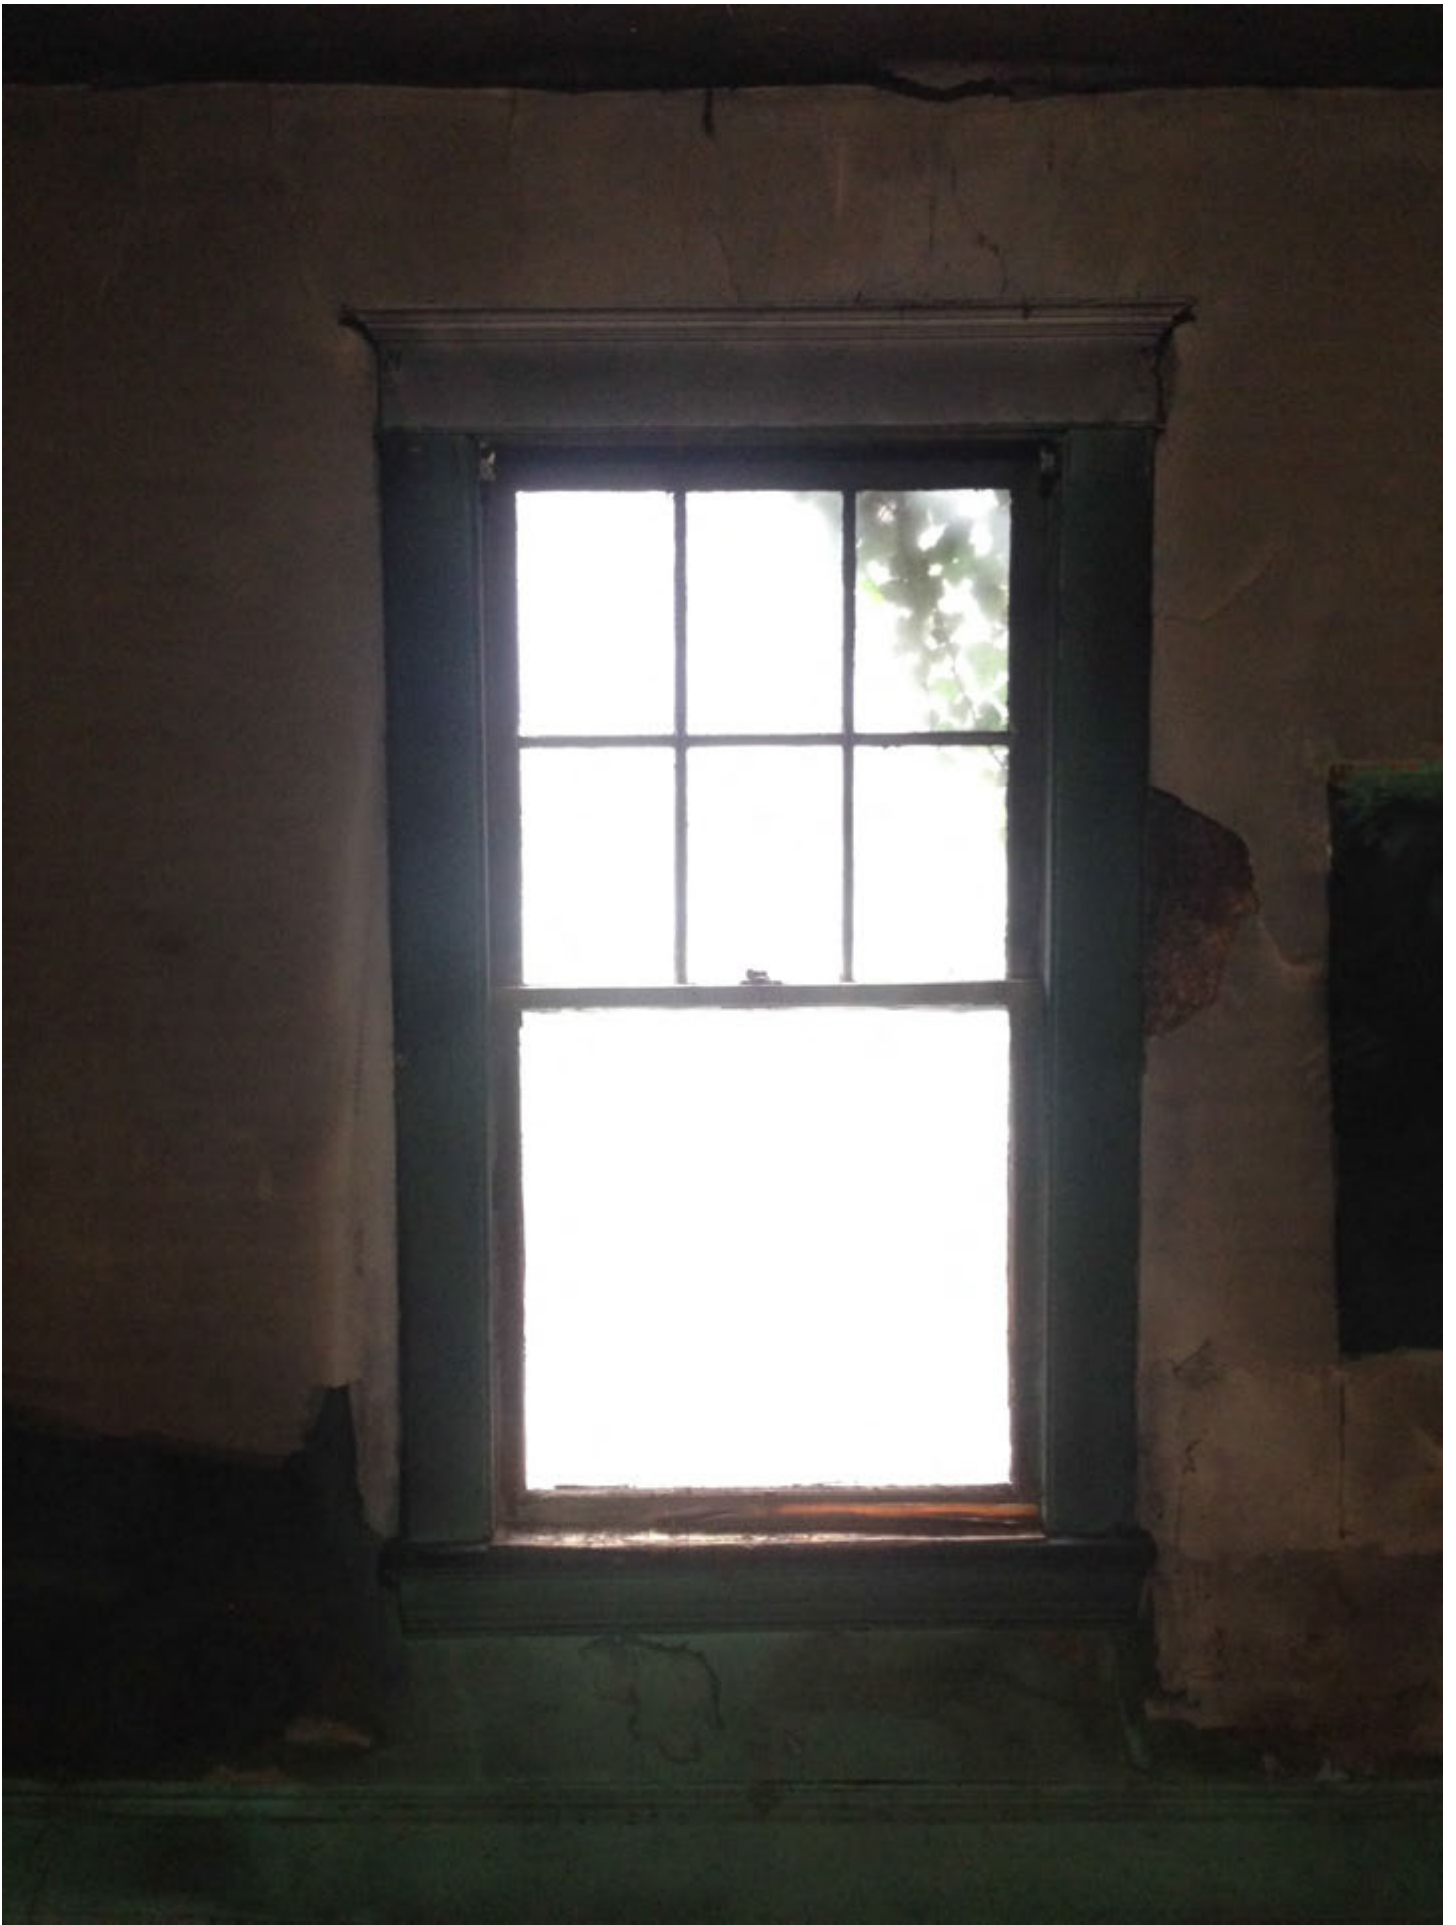
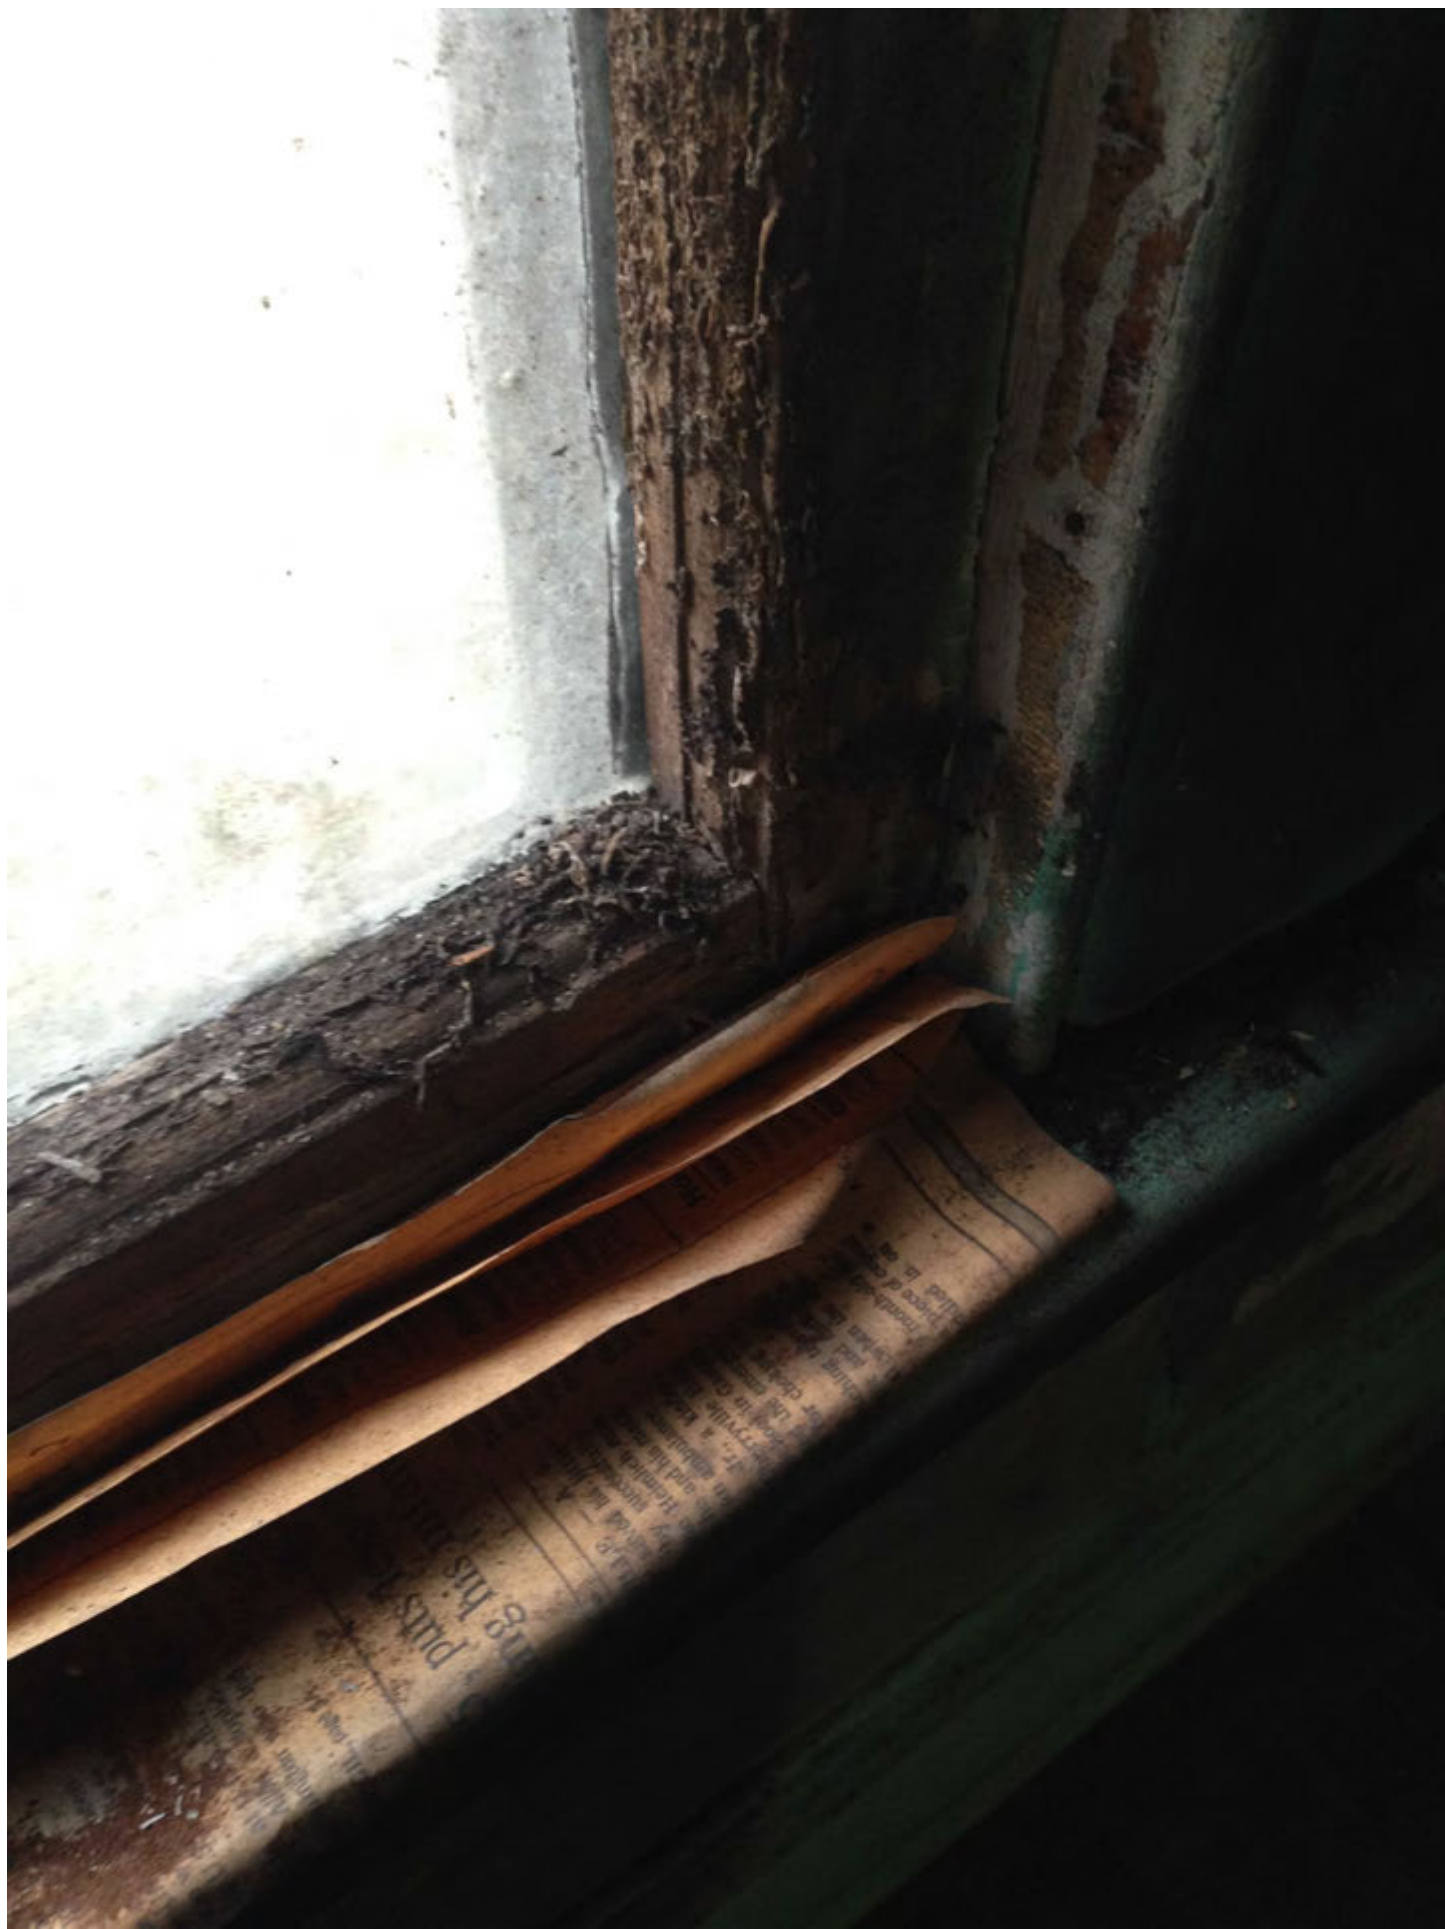
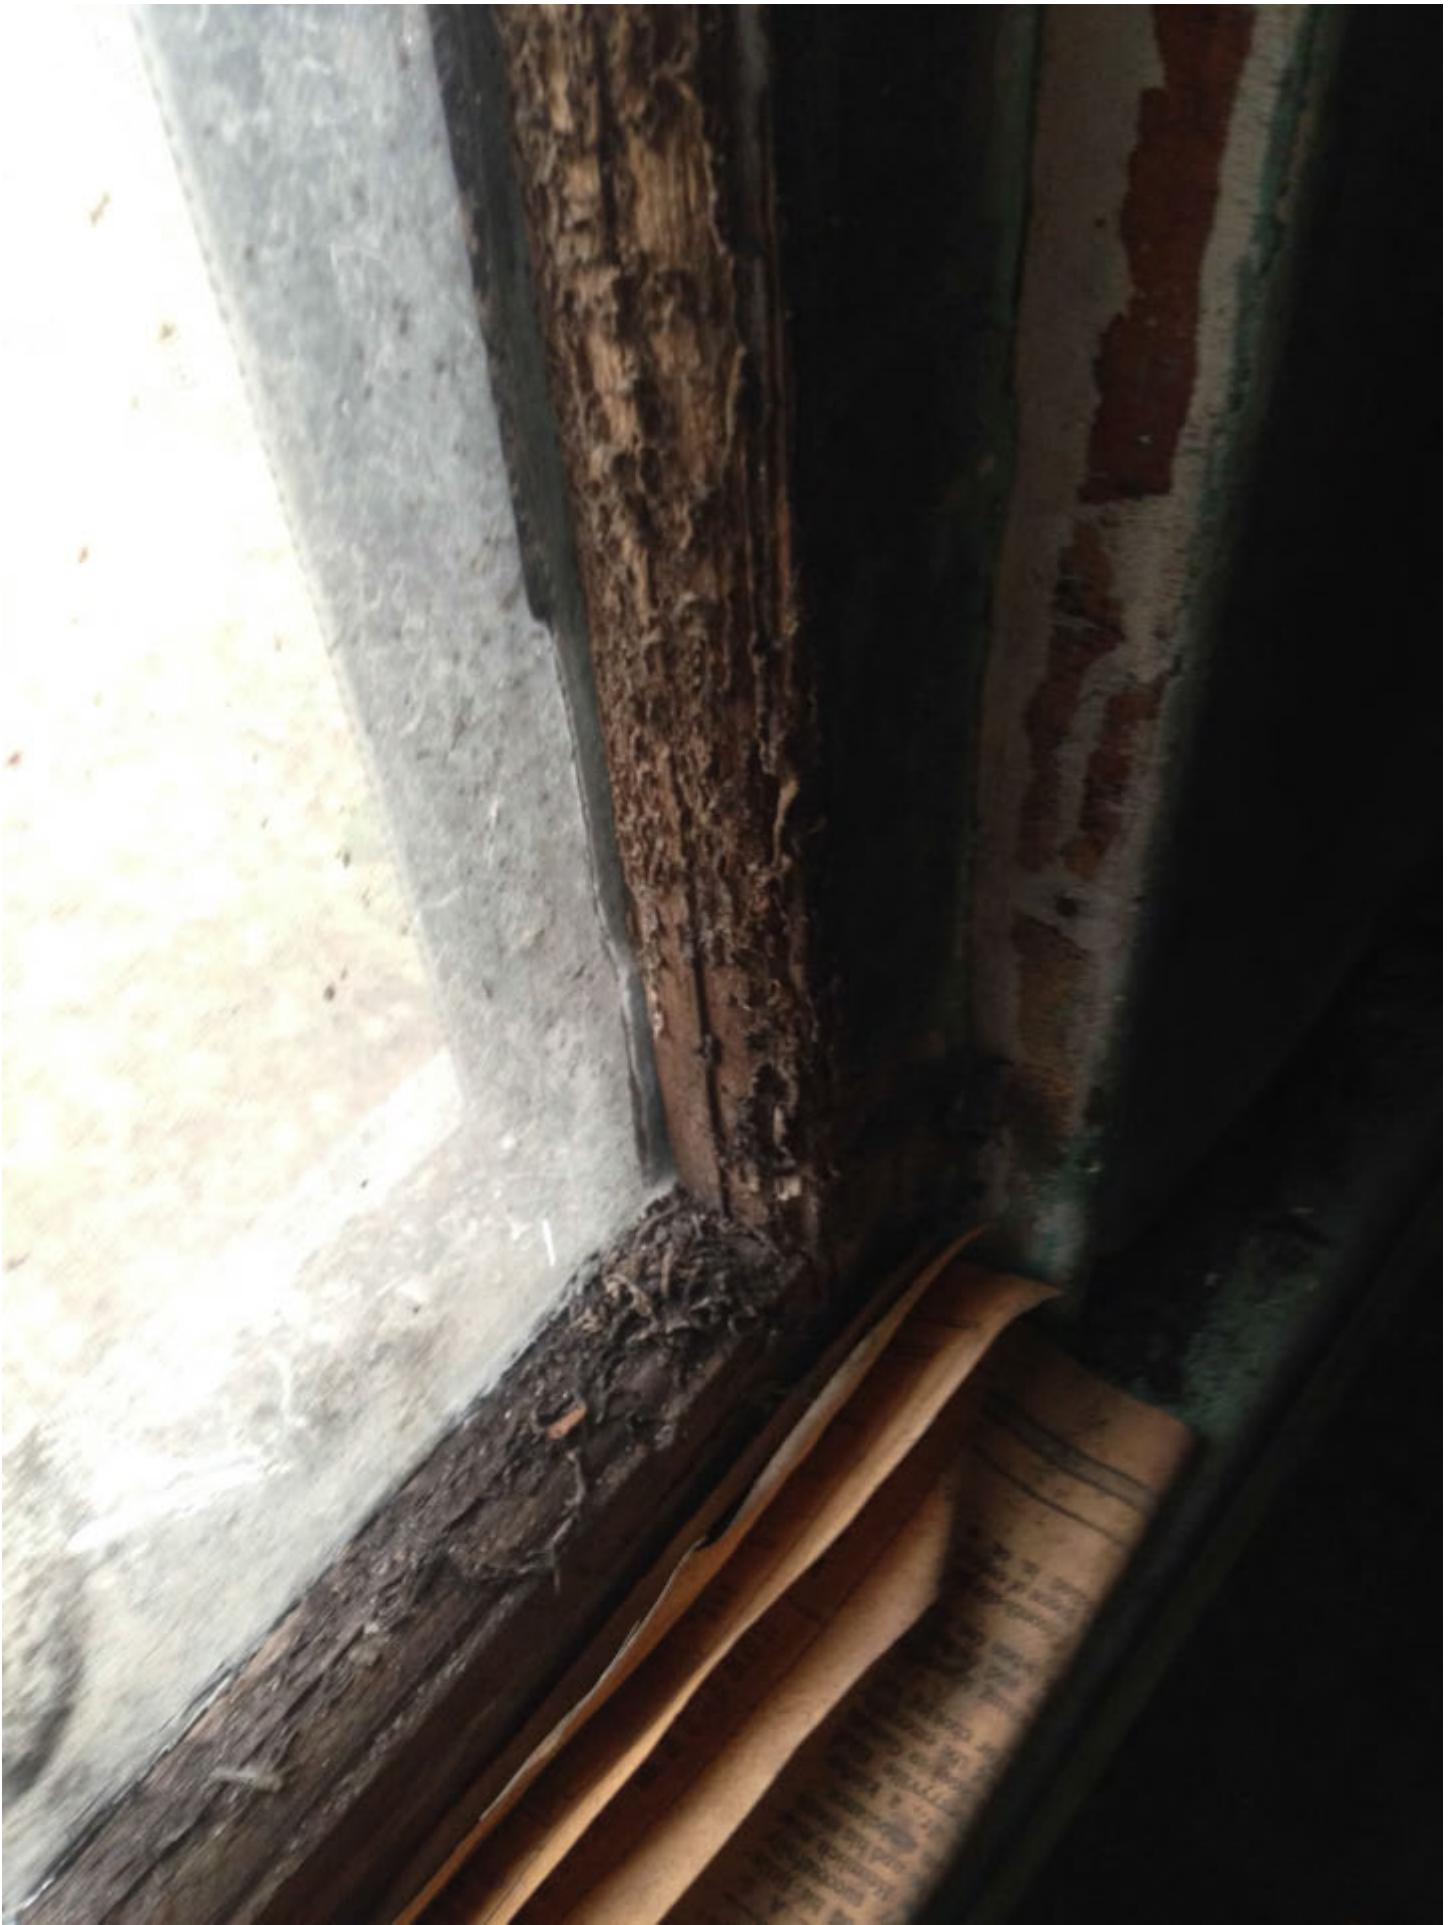
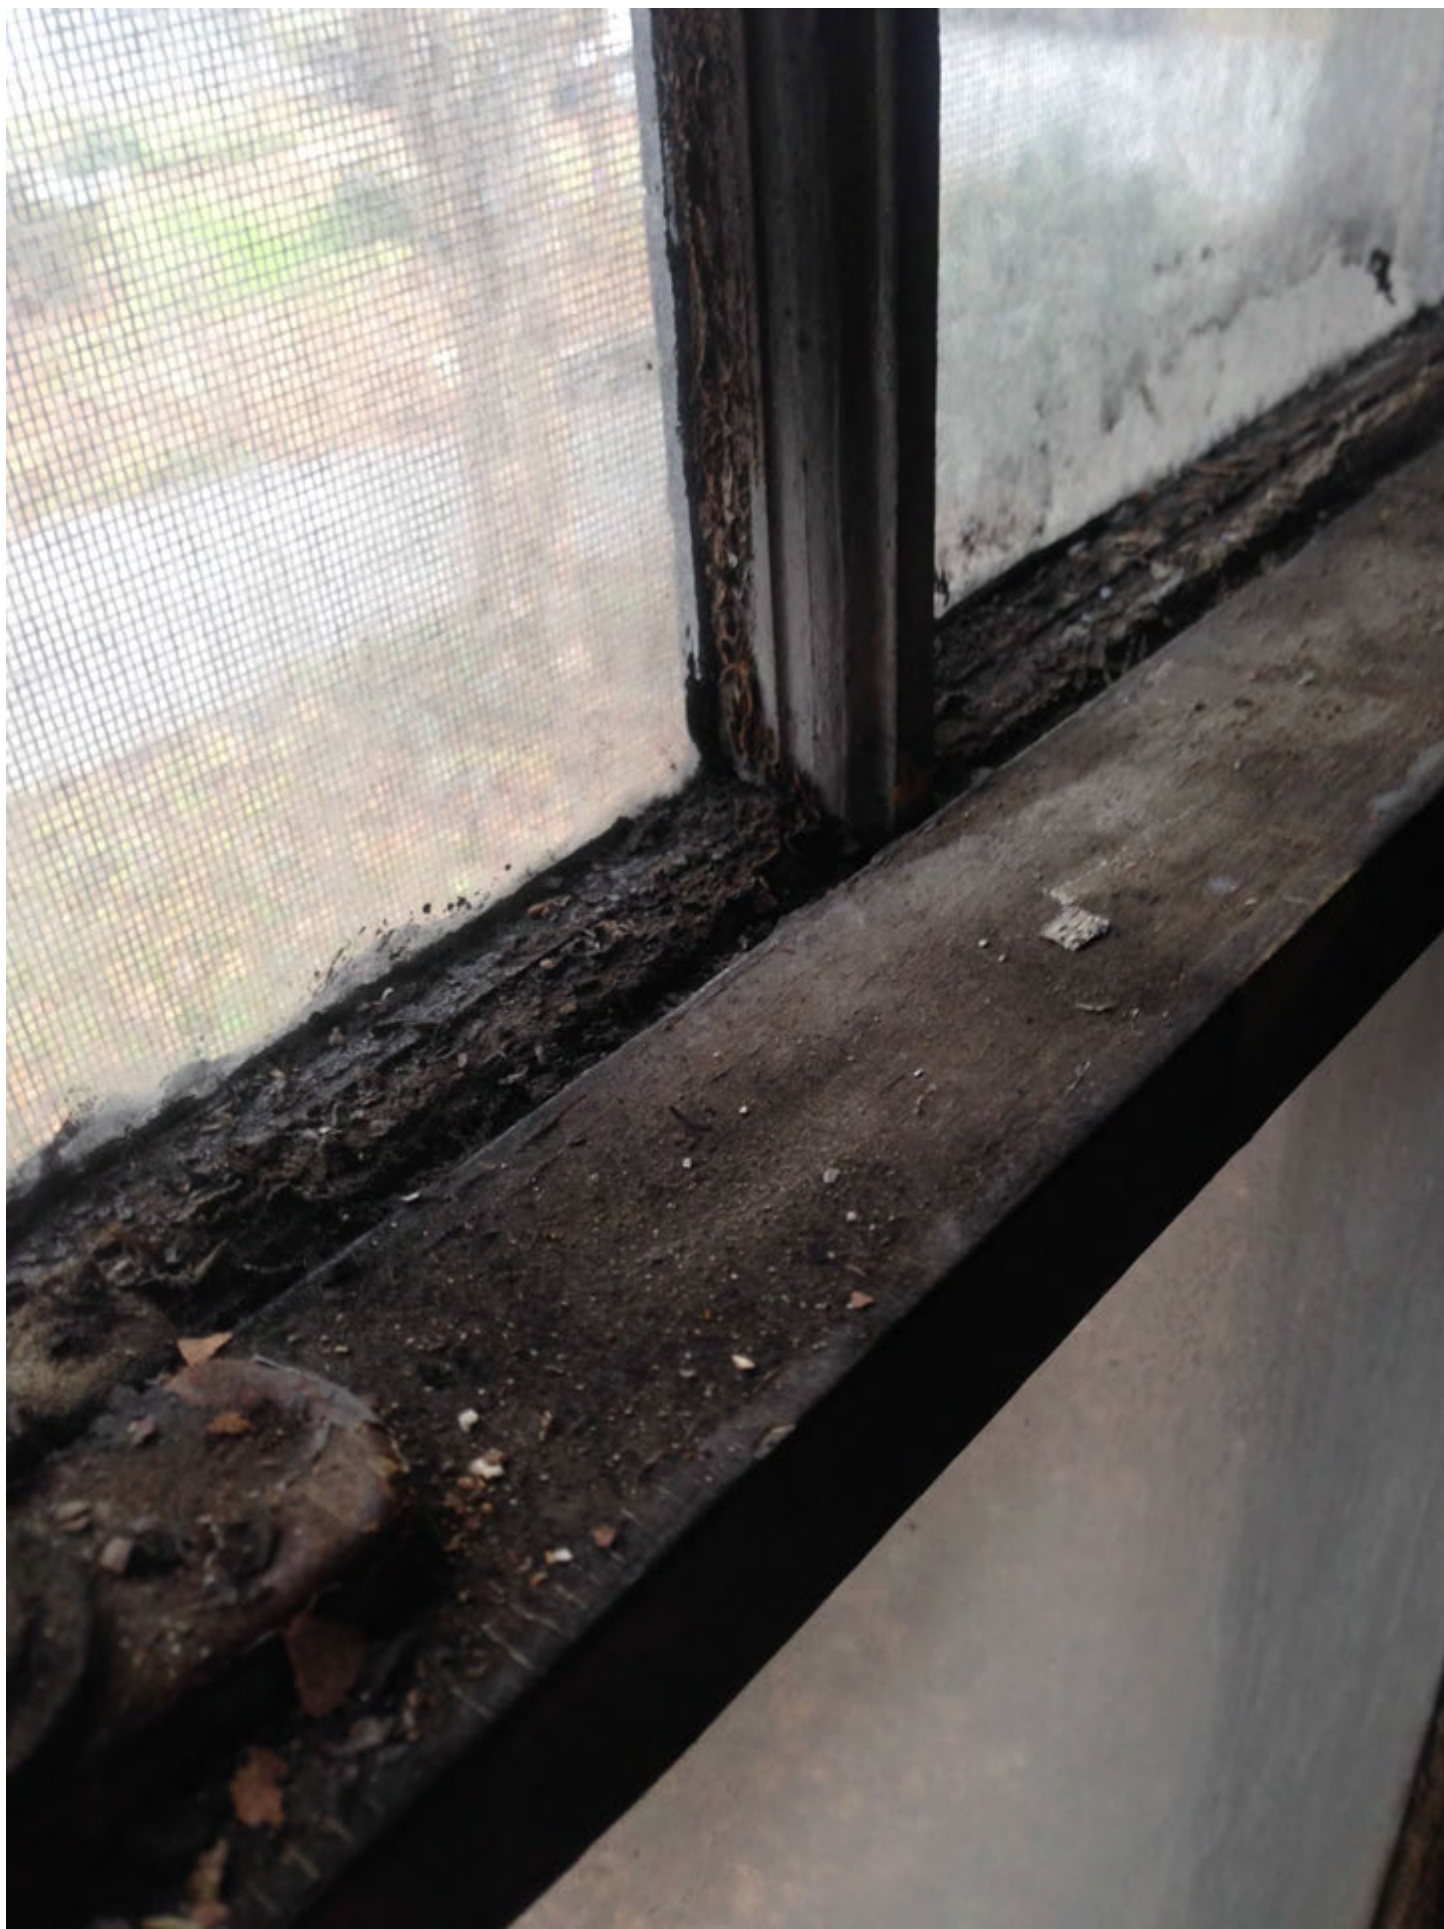
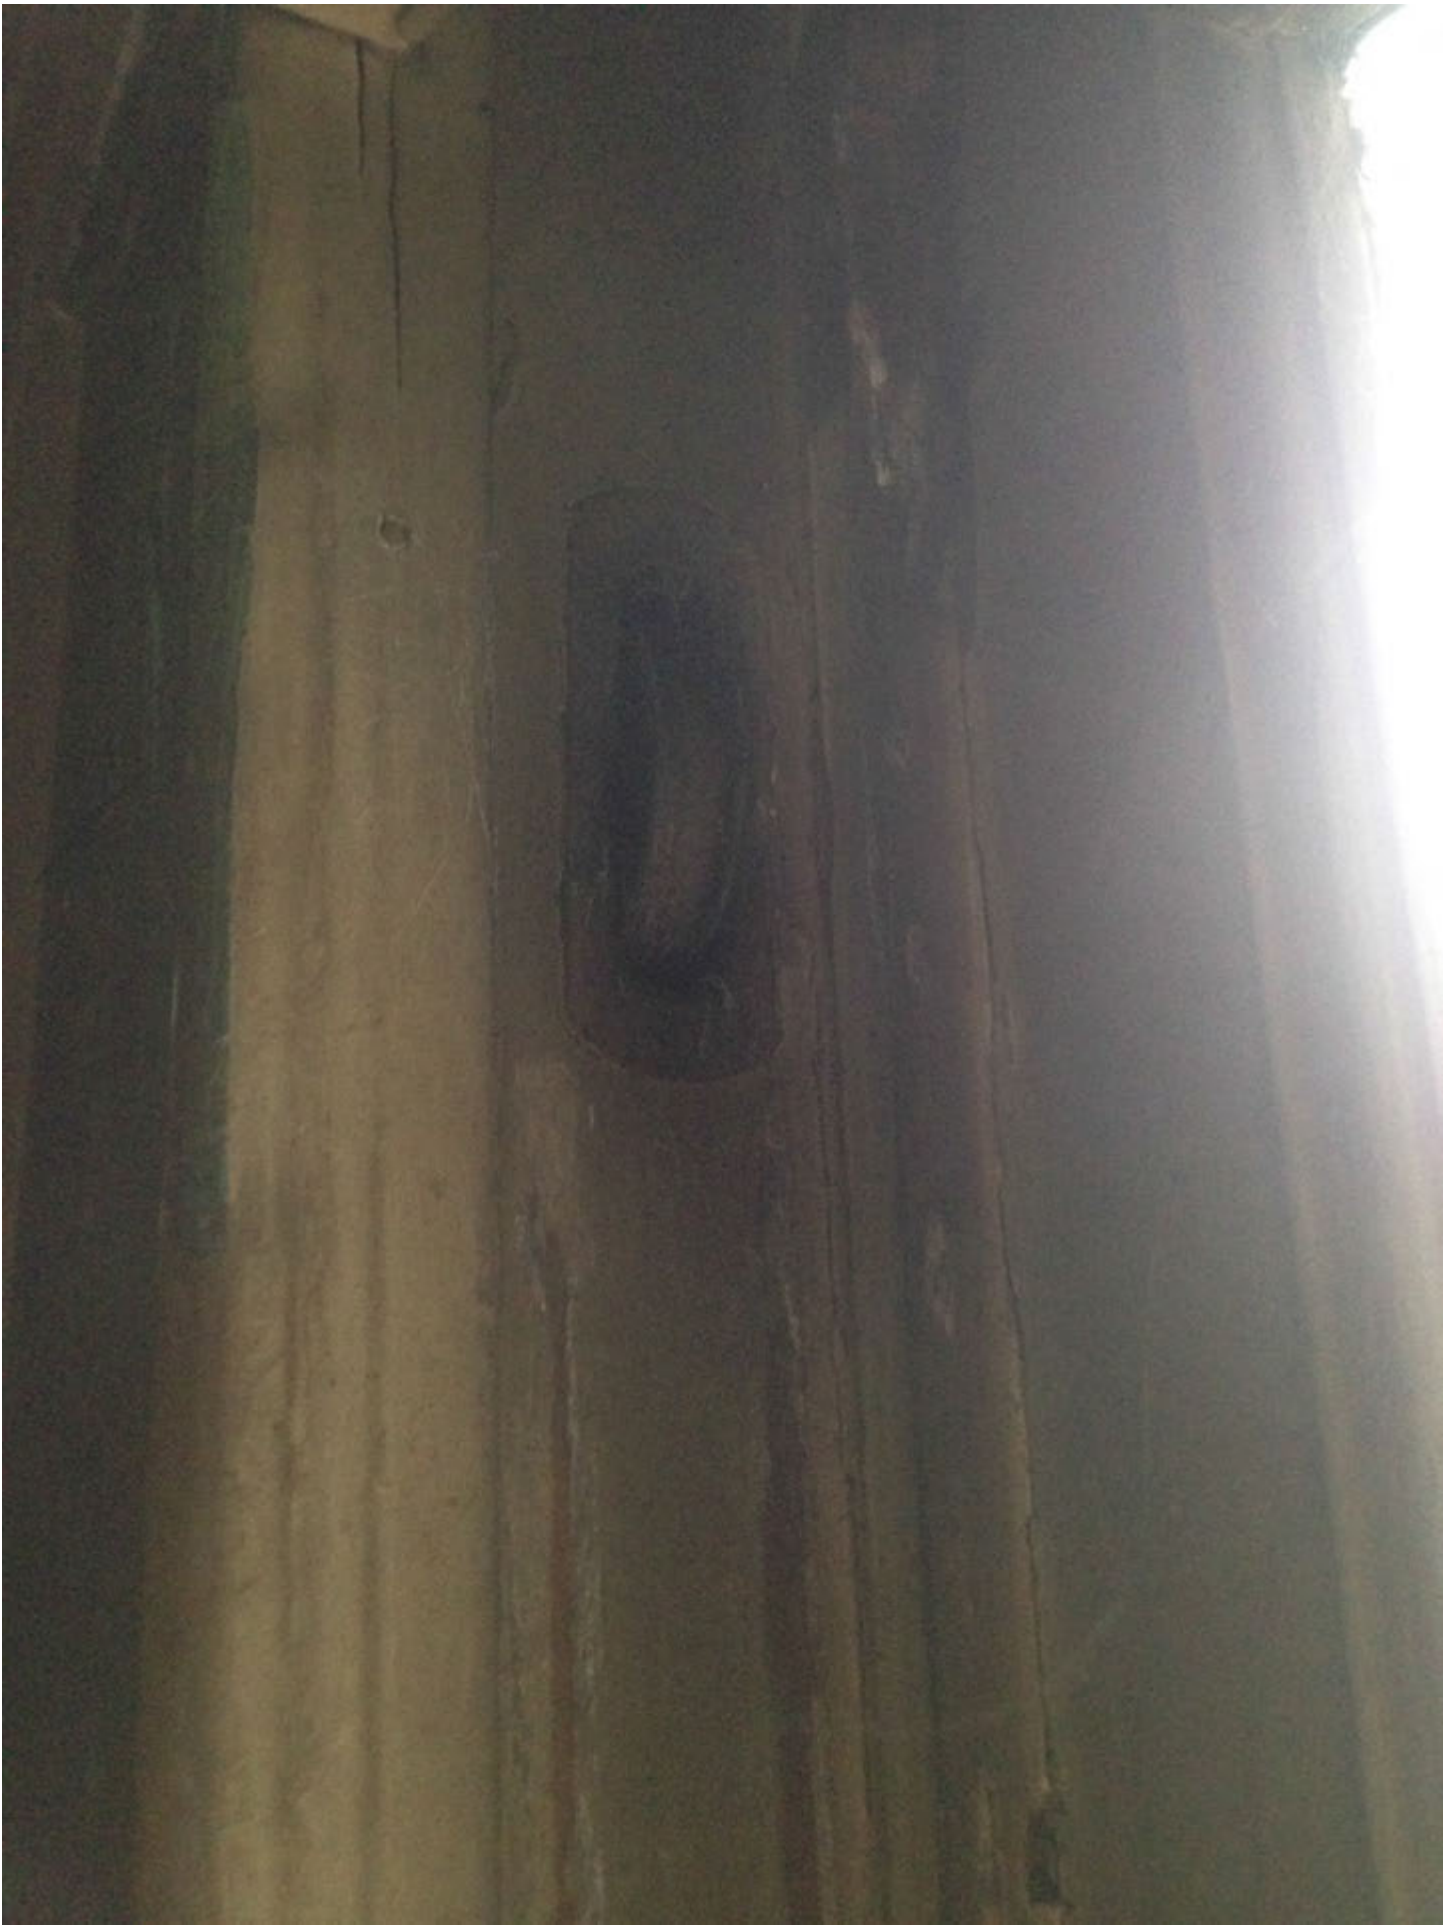
Window #: B2

B2	Double Hung	6/1	IV	IV	IV		X		Double Hung	6/1	This window is located on the east elevation. This window has severe sash, sill, and muntin deterioration and is proposed to be replaced. The sash is in such bad condition that the profile details are completely gone due to deterioration. The sill has newspaper on it that has caused rotting. There is also soot on the window/frame and apparent fire damage. Sash cords are cut and missing as well as counterweights. Panes have visible cracks and window does not operate correctly. Exterior trim is deteriorating at the sill and up portions of the sides from what appears to be years of leaves and rotting yard debris stuck between the sash and window screen. I plan to salvage whatever possible from the exterior trim and replace trim as required with matching materials and profiles. New window shall be sized to match the existing rough opening and muntin configuration.

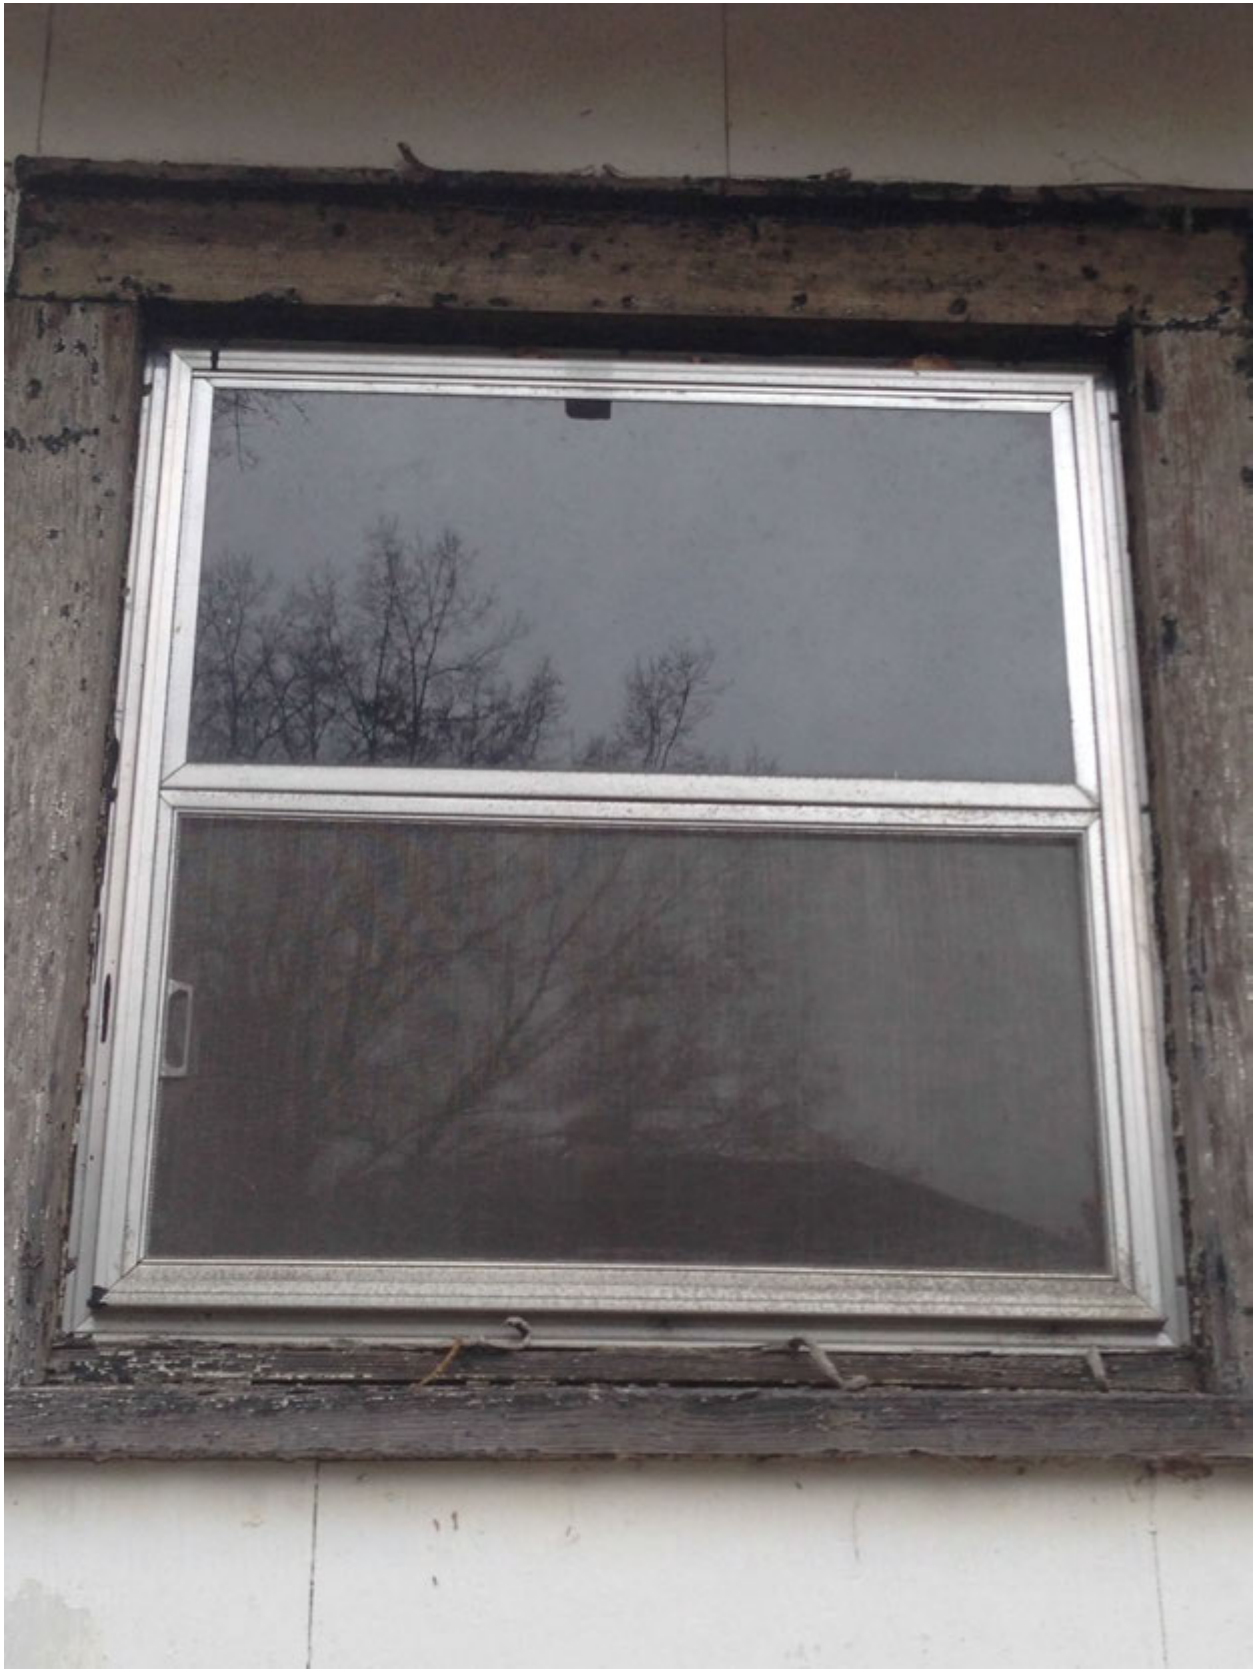
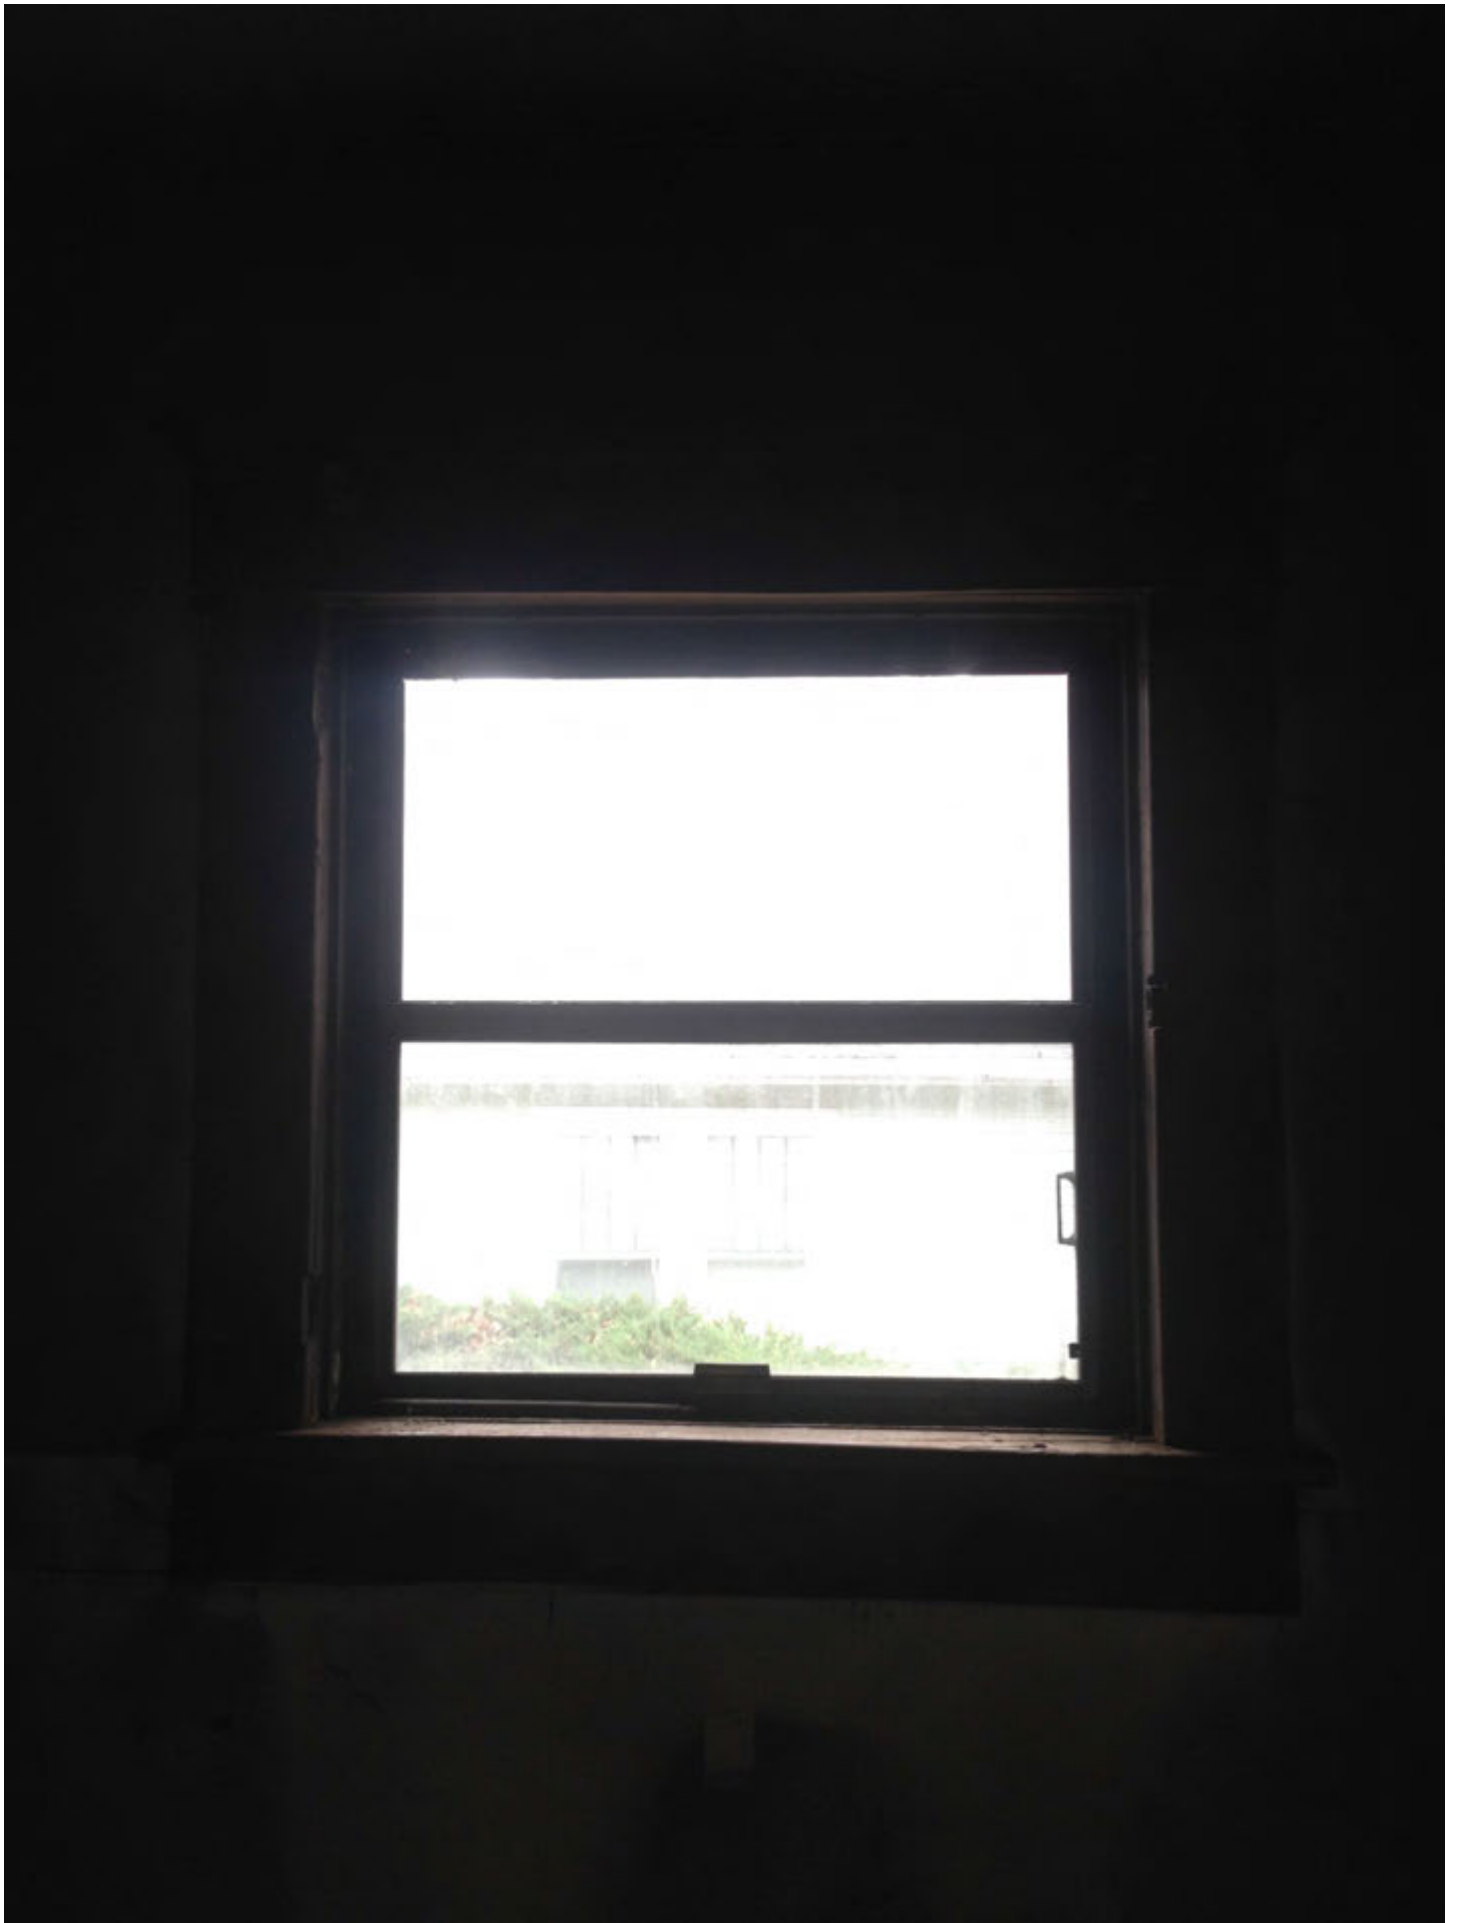
Window #: B3

B3	Storm	N/A	N/A	IV	iv		X		Fixed Frame	6 Lite	This window is located on the east elevation. There is not currently a window installed in this location and it has been replaced with a storm window only. Based on the existing frame it appears it used to be a fixed window (no pulley hardware or tracks to make it operational) and it's been assumed that it matched the 6 lite configuration of the top portion of the other windows (there is one still existing like this on the west elevation, window B10). Exterior trim is deteriorating at the sill (inside and out) due to the storm window leaking. I plan to salvage whatever possible from the exterior trim and replace trim as required with matching materials and profiles. New window shall be non-operational, fixed window, with 6 lite muntin configuration. Window shall be sized to match the existing rough opening.
B4	Double Hung	6/1	IV	IV	IV		X		Double Hung	6/1	This window is located on the east elevation. This window has severe sash, sill, and muntin deterioration and is proposed to be replaced. The sash is in such bad condition that the profile details are completely gone due to deterioration. Panes have visible cracks and window does not operate correctly. Exterior trim is deteriorating at the sill and up portions of the sides from what appears to be years of leaves and rotting yard debris stuck between the sash and window screen. I plan to salvage whatever possible from the exterior trim and replace trim as required with matching materials and profiles. New window shall be sized to match existing rough opening and muntin configuration.

The only windows that would require replacement are the two picture windows on the western elevation (B8 & B9), the one picture window on the eastern elevation (B3), and the bottom sash of the porch window on the eastern elevation (B3). From talking with the preservationist, it appears the bottom sash of B1 was actually taken from B3; therefore I plan to reuse this sash in the location of B3 and replace the bottom sash of B1 with a salvaged single lite sash. In regards to B8 & B9 these need to be replaced. I plan to salvage 6 lite picture windows from Habitat Restore that match B3 to use in these locations.

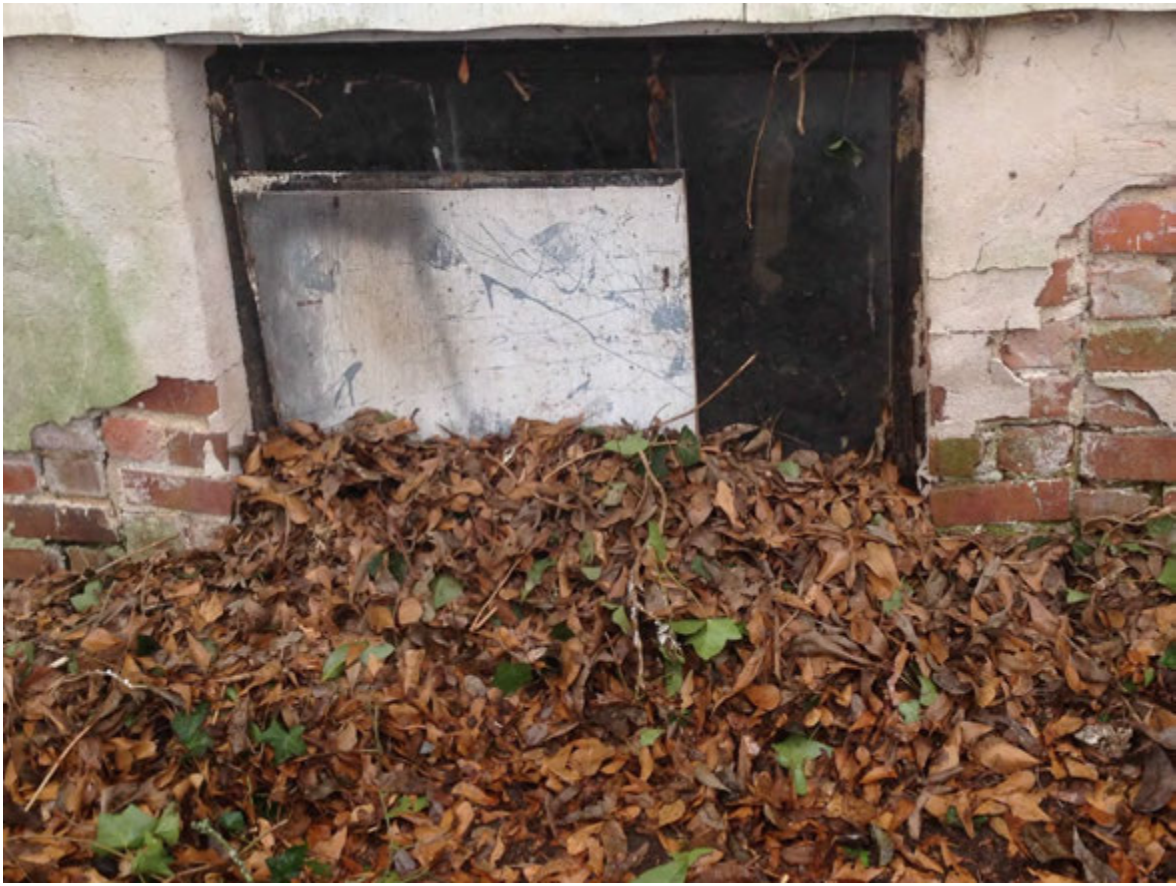
Window #: B5

B5	N/A	N/A	N/A	N/A	N/A	N/A	N/A	N/A	Double Hung	6/1	This is a new window located in the east elevation of the addition. I plan to match the exterior trim of all the other windows on the east elevation with matching materials and profiles. New window shall be sized to match the other larger windows on the east elevation, such as window B4, and have same 6/1 muntin configuration.
B6	Fixed Frame	3 vertical	IV	IV	II		X		N/A	N/A	This window is located on the east elevation and is one of two on this elevation located in the foundation wall to provide natural light into the partial basement. The window has a steel frame with three vertical panes. I plan to repair the glass in this window as required, but overall there will be no changes.
B7	Fixed Frame	3 vertical	IV	IV	II		X		N/A	N/A	This window is located on the east elevation and is one of two on this elevation located in the foundation wall to provide natural light into the partial basement. The window has a steel frame with three vertical panes. I plan to repair the glass in this window as required, but overall there will be no changes.
