RE: 190-14-CA (708 Dorothea Drive)

Property Address: 708 Dorothea Drive

Window Survey

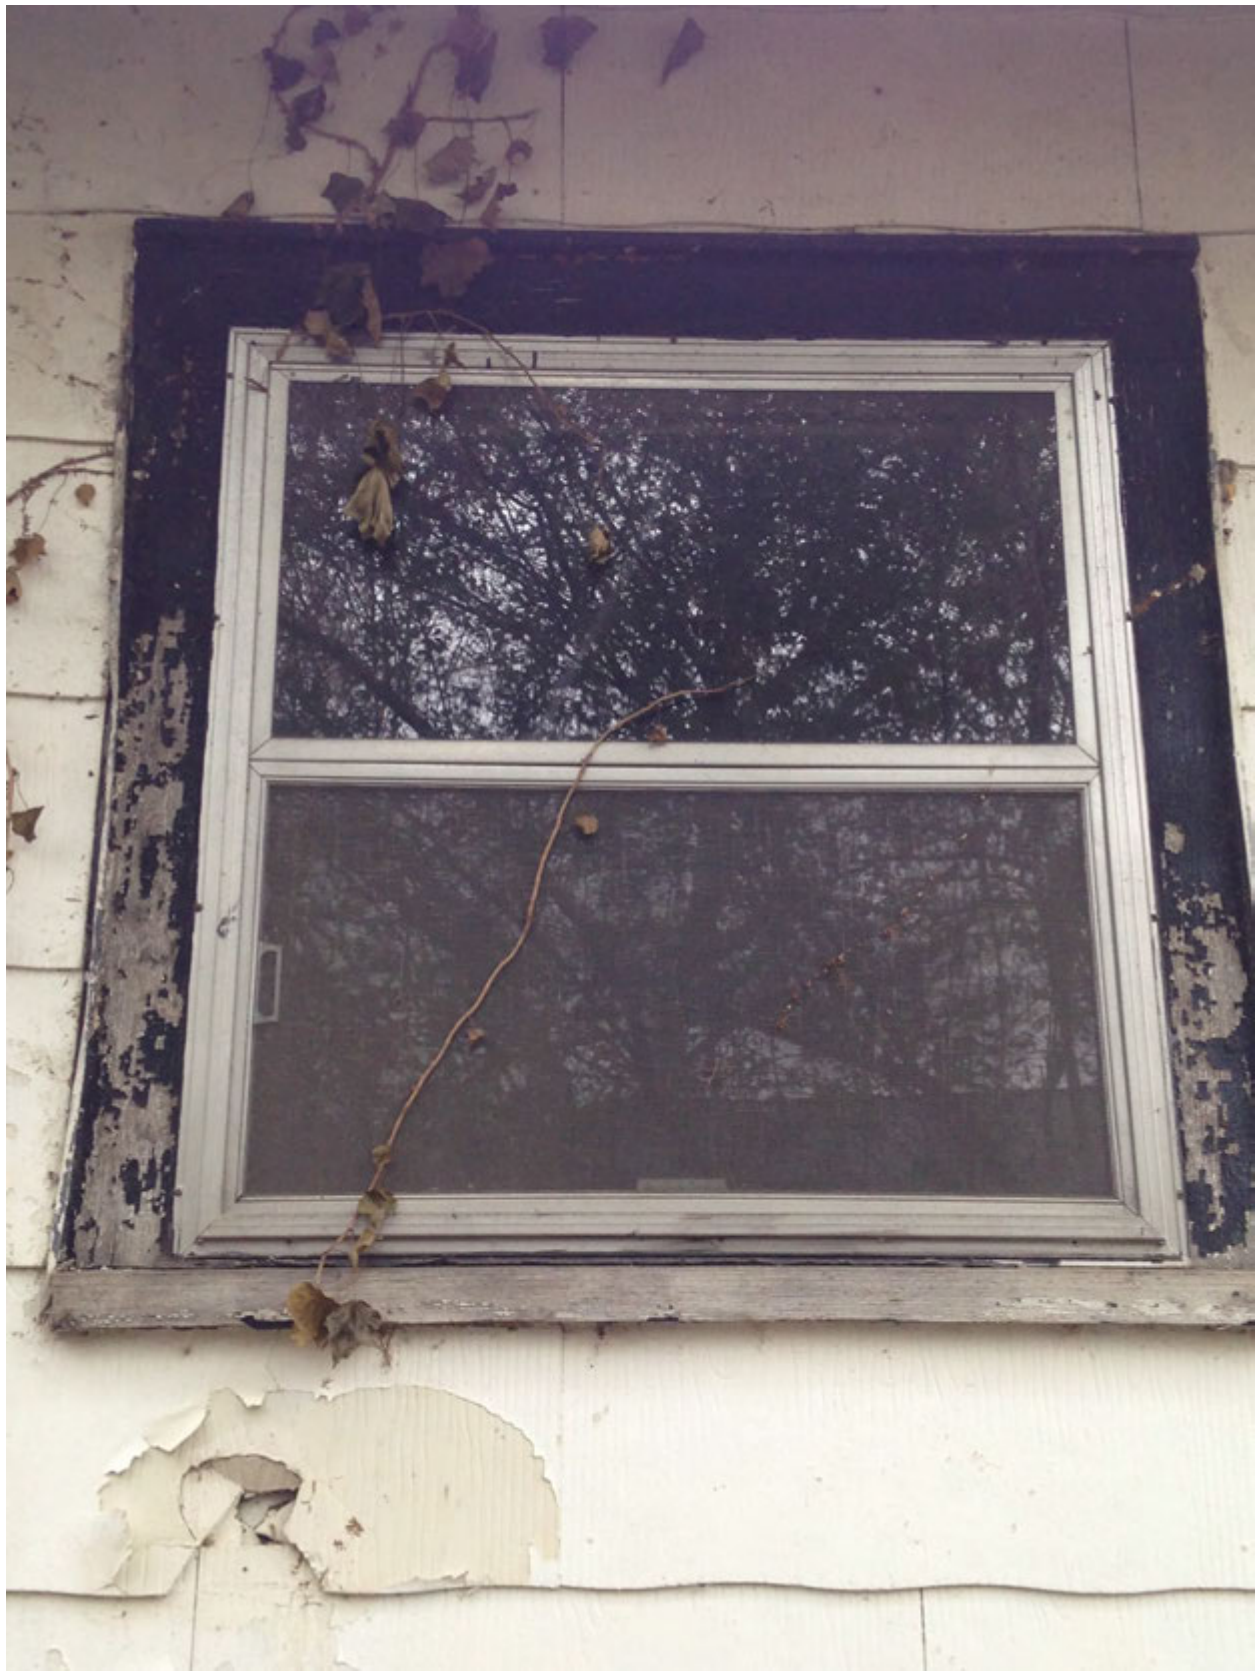
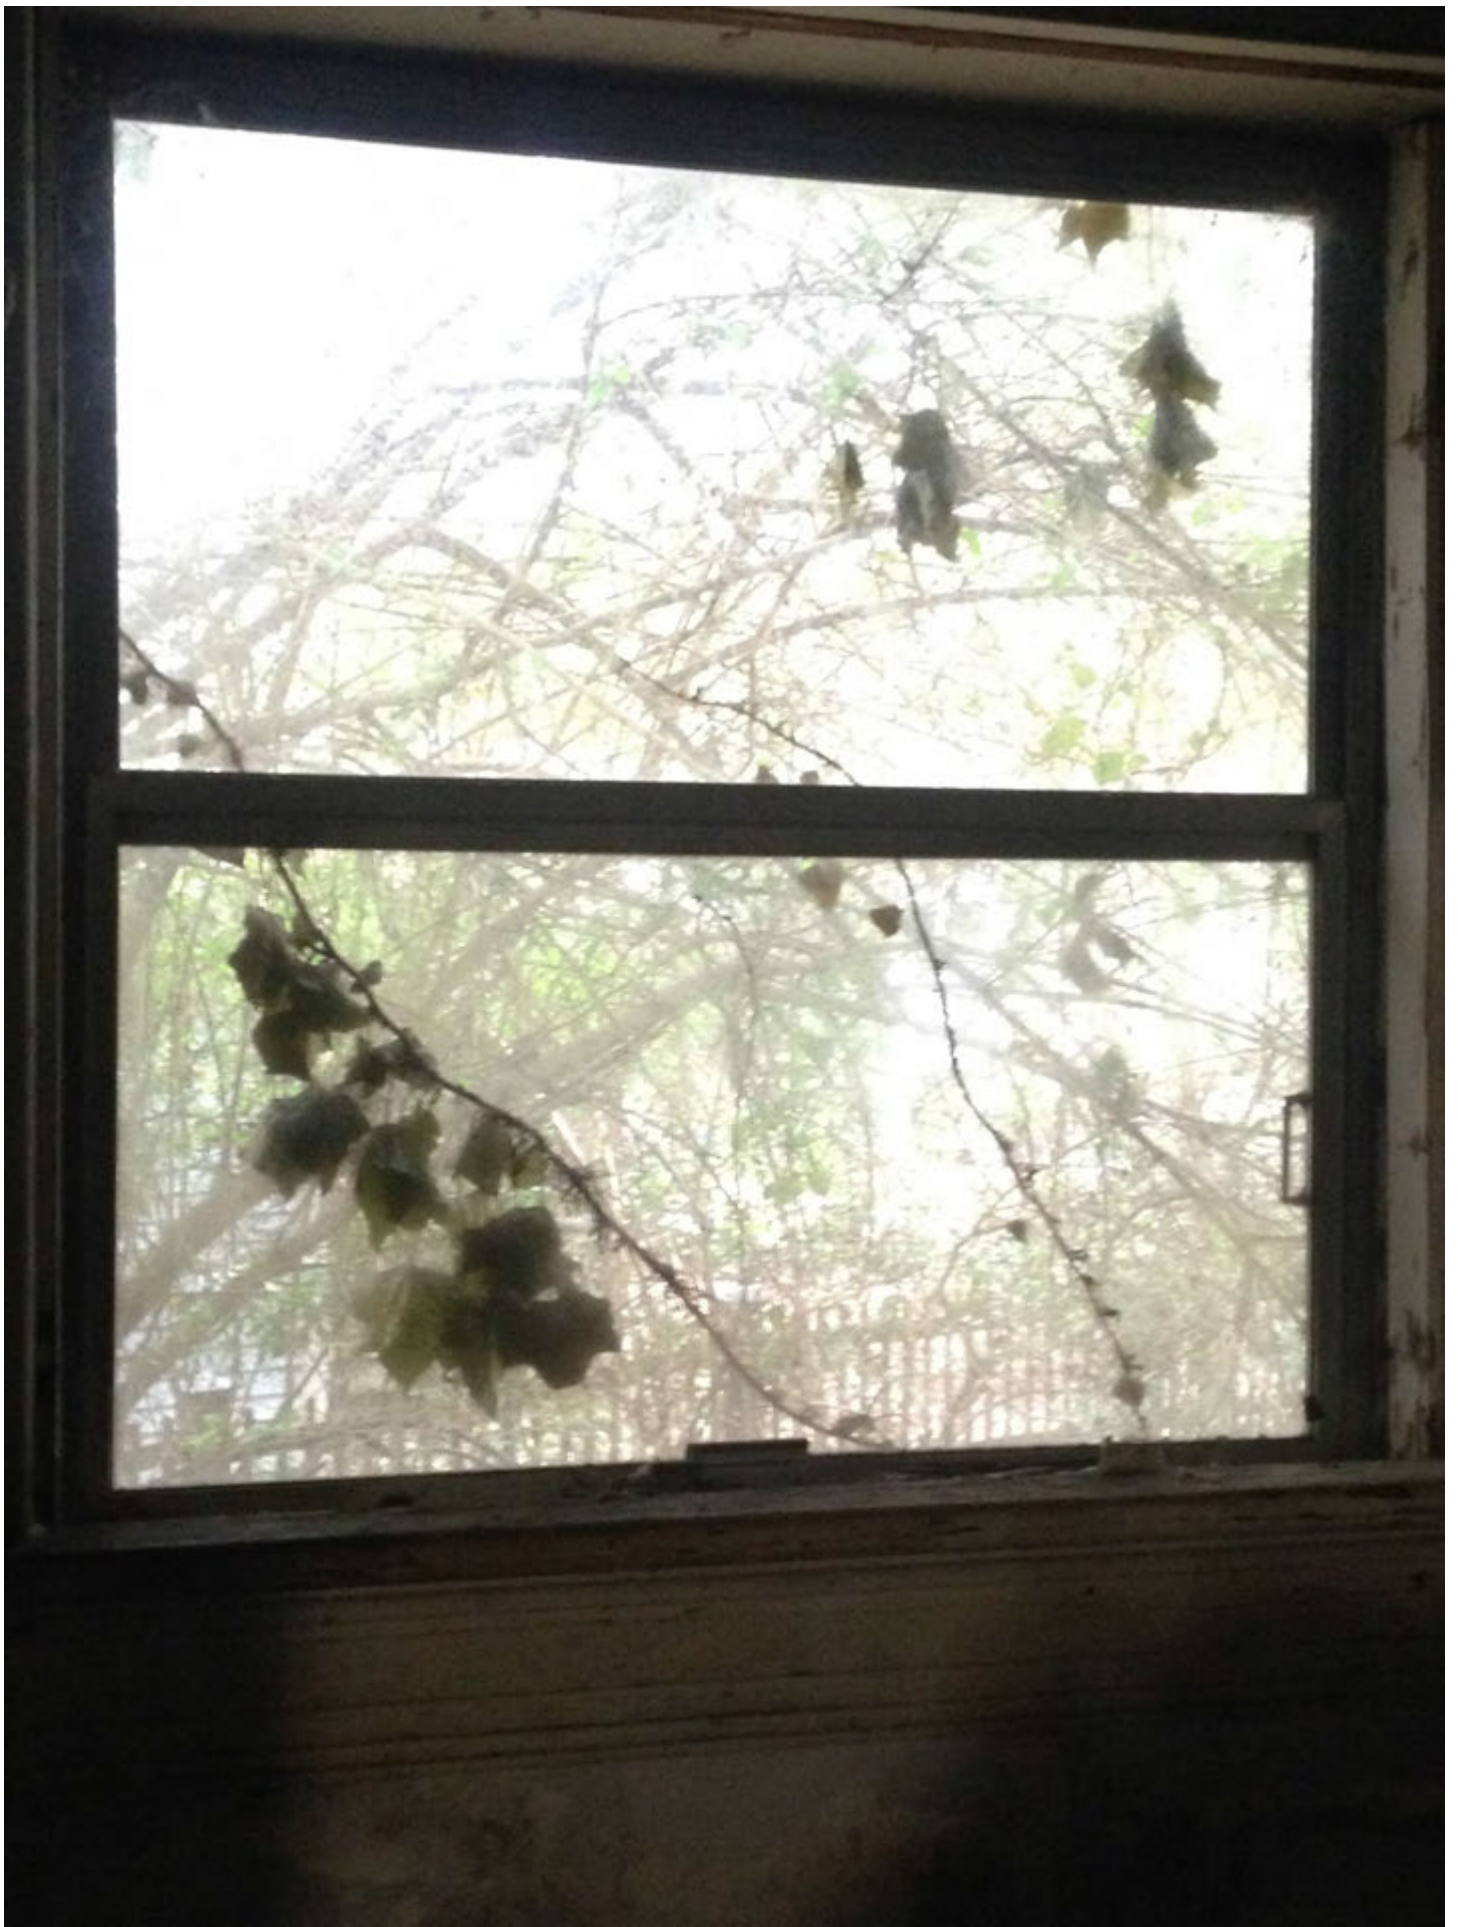
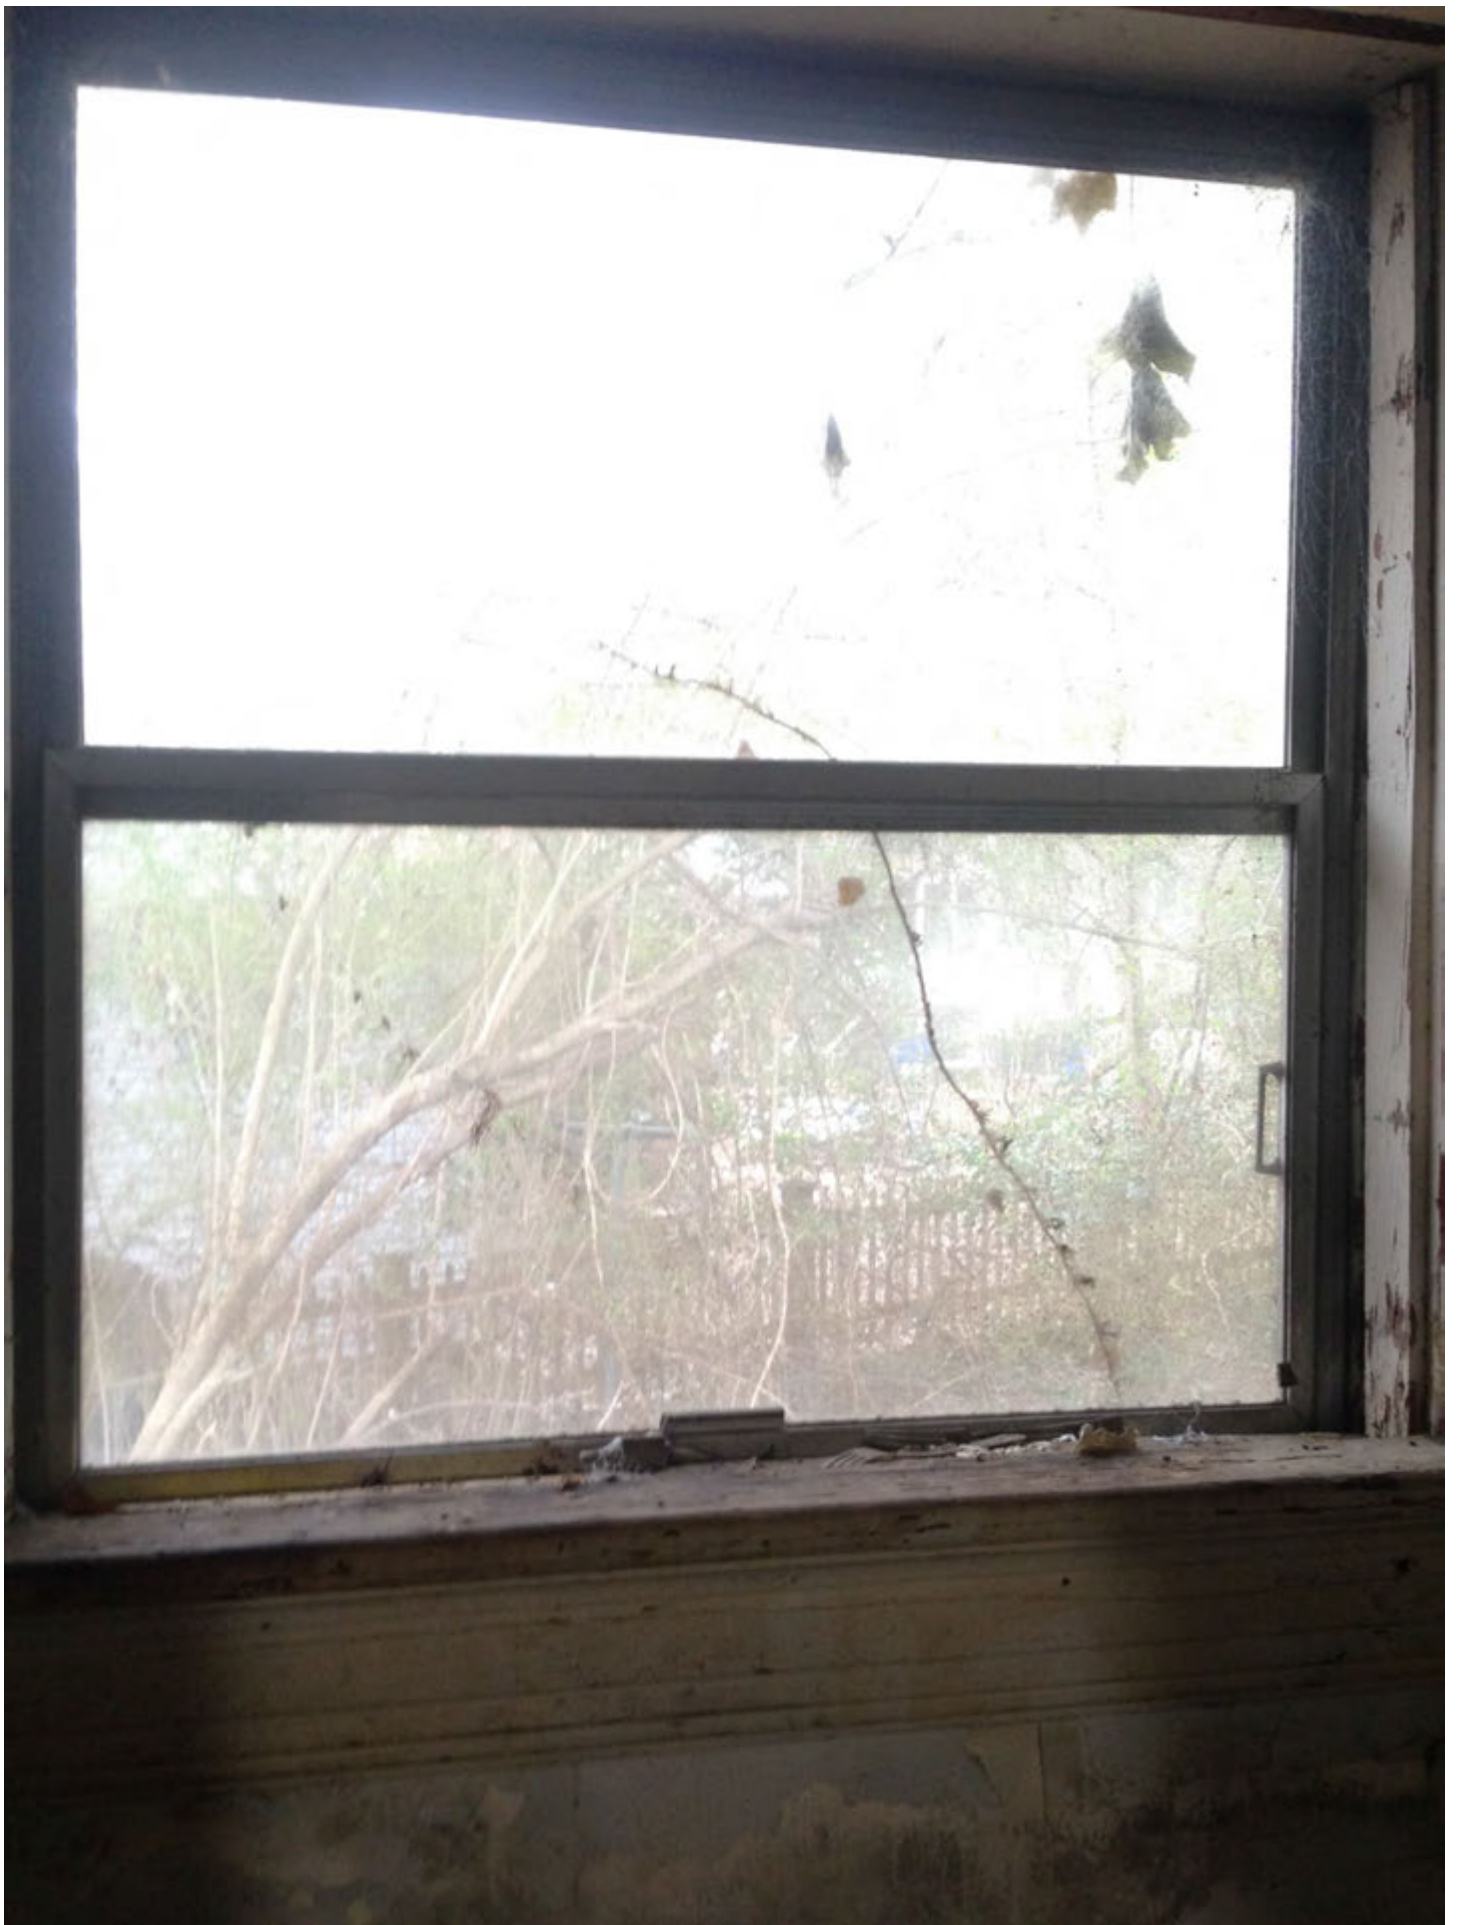
Window #: B8

B8	Storm	N/A	N/A	IV	IV		X		Fixed Frame	6 Lite	This window is located on the west elevation. There is not currently a window installed in this location and it has been replaced with a storm window only. Based on the existing frame it appears it used to be a fixed window (no pulley hardware or tracks to make it operational) and it's been assumed that it matched the 6 lite configuration of the top portion of the other windows (there is one still existing like this on the west elevation, window B10). Exterior trim is deteriorating at the sill (inside and out) due to the storm window leaking. I plan to salvage whatever possible from the exterior trim and replace trim as required with matching materials and profiles. New window shall be non-operational, fixed window, with 6 lite muntin configuration. Window shall be sized to match the existing rough opening.
B9	Fixed Frame	6 Lite	IV	IV	IV		X		Fixed Frame	6 Lite	This window is located on the west elevation. It is a non-operational, fixed window (no pulley hardware or tracks to make it operational) and it has the 6 lite configuration of the top portion of the other windows. The window is completely rotted across the bottom of the sash and has begun to fall apart. Several muntins are broken and deteriorating. Exterior trim is deteriorating at the sill due to an overgrown shrub that had actually grown through an opening in the rotten portion of the window. I plan to salvage whatever possible from the exterior trim and replace trim as required with matching materials and profiles. New window shall be a non-operational, fixed window, with 6 lite muntin configuration. Window shall be sized to match the existing rough opening.

The only windows that would require replacement are the two picture windows on the western elevation (B8 & B9), the one picture window on the eastern elevation (B3), and the bottom sash of the porch window on the eastern elevation (B3). From talking with the preservationist, it appears the bottom sash of B1 was actually taken from B3; therefore I plan to reuse this sash in the location of B3 and replace the bottom sash of B1 with a salvaged single lite sash. In regards to B8 & B9 these need to be replaced. I plan to salvage 6 lite picture windows from Habitat Restore that match B3 to use in these locations.
