RE: 190-14-CA (708 Dorothea Drive)

Property Address: 708 Dorothea Drive

Window Survey

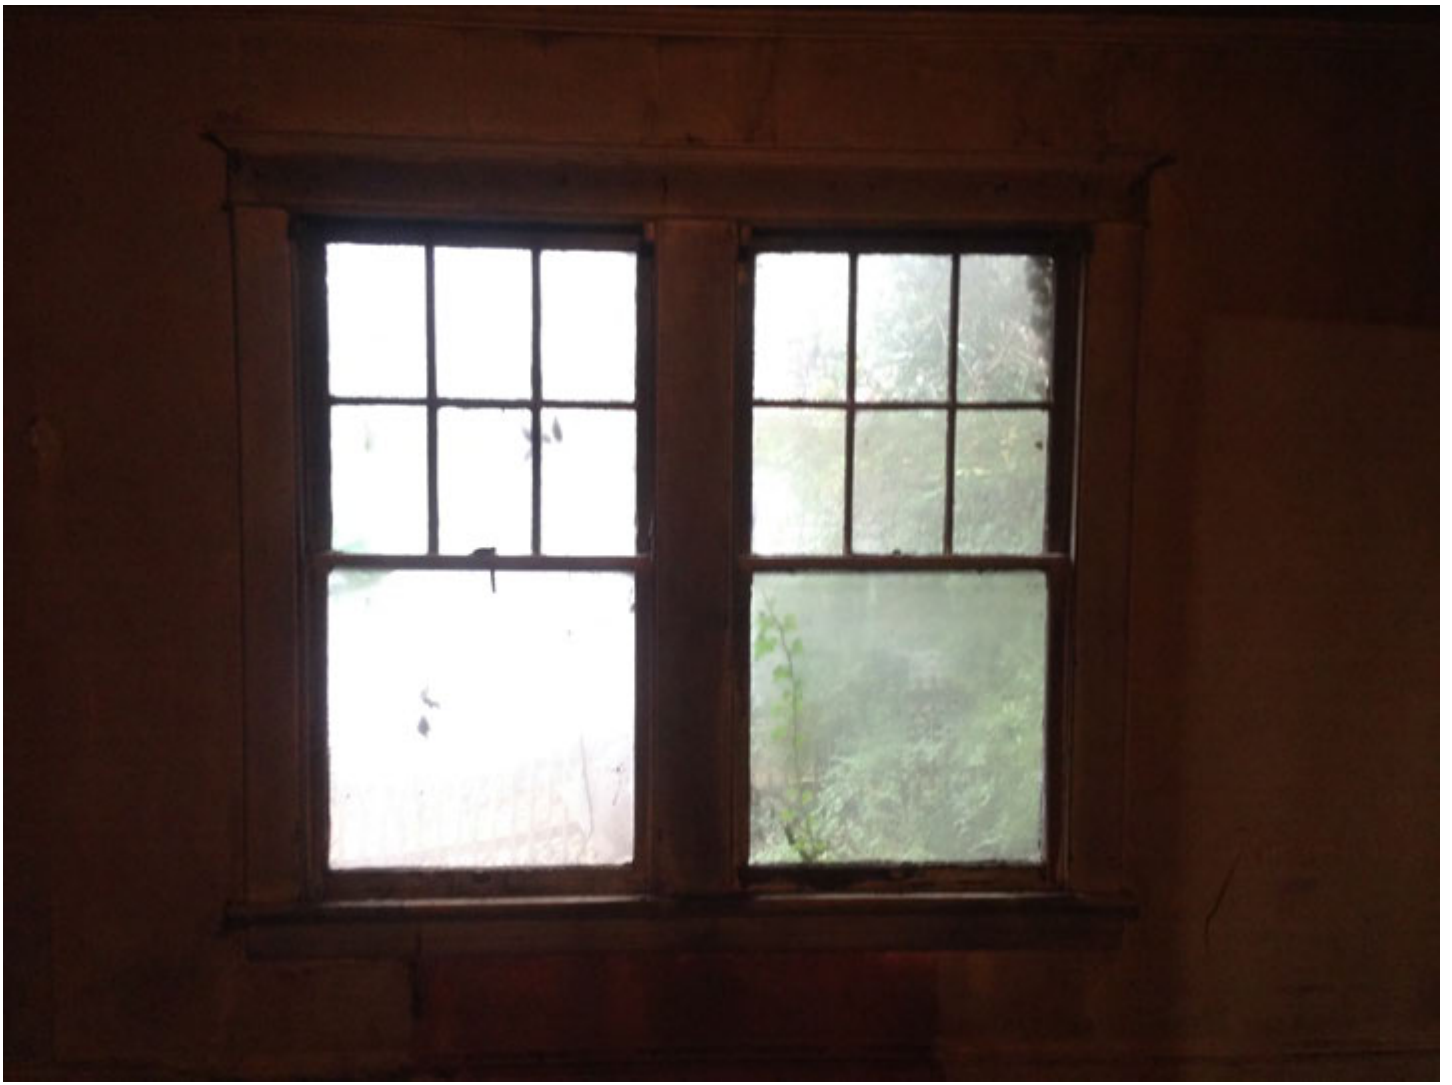
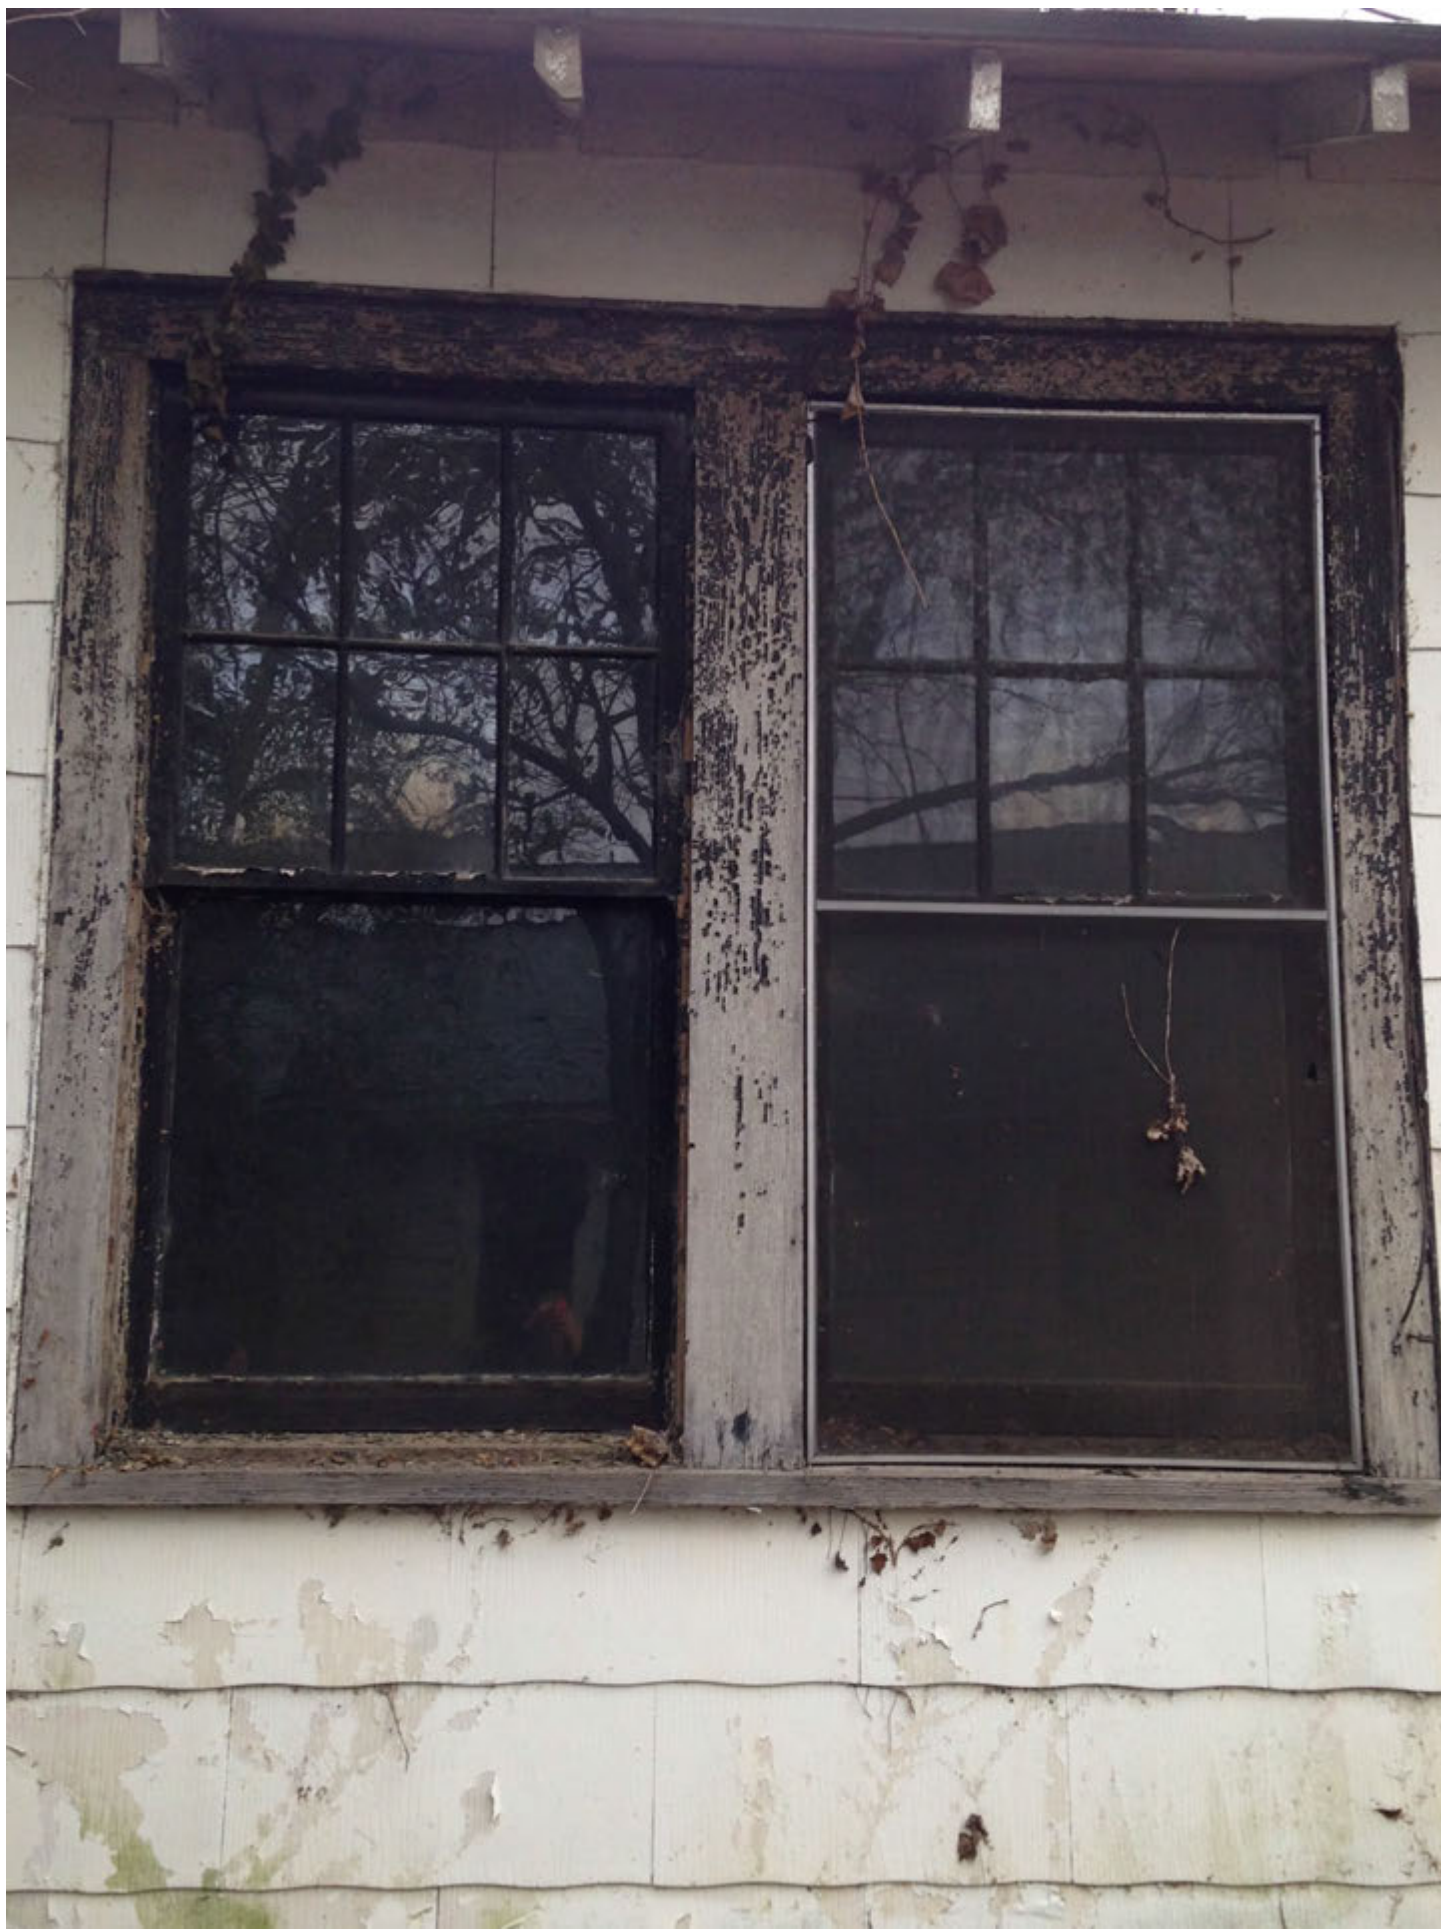
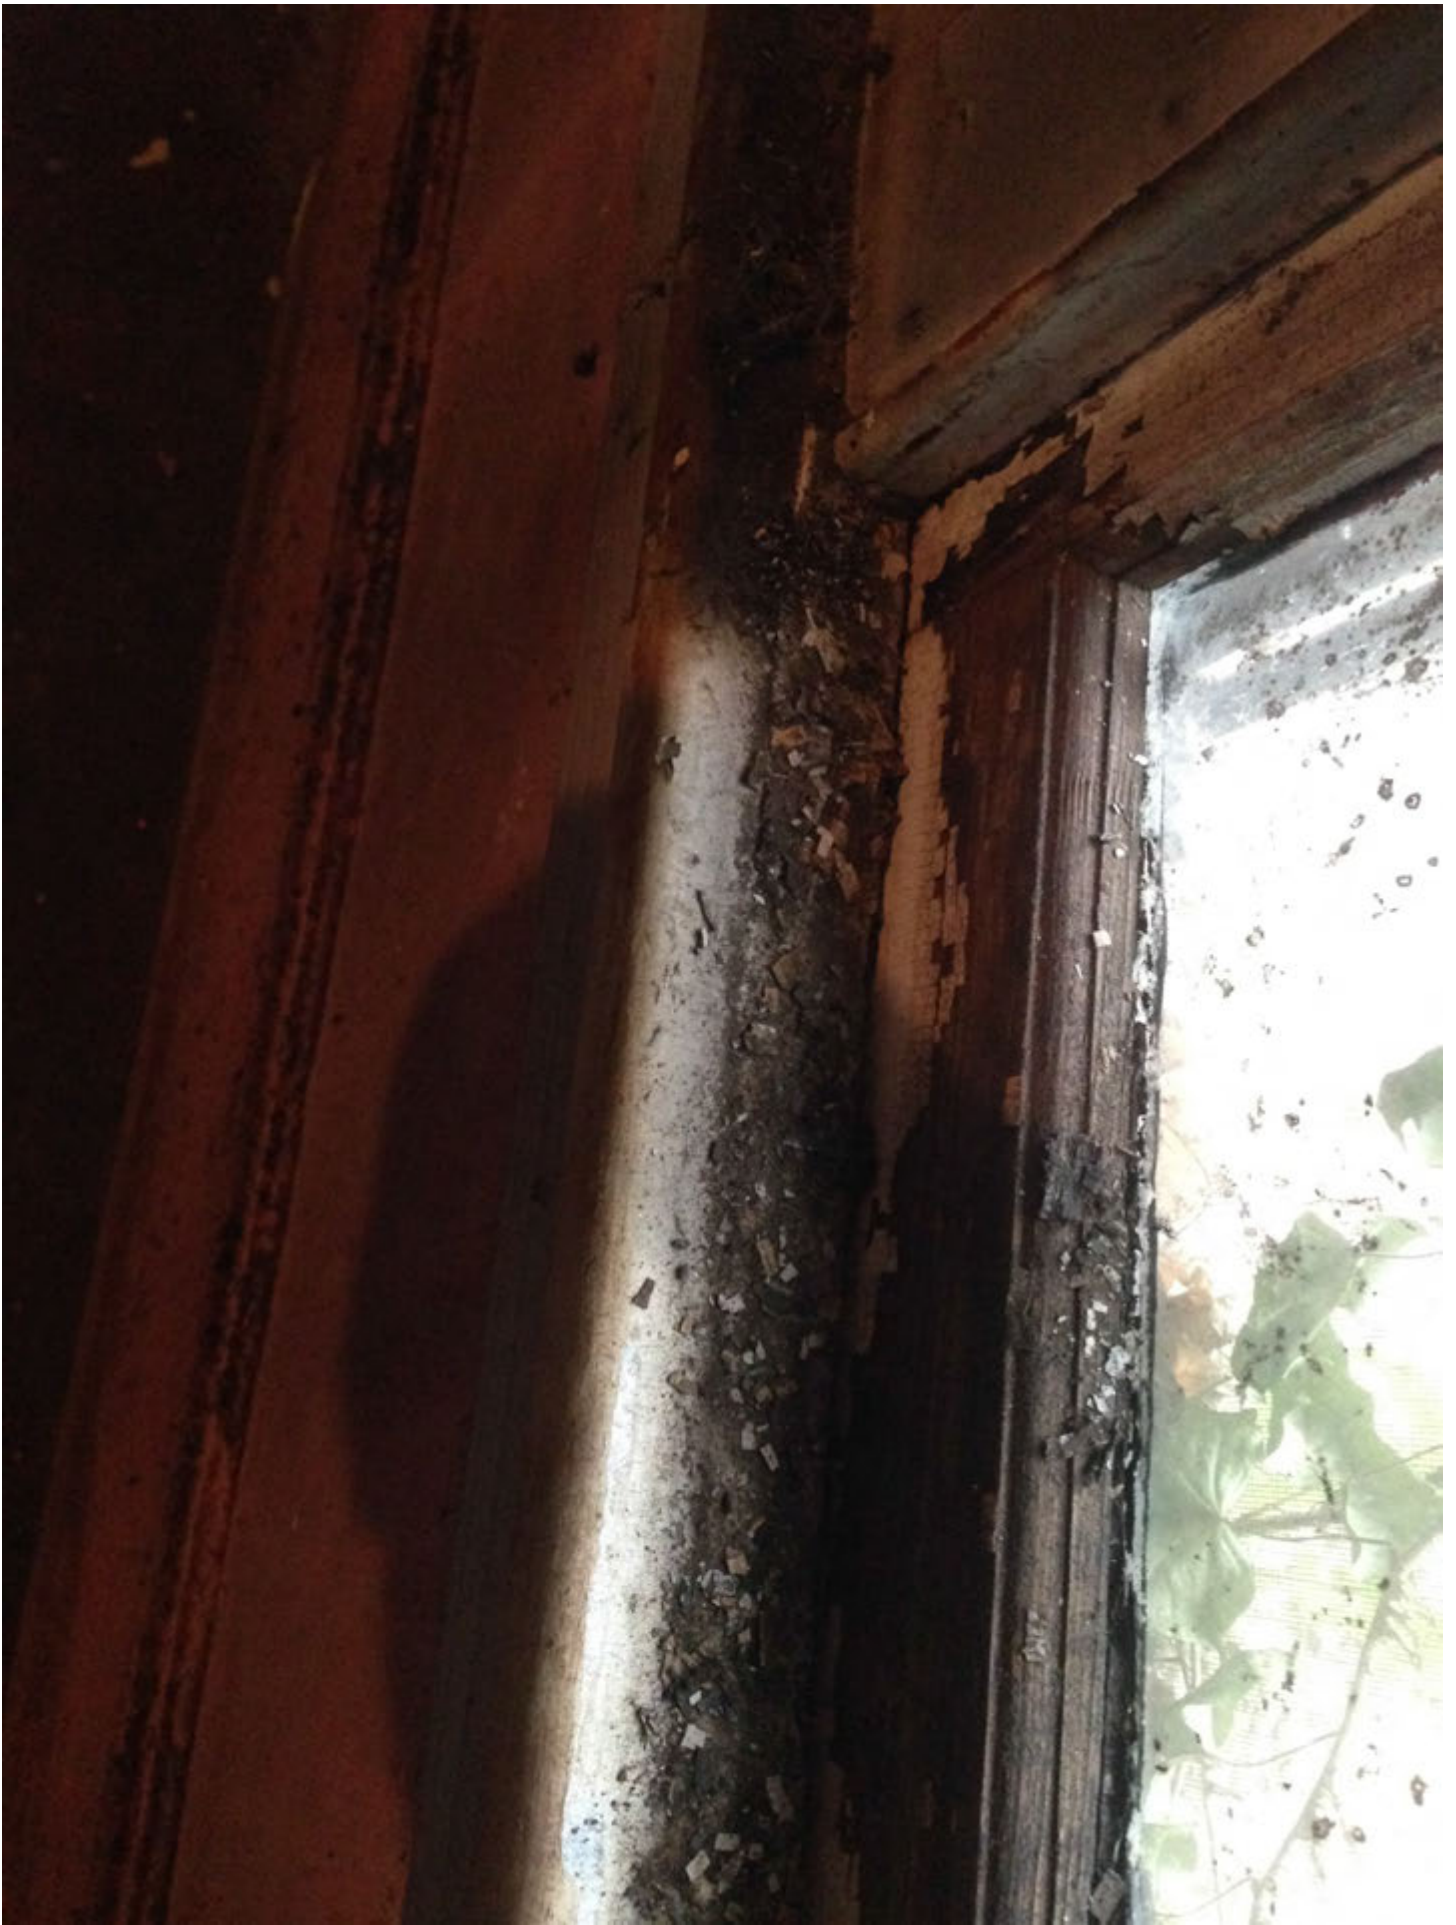
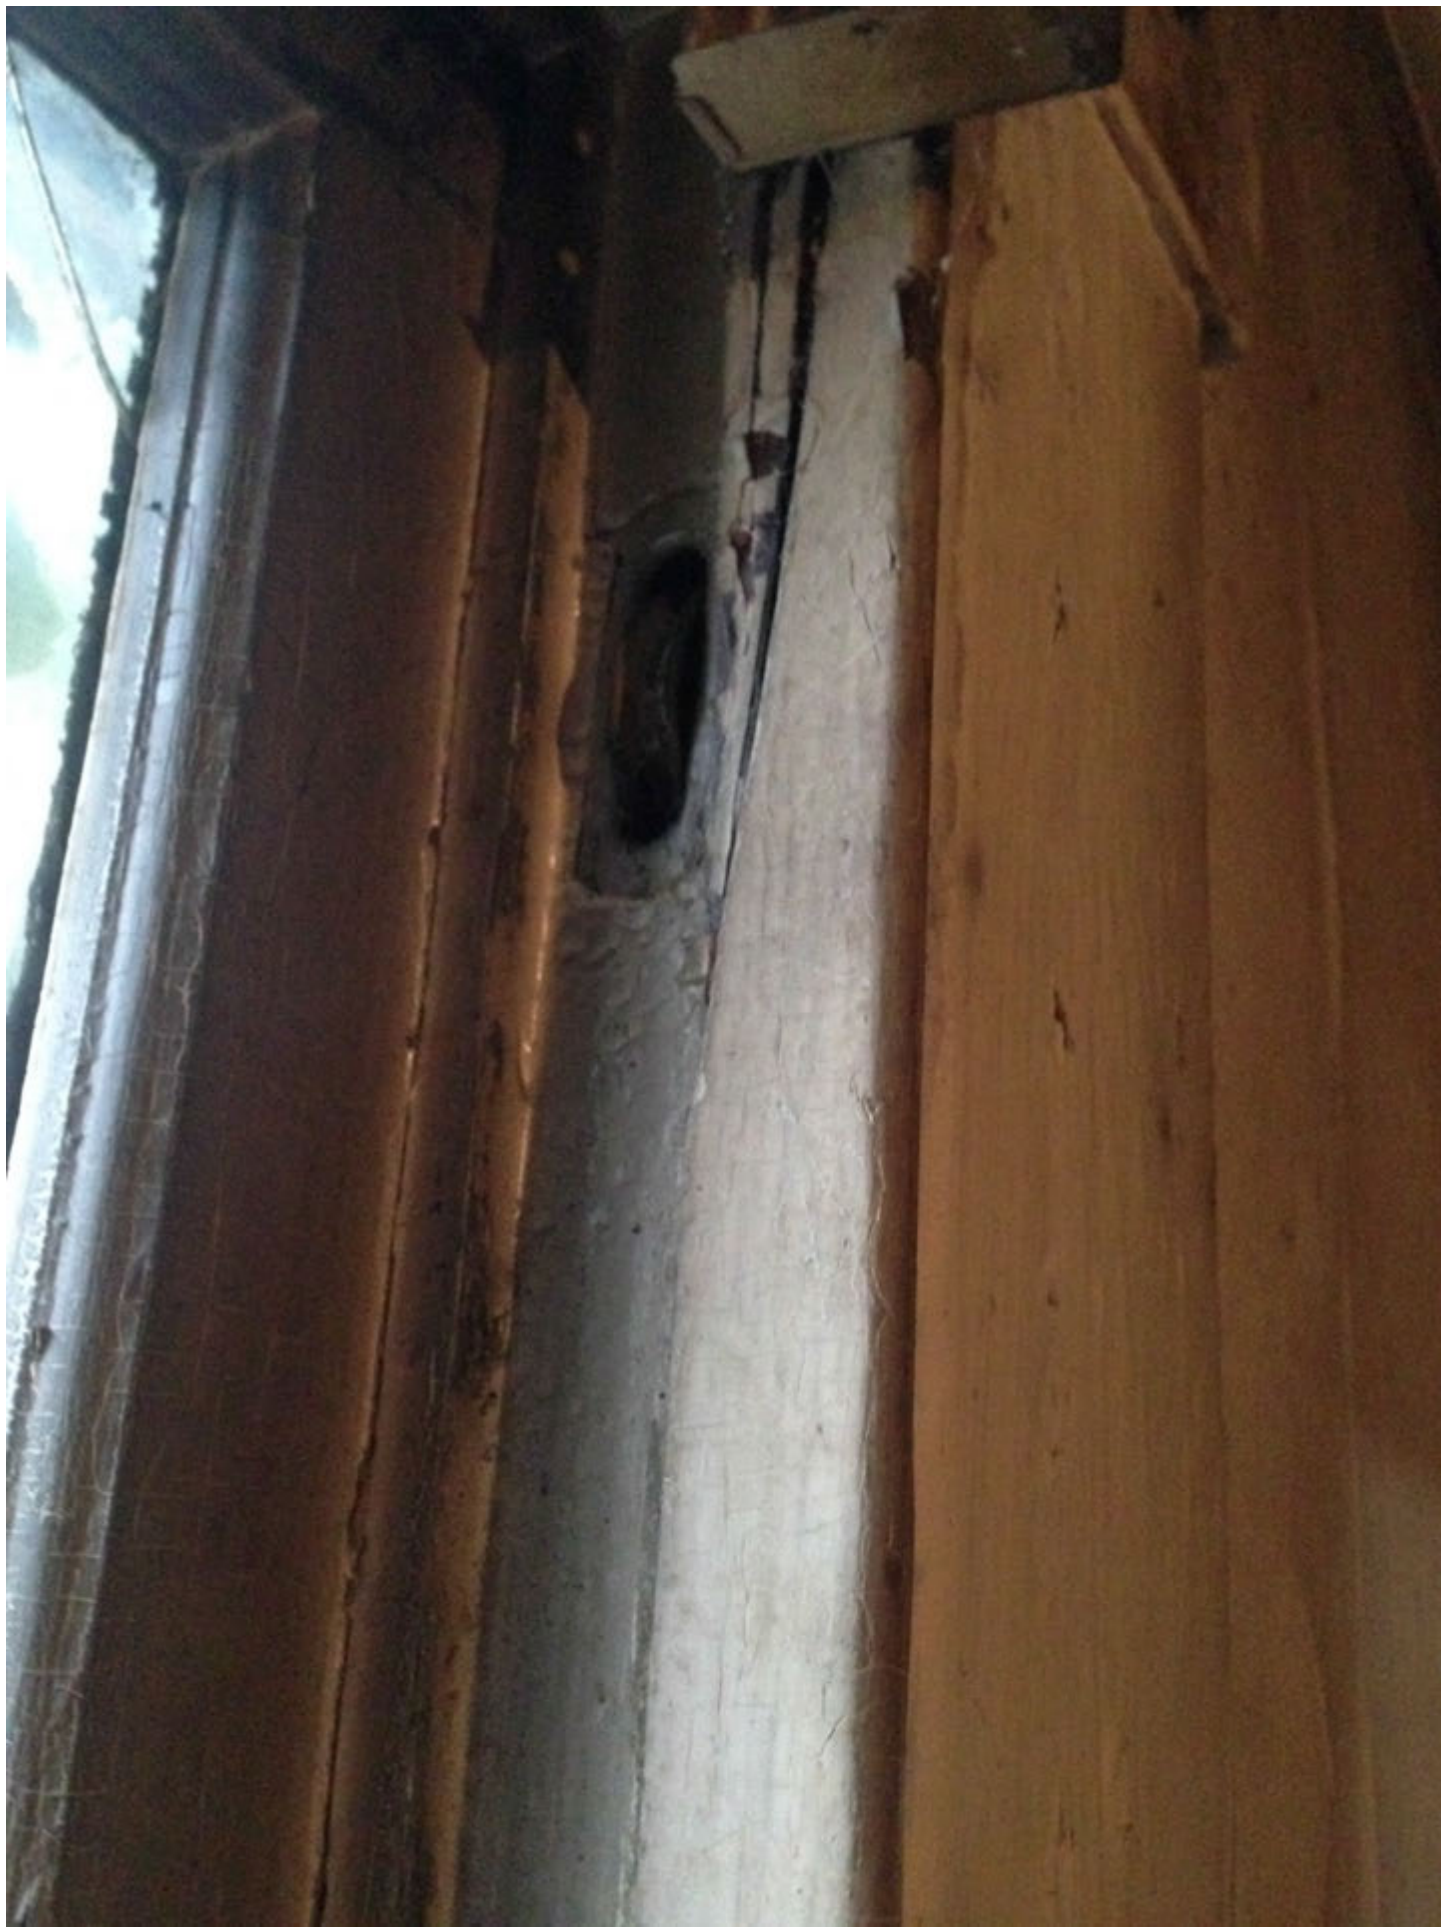
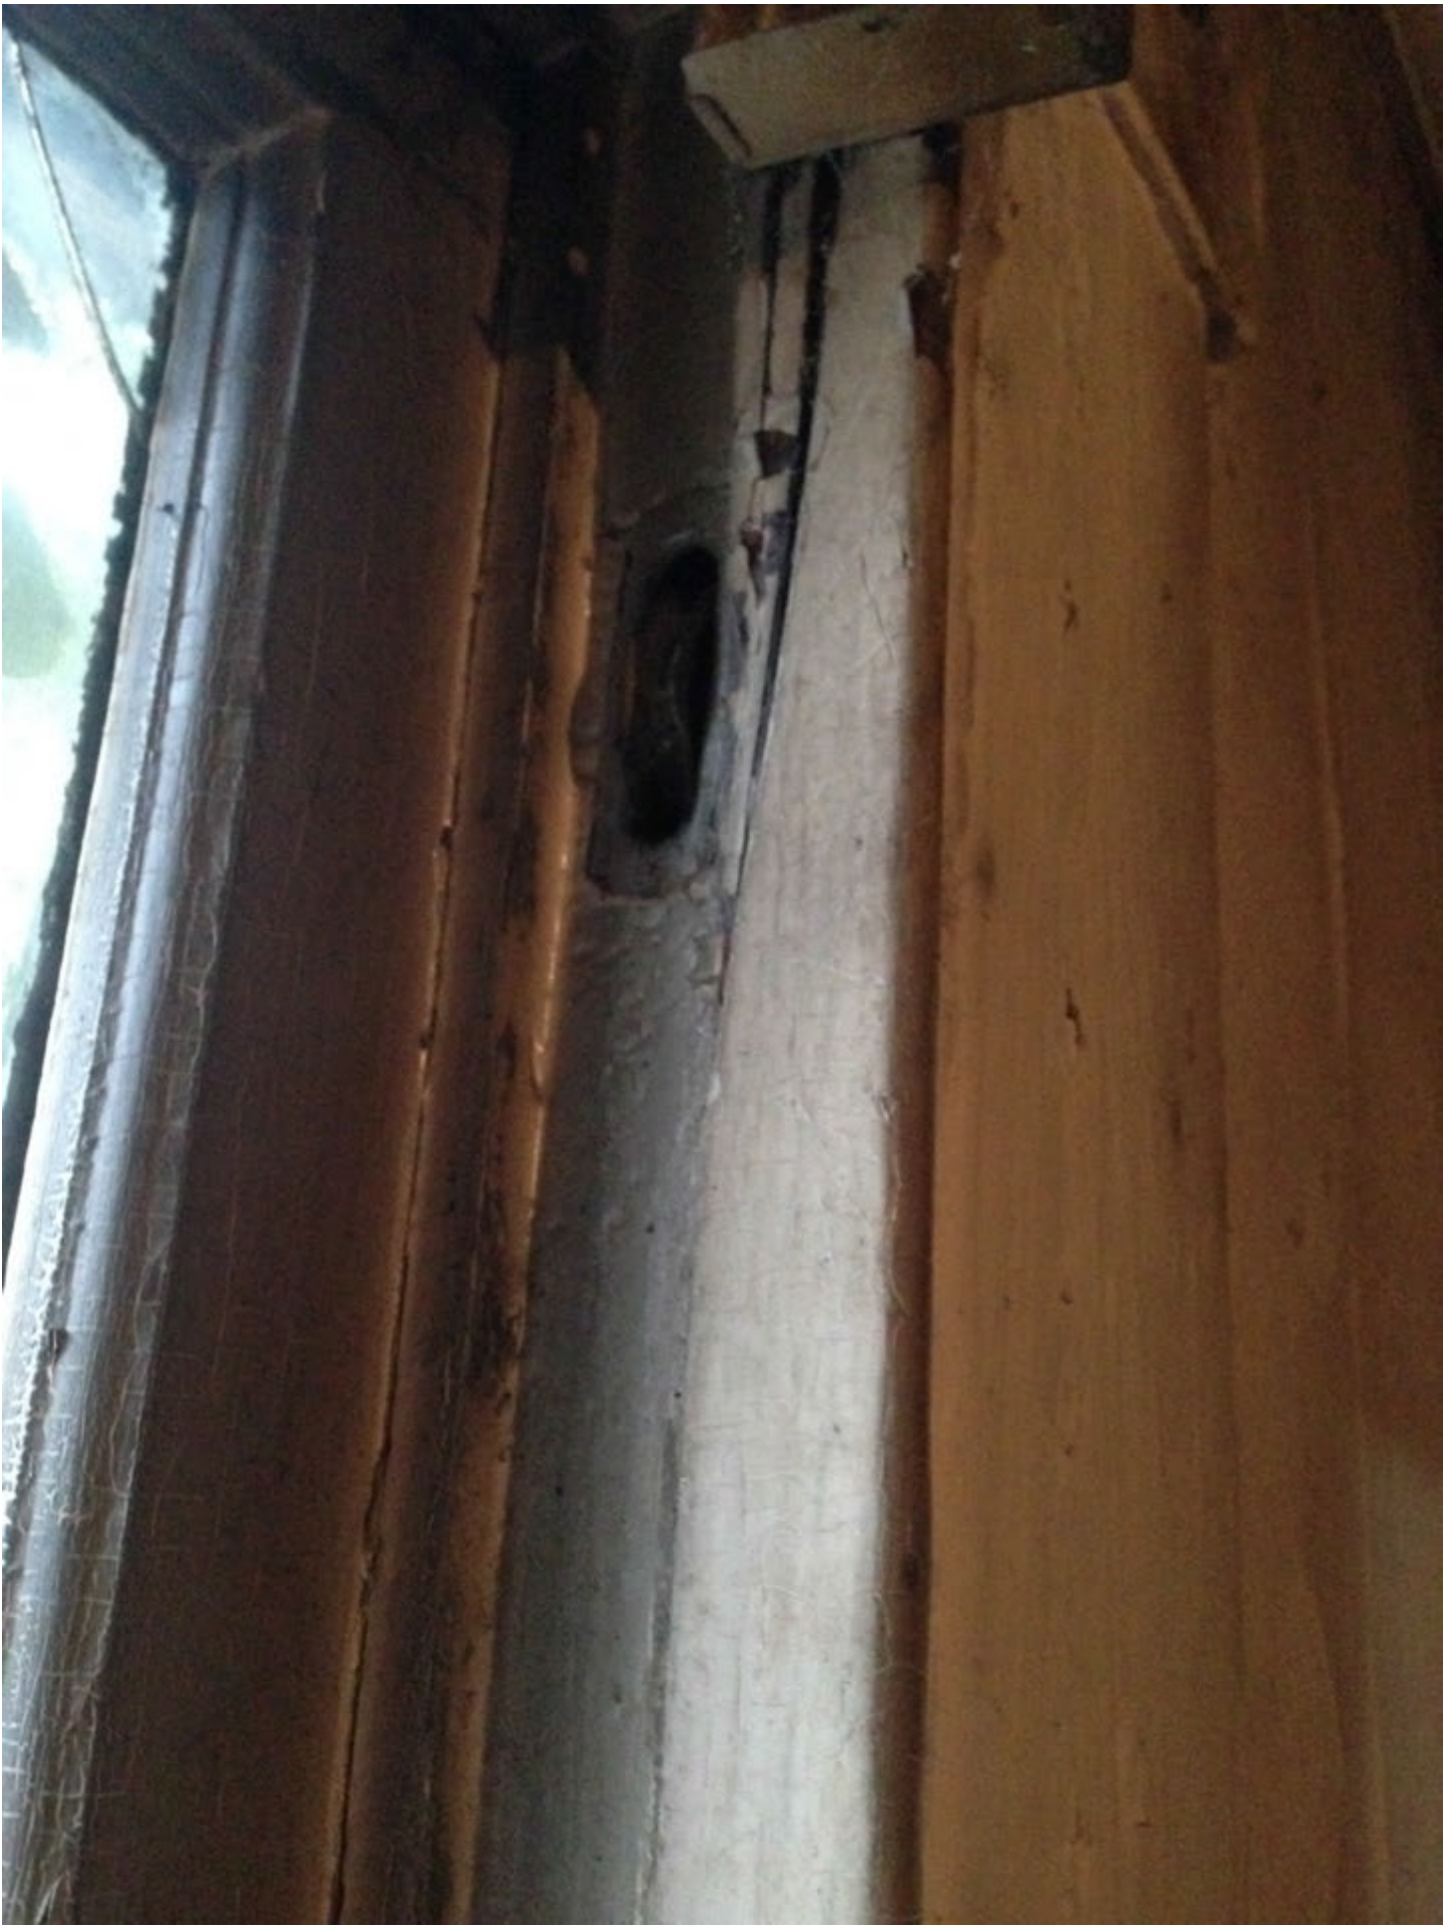
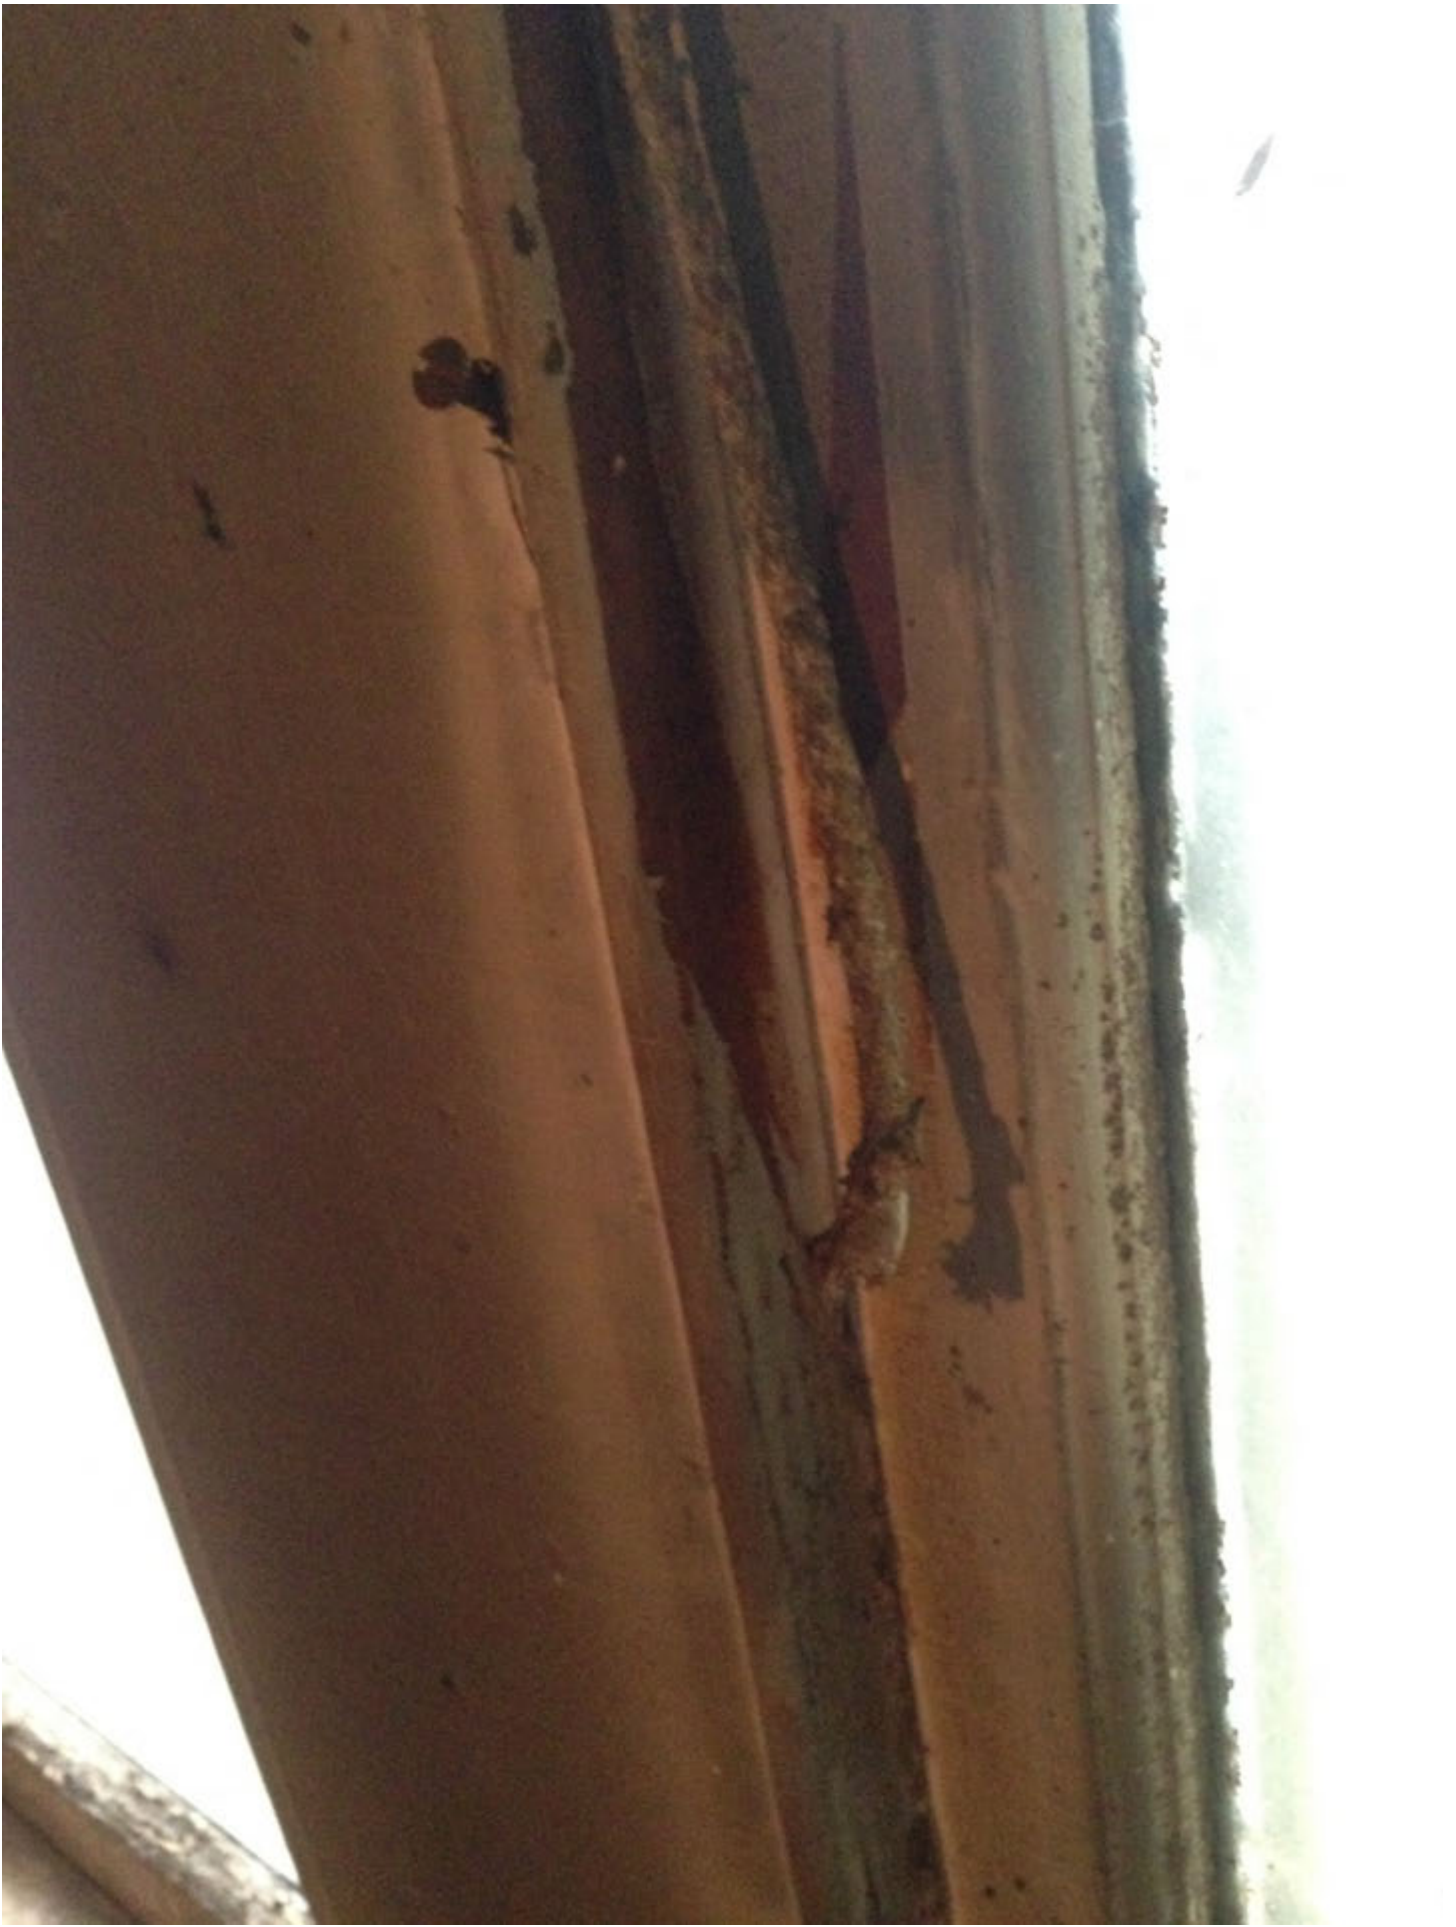
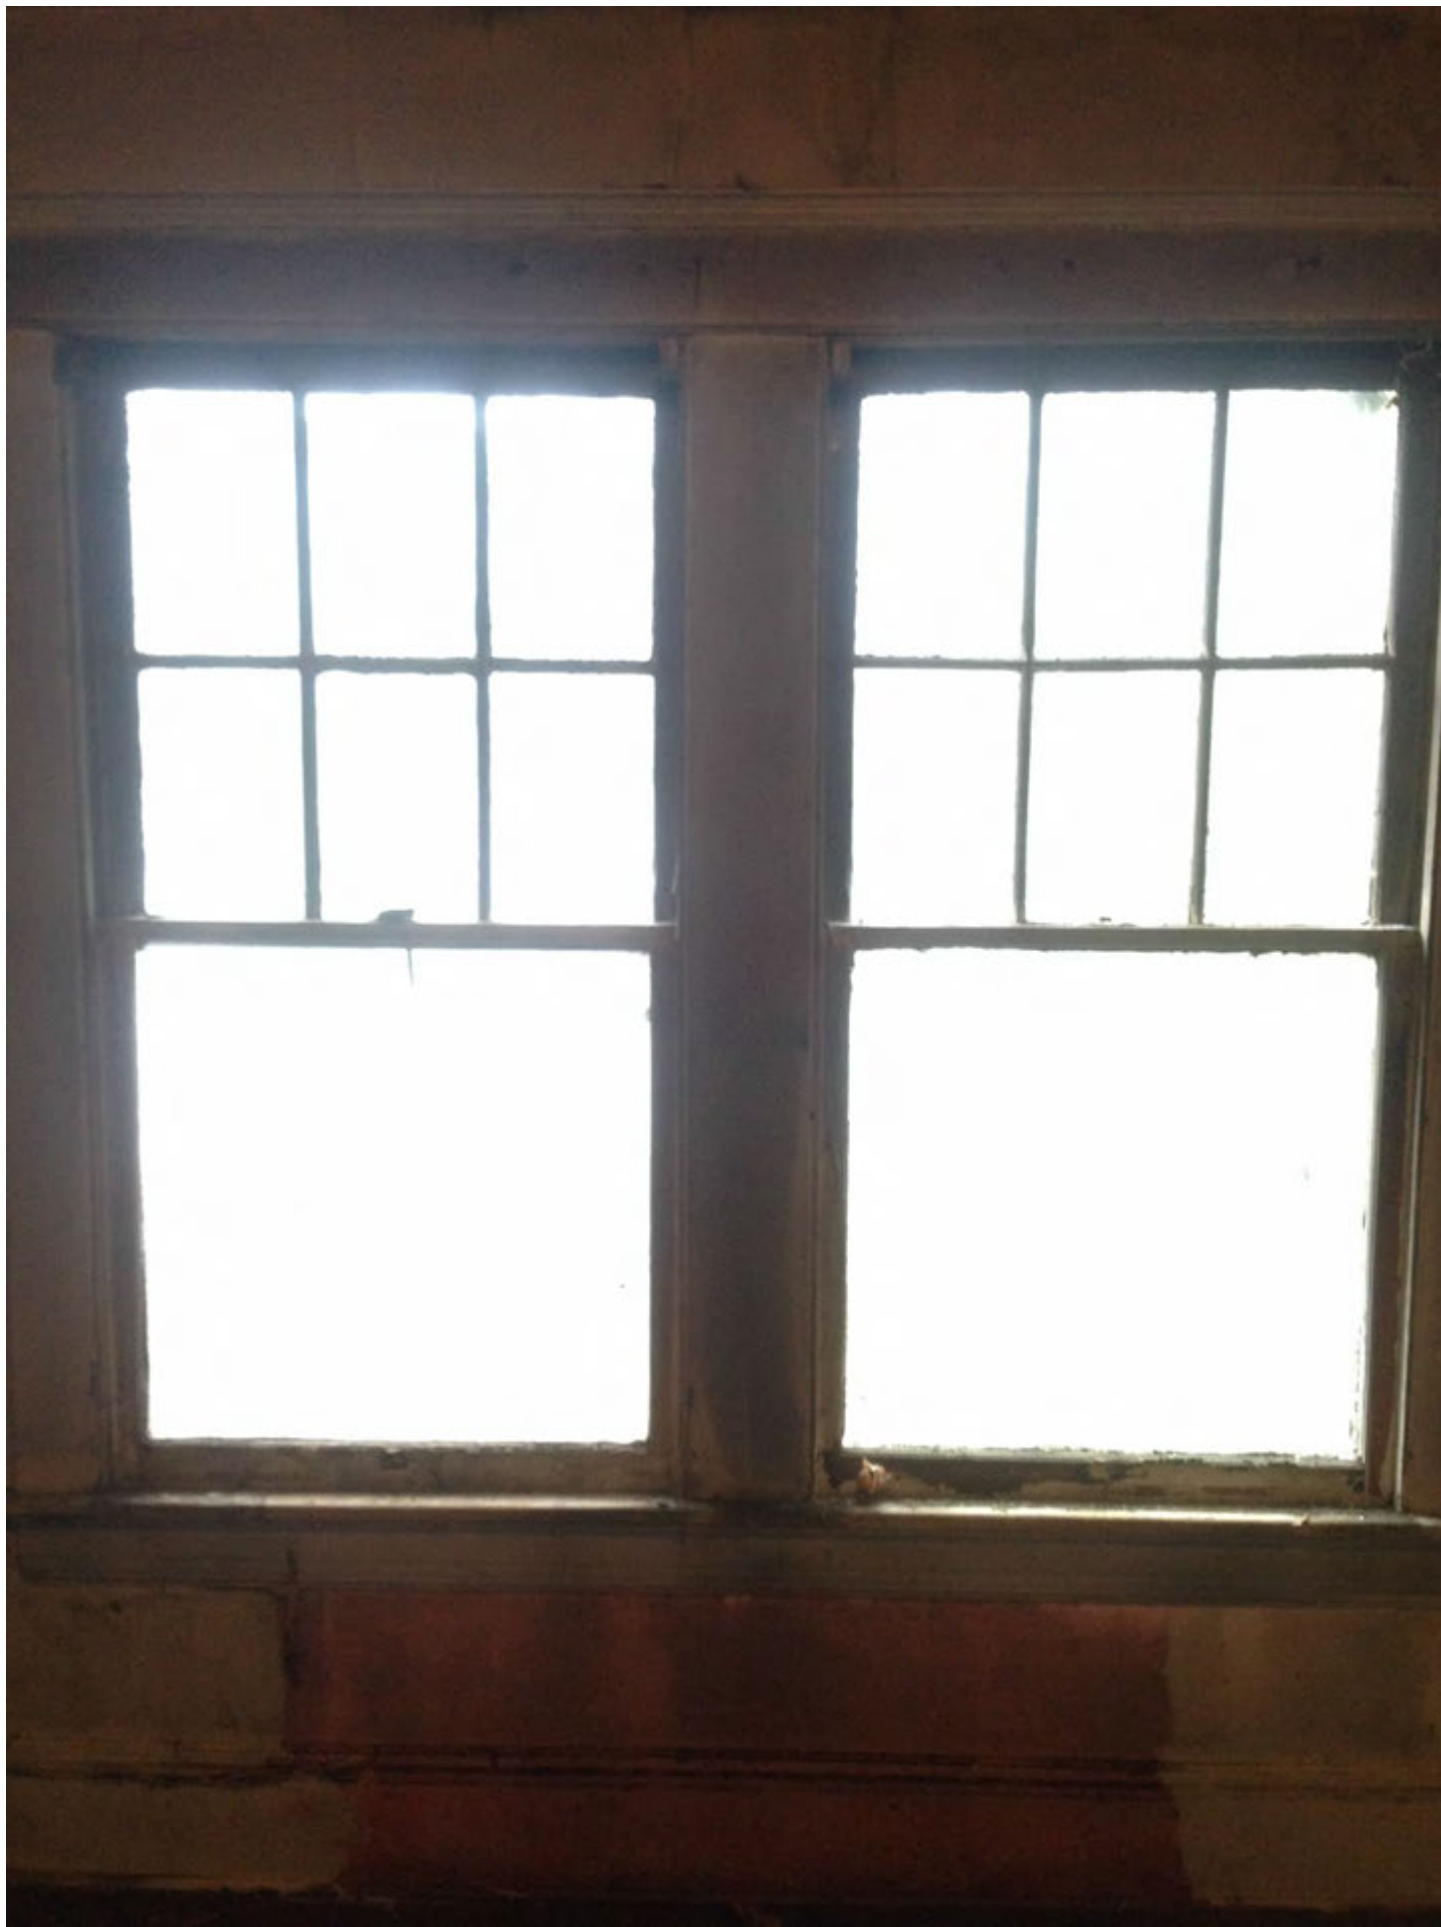
Window #: B10-B11

B10	Double Hung	6/1	IV	IV	IV	X			Double Hung	6/1	This window is located on the west elevation and is one of two grouped together. This window has severe sash, sill, and muntin deterioration and is proposed to be replaced. The sash is in such bad condition that the profile details are completely gone due to deterioration. Sash cords are cut and missing as well as counterweights. Panes have visible cracks and window does not operate correctly. Exterior trim is deteriorating at the sill and up portions of the sides from what appears to be years of leaves and rotting yard debris stuck between the sash and window screen, as well as vines growing through rotted portions of the sash. I plan to salvage whatever possible from the exterior trim and replace trim as required with matching materials and profiles. New window shall be sized to match the existing rough opening and muntin configuration.
B11	Double Hung	6/1	IV	IV	IV	X			Double Hung	6/1	This window is located on the west elevation and is one of two grouped together. This window has severe sash, sill, and muntin deterioration and is proposed to be replaced. The sash is in such bad condition that the profile details are completely gone due to deterioration. Sash cords are cut and missing as well as counterweights. Panes have visible cracks and window does not operate correctly. Exterior trim is deteriorating at the sill and up portions of the sides from what appears to be years of leaves and rotting yard debris stuck between the sash and window screen, as well as vines growing through rotted portions of the sash. I plan to salvage whatever possible from the exterior trim and replace trim as required with matching materials and profiles. New window shall be sized to match the existing rough opening and muntin configuration.
