RE: 190-14-CA (708 Dorothea Drive)

Property Address: 708 Dorothea Drive

Window Survey

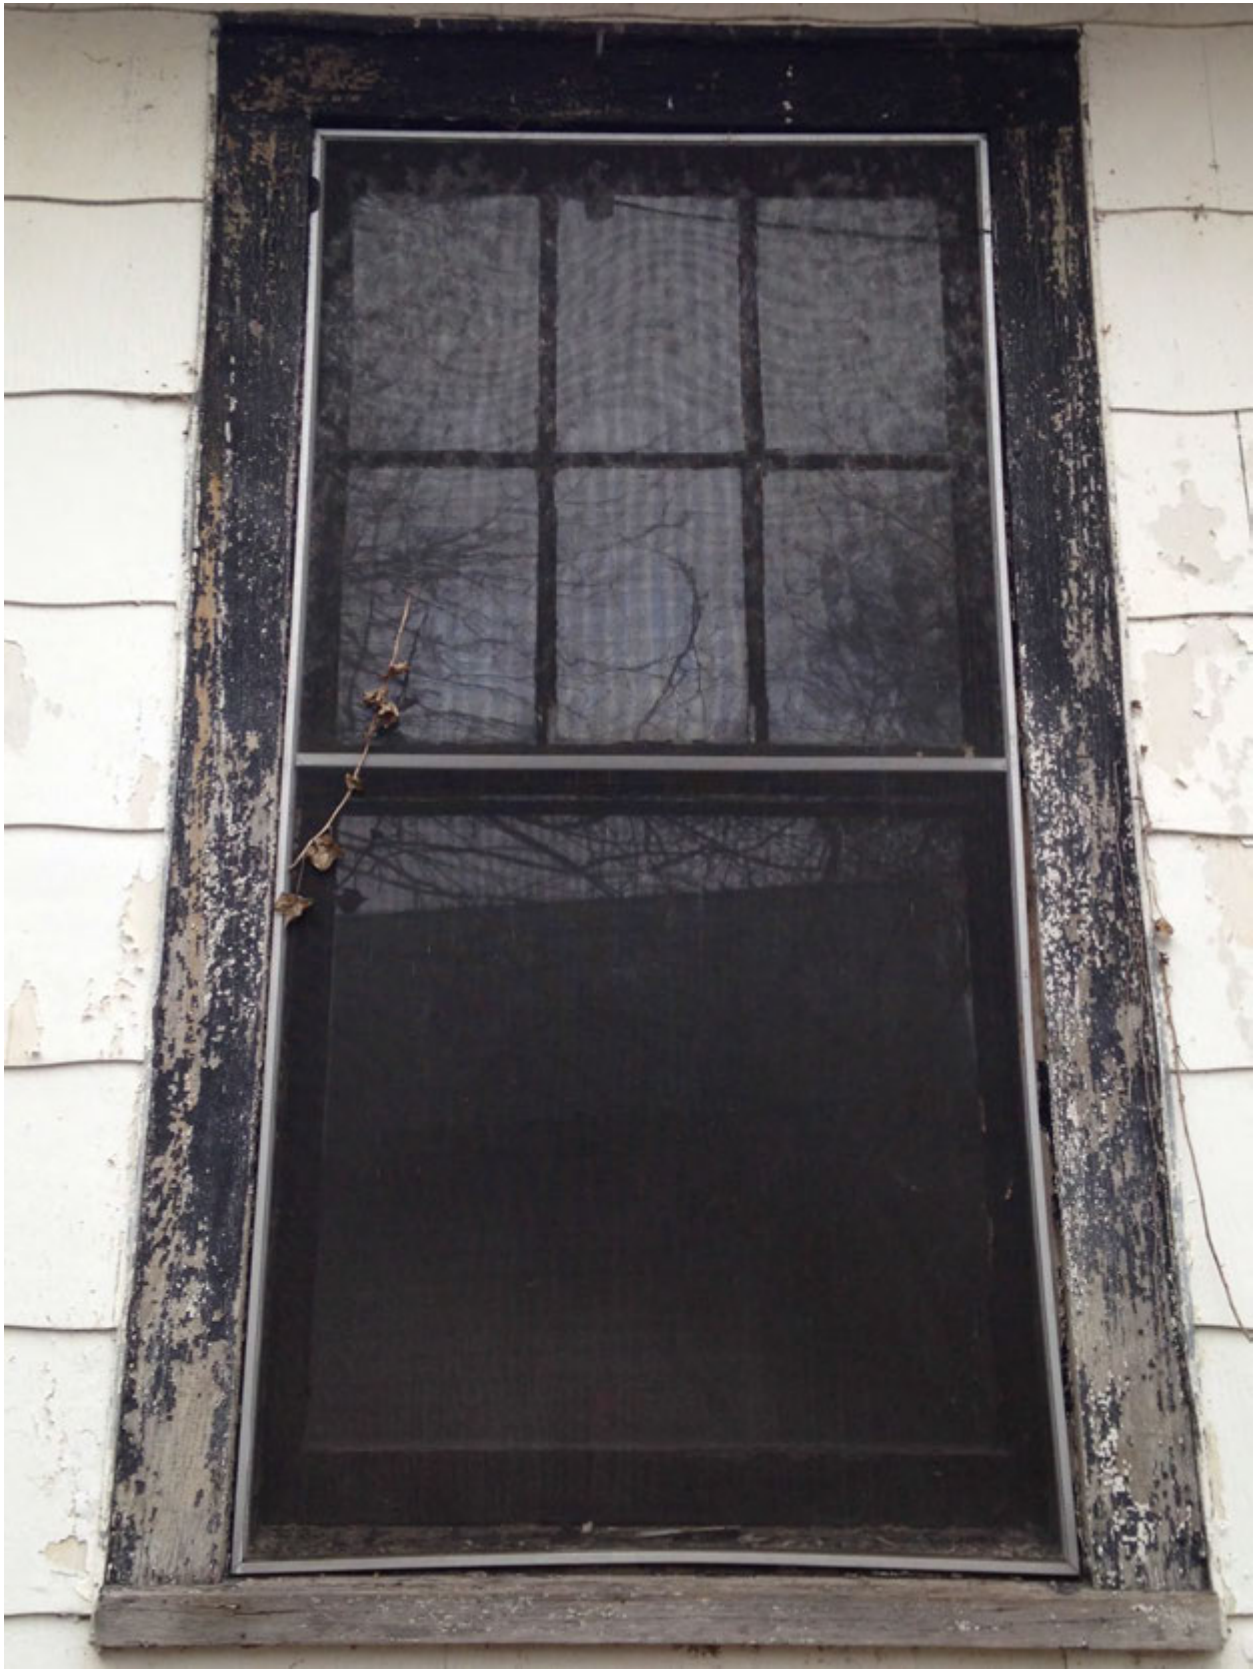
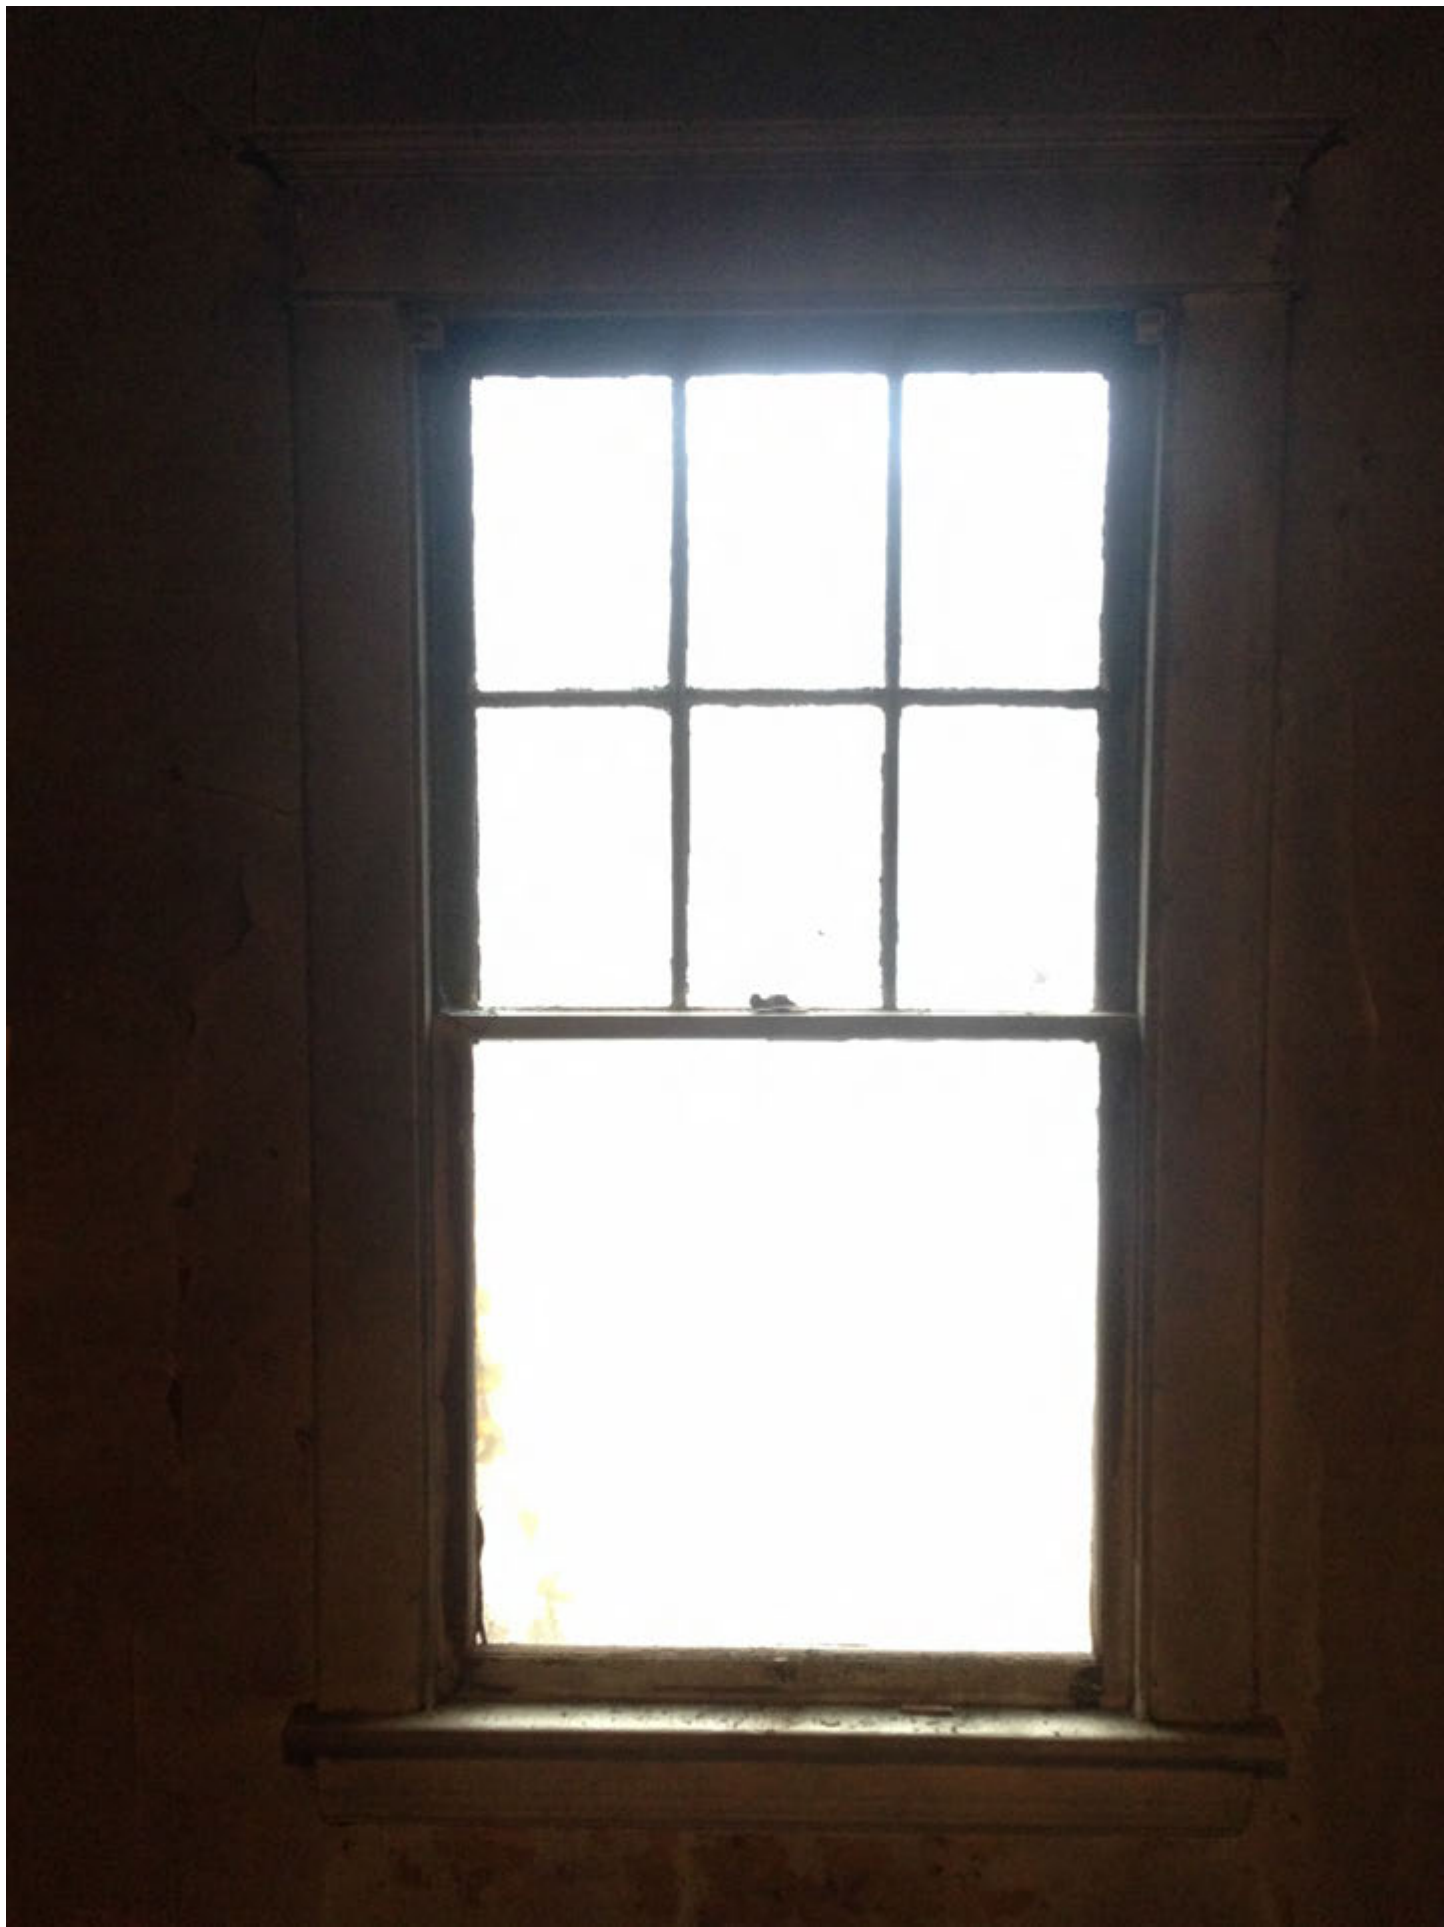
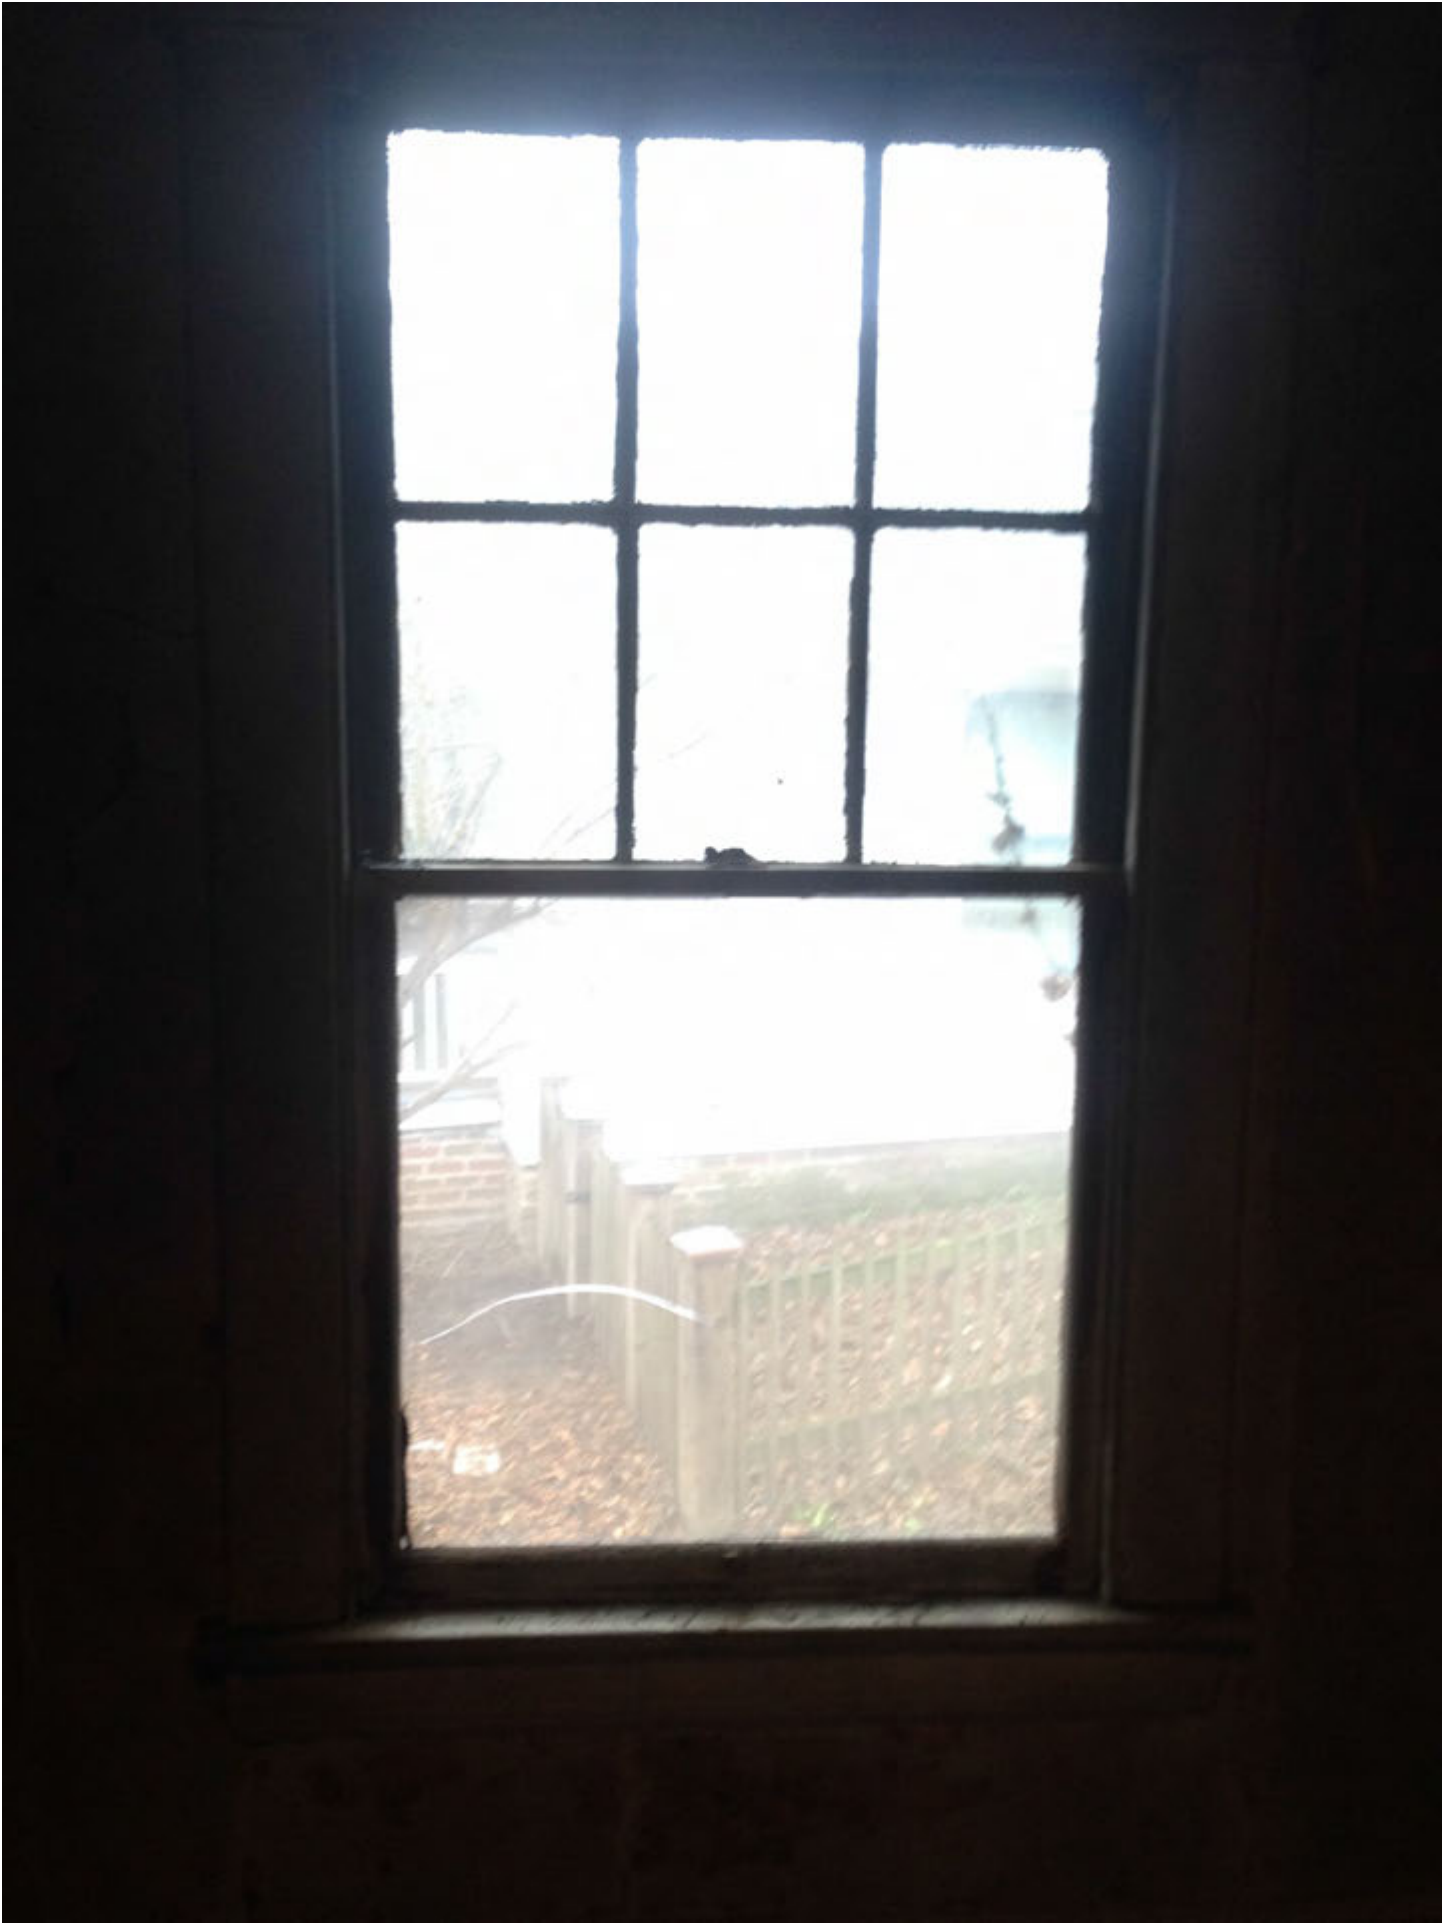
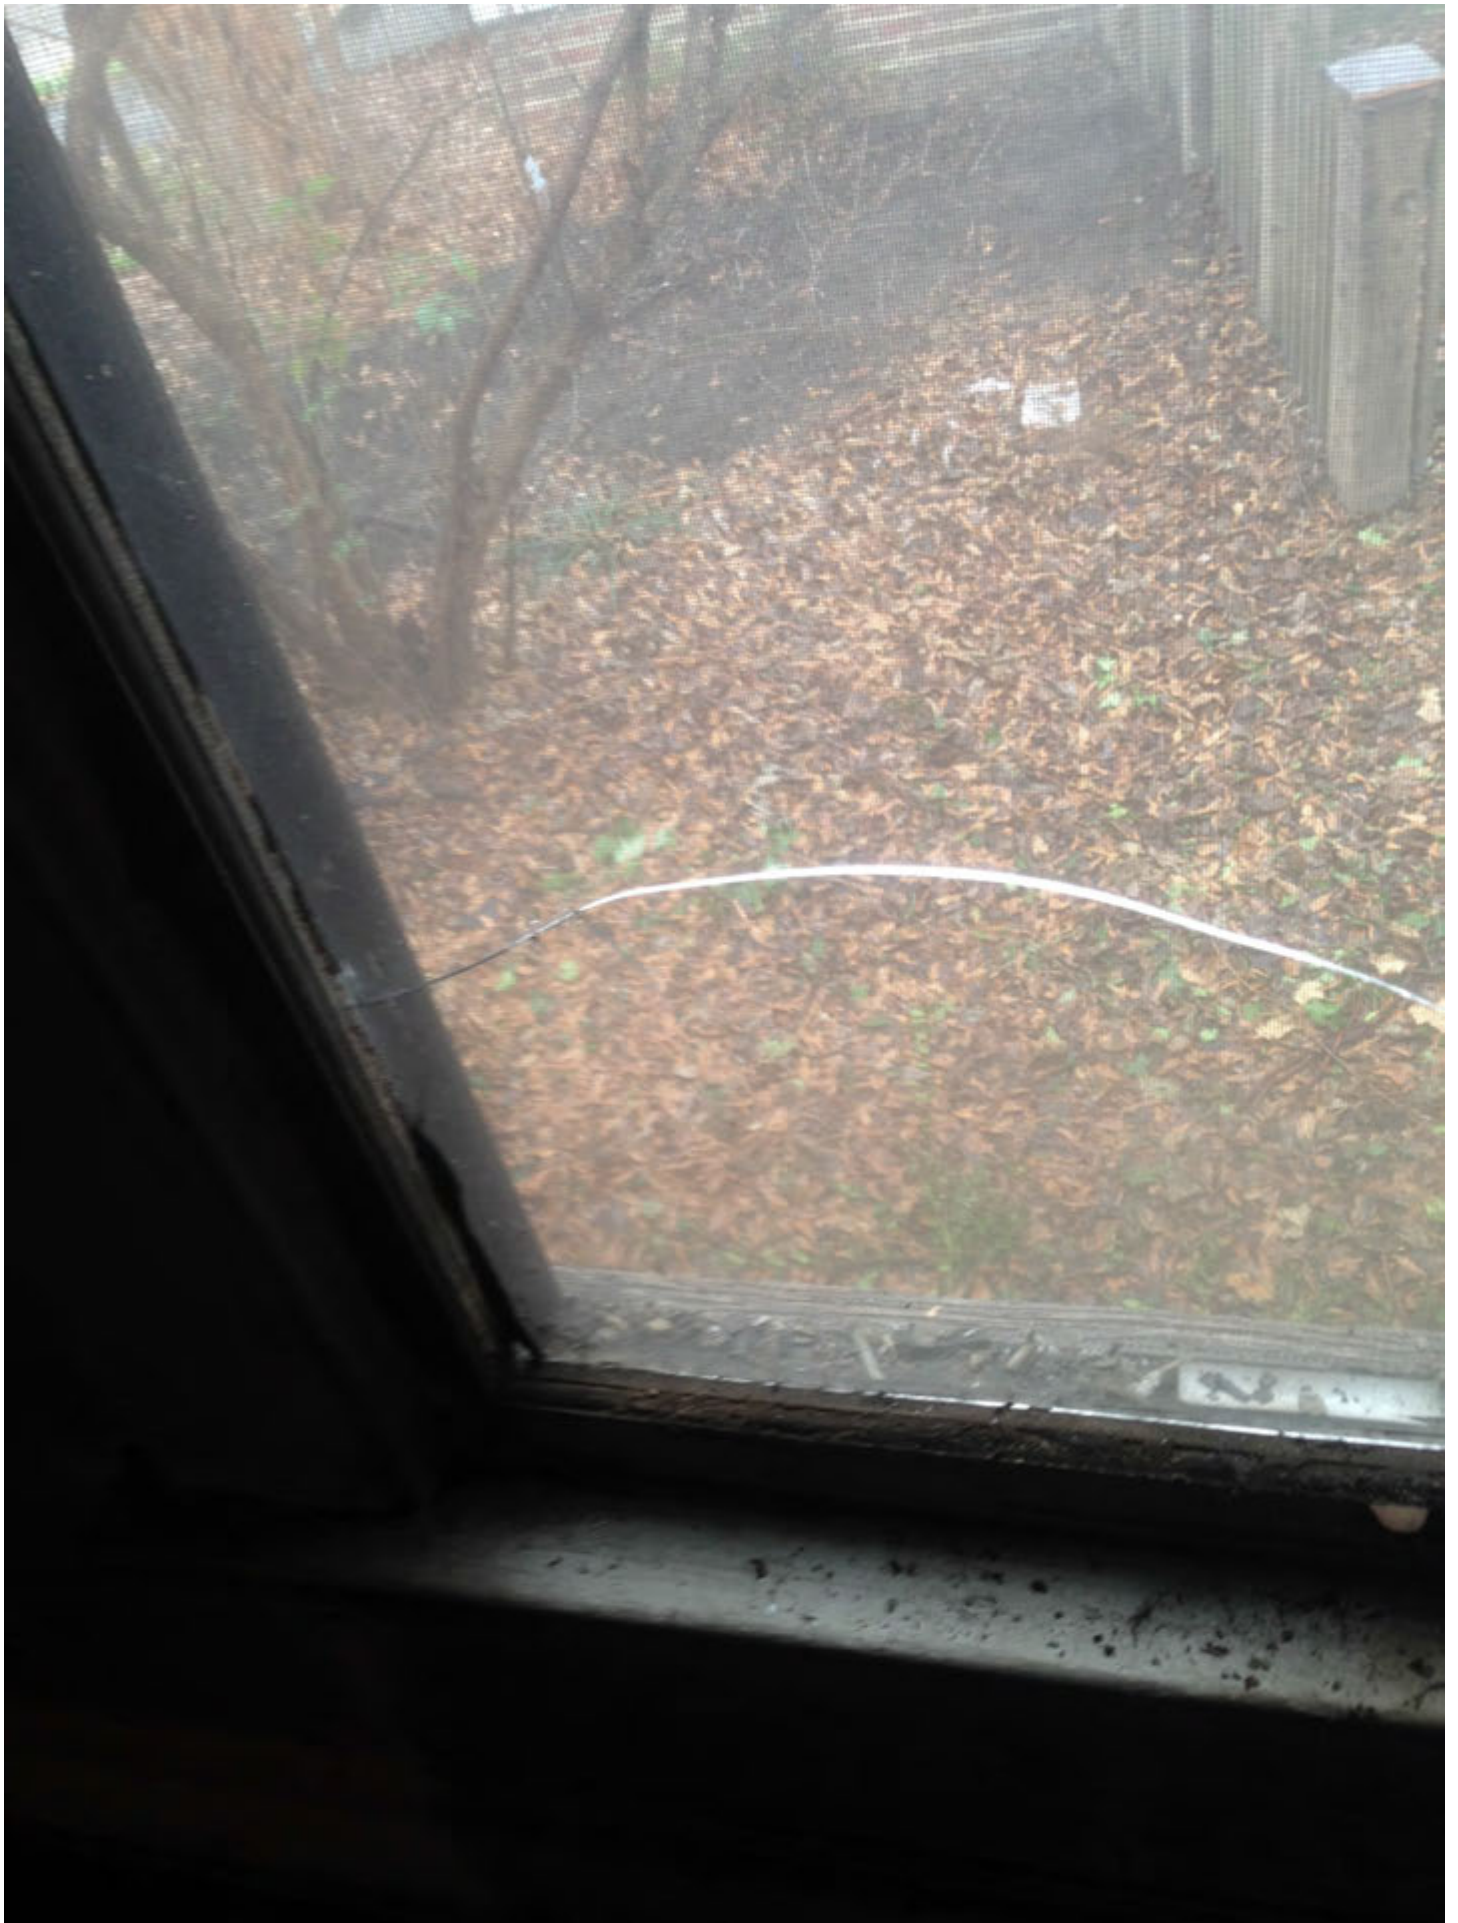
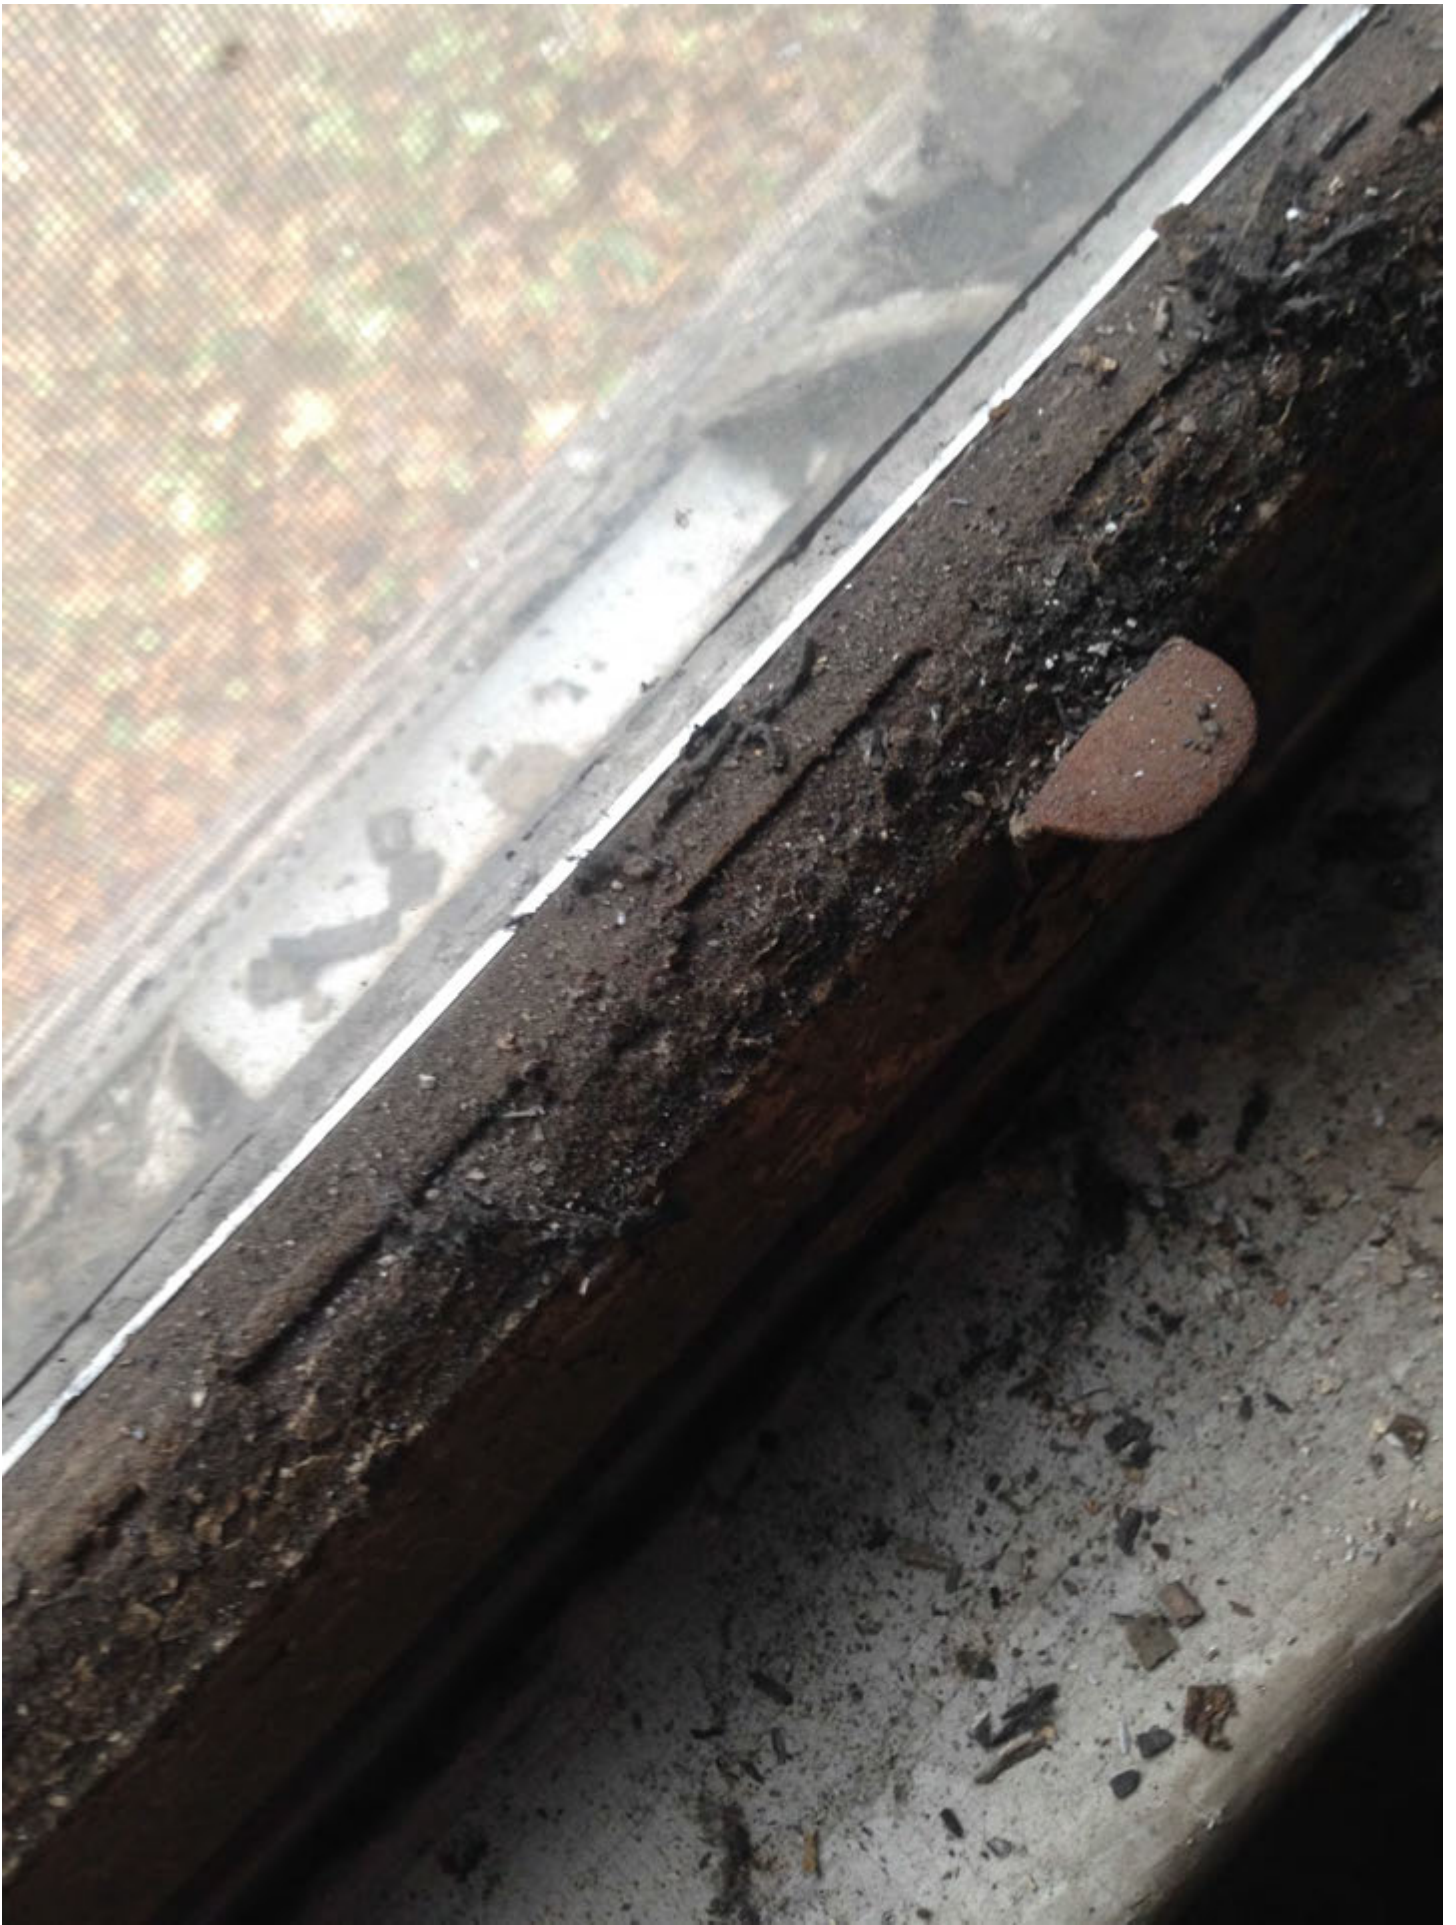
Window #: B12

B12	Double Hung	6/1	IV	IV	IV	X			Double Hung	6/1	This window is located on the west elevation. This window has severe sash, sill, and muntin deterioration and is proposed to be replaced. The sash is in such bad condition that the profile details are completely gone due to deterioration. Sash cords are cut and missing as well as counterweights. Several panes have visible cracks and window does not operate correctly. Exterior trim is deteriorating at the sill and up portions of the sides from what appears to be years of leaves and rotting yard debris stuck between the sash and window screen, as well as vines growing through rotted portions of the sash. I plan to salvage whatever possible from the exterior trim and replace trim as required with matching materials and profiles. New window shall be sized to match the existing rough opening and muntin configuration.
C1	N/A	N/A	N/A	N/A	N/A	N/A	N/A	N/A	Double Hung	6/1	This is a new window located in the north elevation of the addition. I plan to match the exterior trim of all the other windows on the east and west elevations with matching materials and profiles. New window shall be sized to match the other larger windows on the east and west elevation, such as window B4, and have same 6/1 muntin configuration.
