FIBER-REINFORCED CEMENT SIDING MATERIALS SHOULD THEY BE USED ON HISTORIC BUILDINGS?

Janet W. Foster, Assoc. Dir. for Urban Planning and Historic Preservation, Columbia University

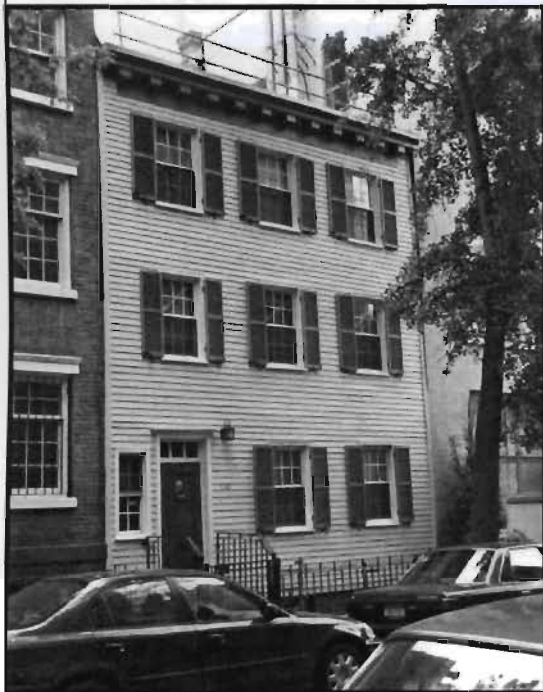
132 Charles Street in New York City is a rare example of a surviving wooden building.
Photo: courtesy of the author

Although New York City outlawed wooden buildings in 1875, some still survive, like the house in Greenwich Village at 132 Charles Street, built in 1819 (shown left). In the 1920s, the original wooden clapboards had been covered by a two-inch thick Portland cement stucco application in an attempt to make the building comply with fire-rating standards. By the time the building underwent a thorough rehabilitation in 2003-04, the architects for the project, JHPA, determined that water infiltration between the original clapboard and the later stucco covering had so rotted the wood that it was unsalvageable. New York City Department of Buildings required a fire rating that prevented use of new clapboard in this dense urban location. So JHPA chose to use a fiber-reinforced cement siding material.

Says Michael Devonshire, a JHPA partner, "Our office was a bit hesitant, but mock-ups proved to be quite reasonable. Until you tap it, you cannot tell that it is not wood. It certainly worked in that application, and has an ideal fire rating."

At the time of the application of the new siding, the house and its block were not regulated by New York City Landmarks Law, although they were included in the 2006 expansion of the Greenwich Village Historic District. The owners at the time of the 2003 renovation appreciated the historic character of the house, probably built by a carpenter named Matthew Armstrong. On their behalf, JHPA sought an opinion from the New York City Landmarks Commission (LPC) on the use of the fiber-reinforced cement clapboard on the building, as it was in a proposed historic district. The LPC endorsed the idea and approved of the final results, designating 132 Charles a contributing building within the expanded historic district.

In this application, and in many others on historic buildings around the country, fiber-reinforced cement siding is applied on a flat, solid surface. It may be attached to the diagonal sheathing often found on 19th century buildings, or on new plywood underlayment. The result is a new, durable exterior skin. Unlike the vinyl and aluminum siding used in the late 20th century to refurbish the look of wooden buildings, the reinforced cement clapboard does not cover the original siding. Thus it does not set up the possibility for increased deterioration of the building's original siding and framing through hidden leaks or unseen insect infestation. It allows original, wooden detail-work around windows, doors and cornices to project from the elevation, as they were intended to do. Too often in the application of aluminum and vinyl siding, the wooden detail is shaved off in the siding application, or, if it remains intact, lacks the depth that it once had.

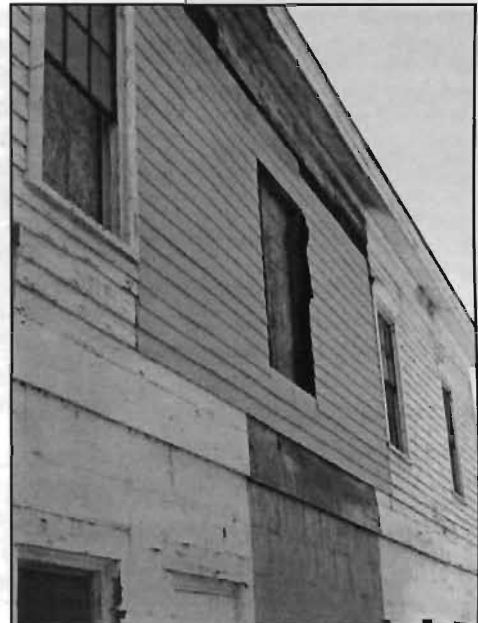
*New fiber-cement siding on 1857 Merced Co. (California) courthouse.
Photo courtesy of Mark Odell.*

tional cedar or redwood siding. Some premium product lines, however, offer fiber-cement siding at 1.5 inches. Fiber-cement shakes are also thinner in section than their traditional wooden counterparts and—to a trained eye—they appear unacceptably flat on a historic building. The flatness of the siding is also more pronounced if the planks are not beveled (in section) to match traditional wood clapboards. Some producers offer fiber-cement siding with a beveled detail, but it costs more and may not be readily available.

Problems with installation: Some fiber-cement planks come in lengths as long as 16 feet. The material is also much heavier than wood. When installed over long spans, it usually has a slightly uneven surface, and

this "ripple effect" creates jagged shadow lines (unlike wood siding). An option is to install the material in short lengths. Some manufacturers also advise against caulking the butt joints in cementitious planks to allow adequate permeability of moisture from inside a building. To those accustomed to wood clapboards on a historic house, these "gaps" in the butt joints are obvious change.
