RE: 190-14-CA (708 Dorothea Drive)

Property Address: 708 Dorothea Drive

Window Survey

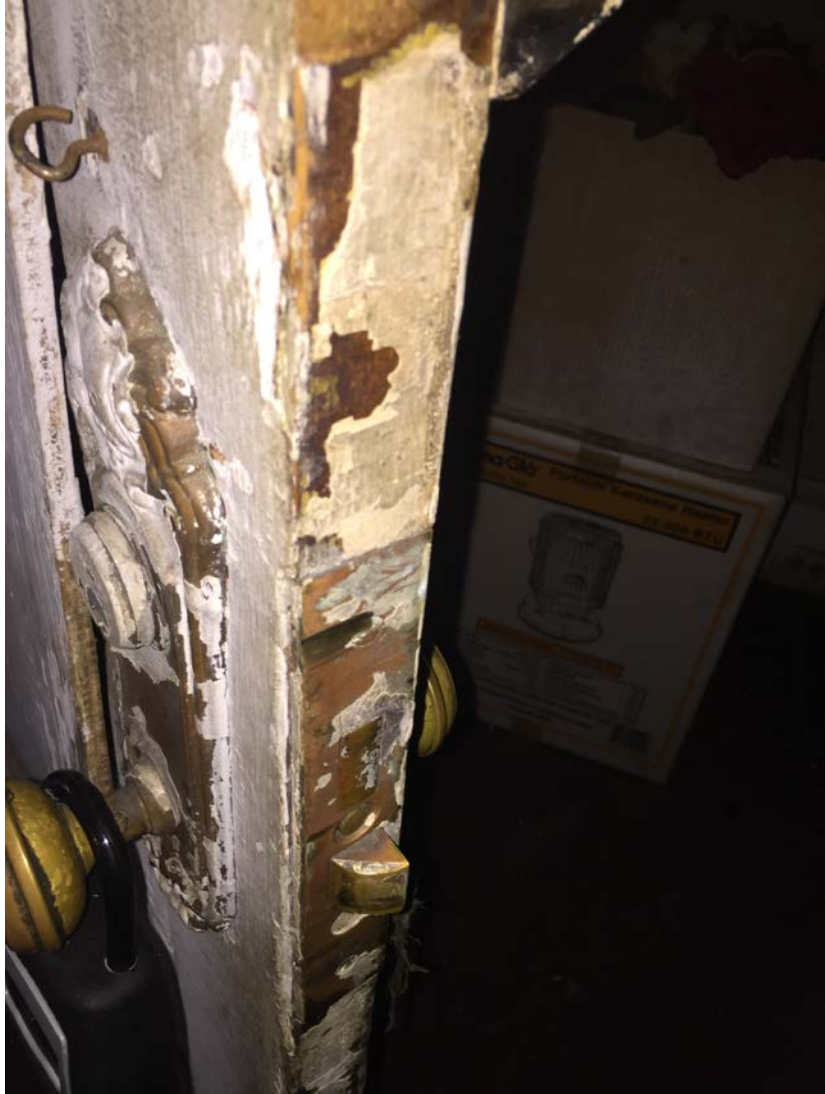
Existing front door damage:

In regards to the front door, I would still like to replace this. The historic preservationists I talked with would not give me a quote for fixing the door; therefore I would still like to replace it. I've included some additional pictures that show the extensive damage to the door. Previously a door was submitted for approval and I ask this be re-reviewed based on the information provided.
