## B. RESOURCES RECOMMENDED ELIGIBILITY FOR NATIONAL REGISTER LISTING

### BERRY O'KELLY SCHOOL HISTORIC DISTRICT (NCDOT SURVEY #15, #16, AND #17)

Resource Name:	Berry O'Kelly School Historic District
HPO Survey Site #	WA 6527
Location	512, 514, and 520 Method Road
PIN	794035766, 0794037650, and 794034561
Date(s) of Construction	1941; circa 1947; circa 1997
Recommendation	Eligible for NRHP Under Criteria A, B and C

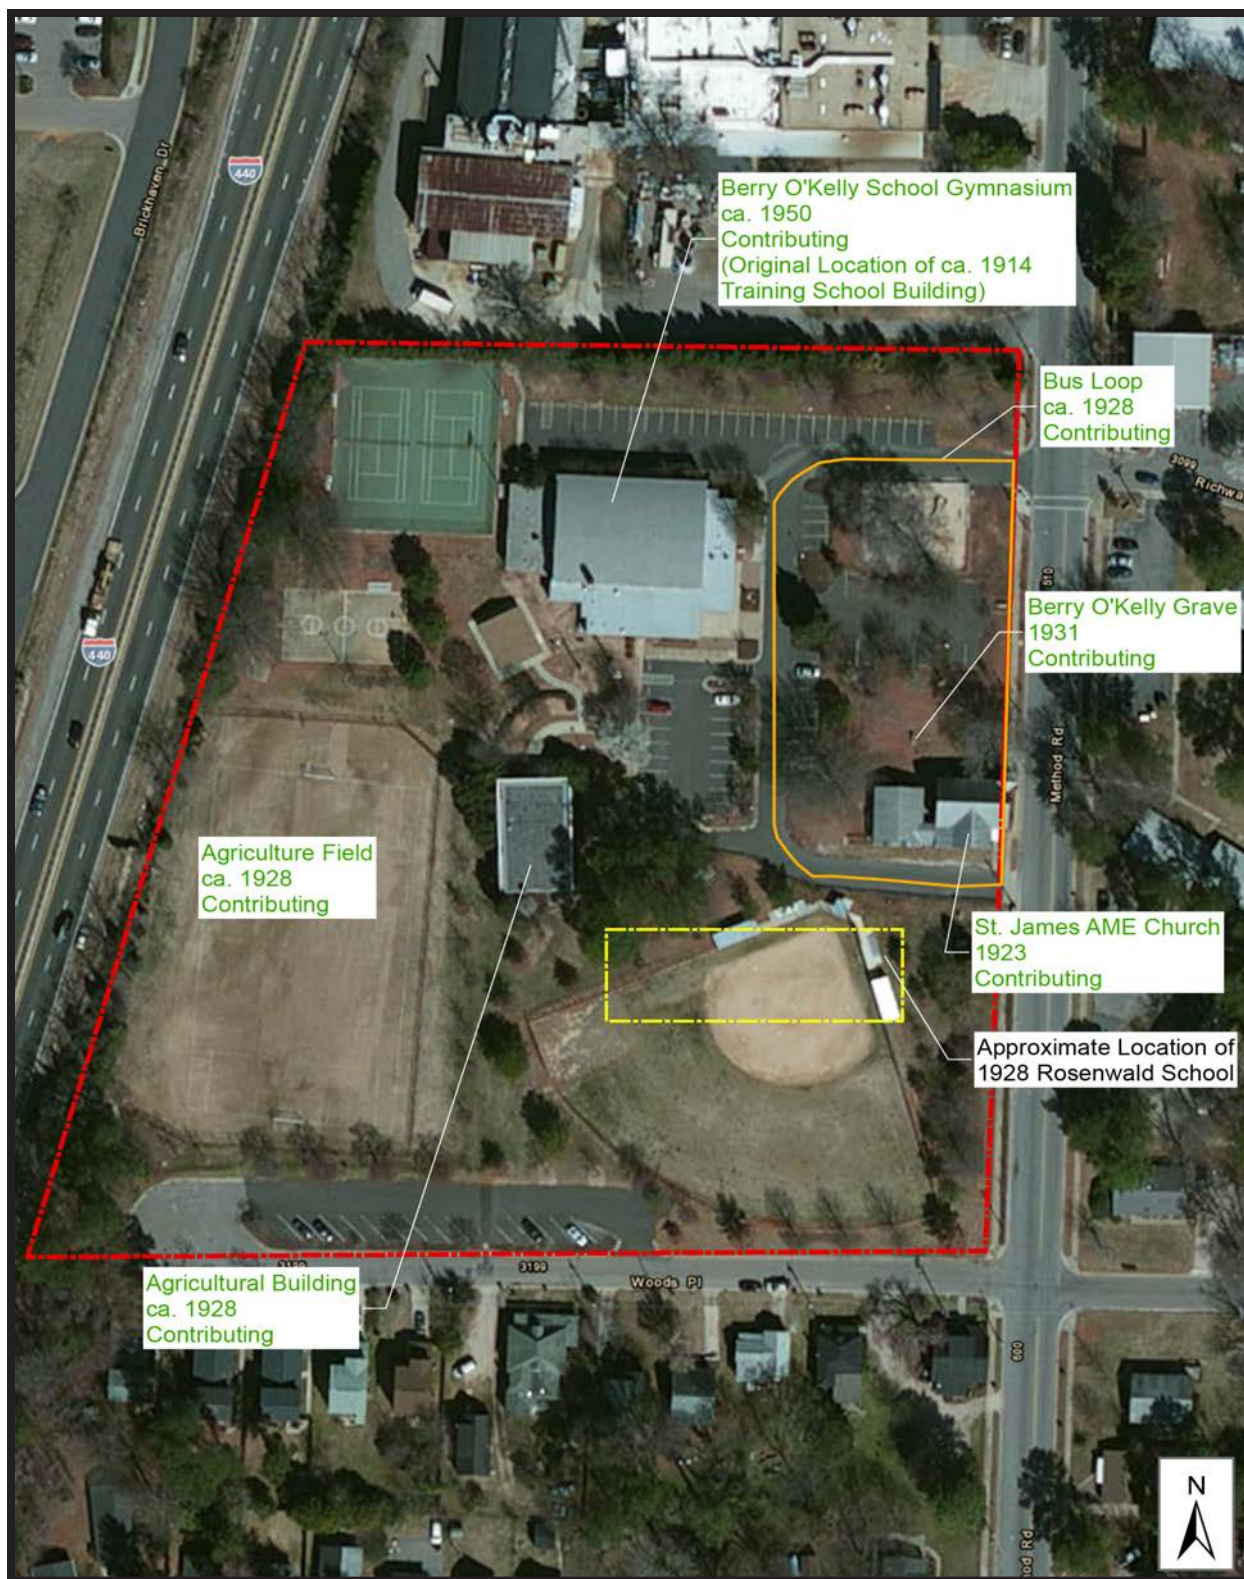
Figure 18. Berry O'Kelly School Historic District Recommended NRHP Boundary

The Berry O'Kelly School campus is recommended eligible for the NRHP. It consists of approximately 8.5 acres at the north end of the historic Method community. Historically, the campus was larger, extending to the north and east. Today, the campus is bounded on the east side by Method Road, to the south by Woods Place, and to the west by I-440 (Figure 18). A tree buffer mostly blocks the view of the interstate from the campus. The campus shares its north boundary with Surtronics, a company specializing in commercial metal plating and anodizing. East and south of the campus are areas of modest single-family dwellings and multi-unit housing. The surrounding Method neighborhood contains a mix of long-term residents, North Carolina State University students, and young families and others attracted to the recently constructed, moderately priced homes erected at the west ends of Steadman Drive, Wilder Street, and Ligon Street.

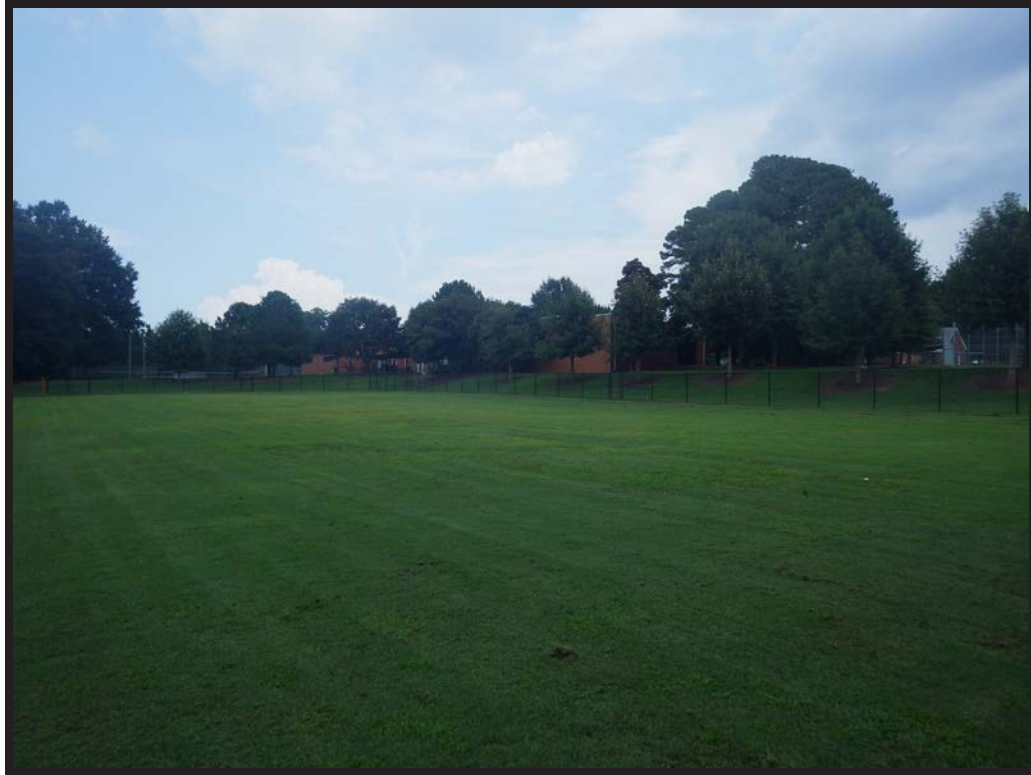
The circa 1928 Agriculture Building is situated west of St. James AME Church and was constructed the same year as a Classroom and Administration Building, which was demolished in the late 1960s. West of the Agriculture Building is a cleared, level field, which was originally used as the school's crop field for its vocational agriculture program and as a recreational playing field since as early as the 1950s (Figure 19).

*Figure 19. Agriculture/Playing Field Looking North  
Gymnasium, Agriculture Building and St. James AME Church are in the  
background.*

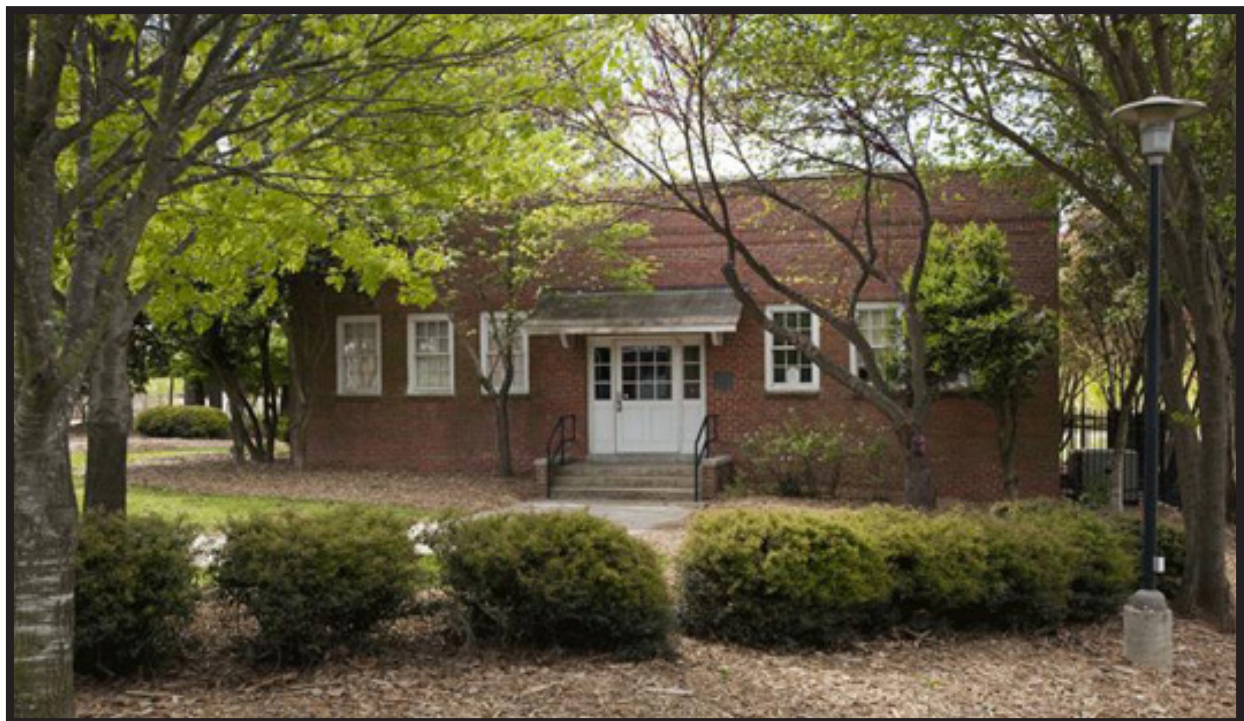
The Agriculture Building was constructed from "two-room shop" plans provided by the Julius Rosenwald Fund. It is a utilitarian, one-story, flat-roofed building (Figure 20). An addition was built on south side circa 1950, making it a longer rectangular building. The 1928 section has walls of 4:1 brick and a parapet roofline. The circa 1950 addition is laid in a 6:1 brick bond and has a stepped parapet on the sides and no parapet across the rear (Figures 21 and 22). The old and new sections are unified by a "cornice" of soldier bricks with a projecting header row above it. The north facing façade has a central entry with three 6/6-replacement window sashes with brick header sills on either side of it. The entry door is wood and has nine lights over two vertical raised panels. Flanking the door are three-light sidelights over a single raised vertical panel. A shed-

*Figure 20. Agriculture Building, North Side*

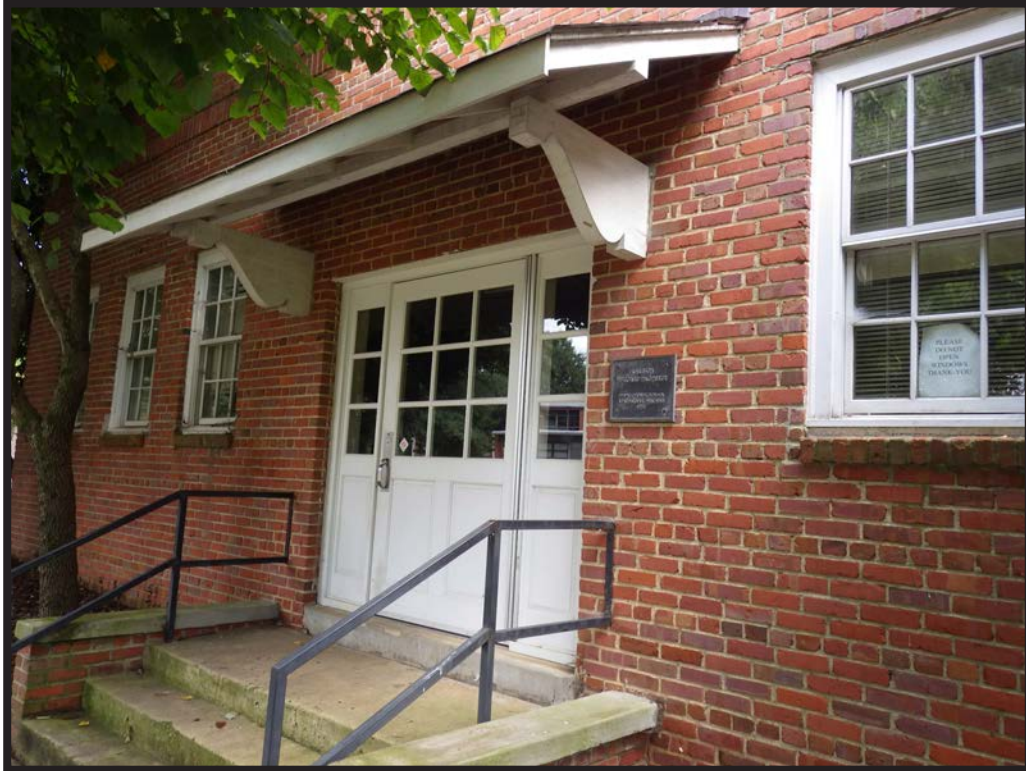
roof stoop porch, supported by robustly curved brackets, shelters the entry (Figure 23). A set of concrete steps set between a brick stringer wall access the front door.

*Figure 23. Entry Detail*

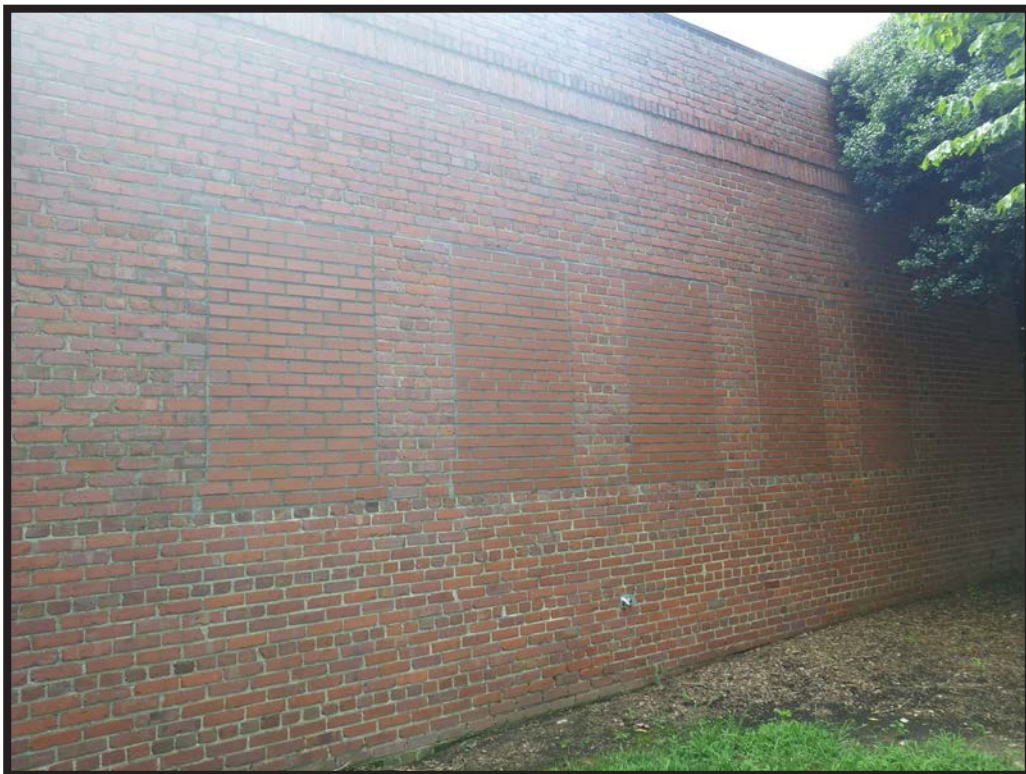
Photographs of the building from 1982 show the window openings on all four sides of the building were bricked over. The City of Raleigh restored some of the window openings after acquiring the property in 1983. The windows flanking the front entry are replacement 6/6 sashes that match the historic light pattern. The six window openings on the east side of the 1928 section remain filled with brick; the east side of the addition has three 6/6 replacement windows (Figures 24 and 25). The nine window openings on the west side of the building, six on the 1928 section, and three on the circa 1950 section, are 6/6 replacements sashes as well. The four window openings across the rear remain bricked over (Figure 26). A modern glass and metal door assembly is at the east end of the south wall. The opening corresponds with the size and location of an original garage bay door. An exterior square stove flue rises at the approximate center of the rear wall.

*Figure 24. Filled Windows on East Wall of 1928 Section*

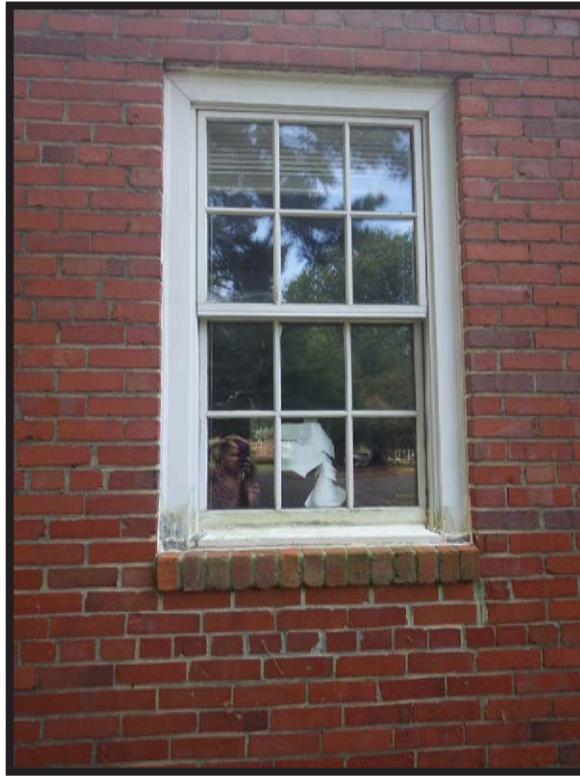
*Figure 25. Replacement Windows on East Wall of Circa 1950 Section*

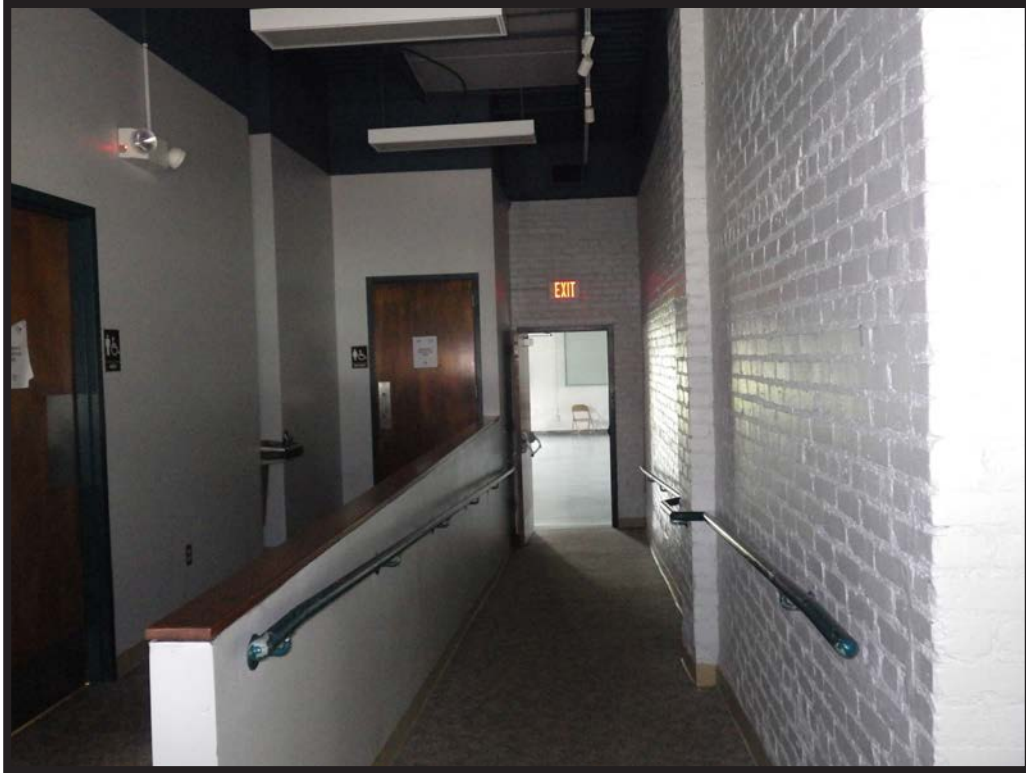
On the interior, the two-room floor plan remains intact. There is a small lobby at the north end, and a narrow center hall bisects the 1928 building and leads to the circa 1950 addition (Figures 27 and 28). The west room has walls of exposed brick and currently houses an exhibit on the history of Method and the school. The room on the east side of the hall was not accessible. The 1950's addition (Figure 29) is a large room with exposed metal roof trusses and walls of exposed brick and concrete block.

*Figure 27. View South From Lobby Down Hall to Circa 1950 Addition*

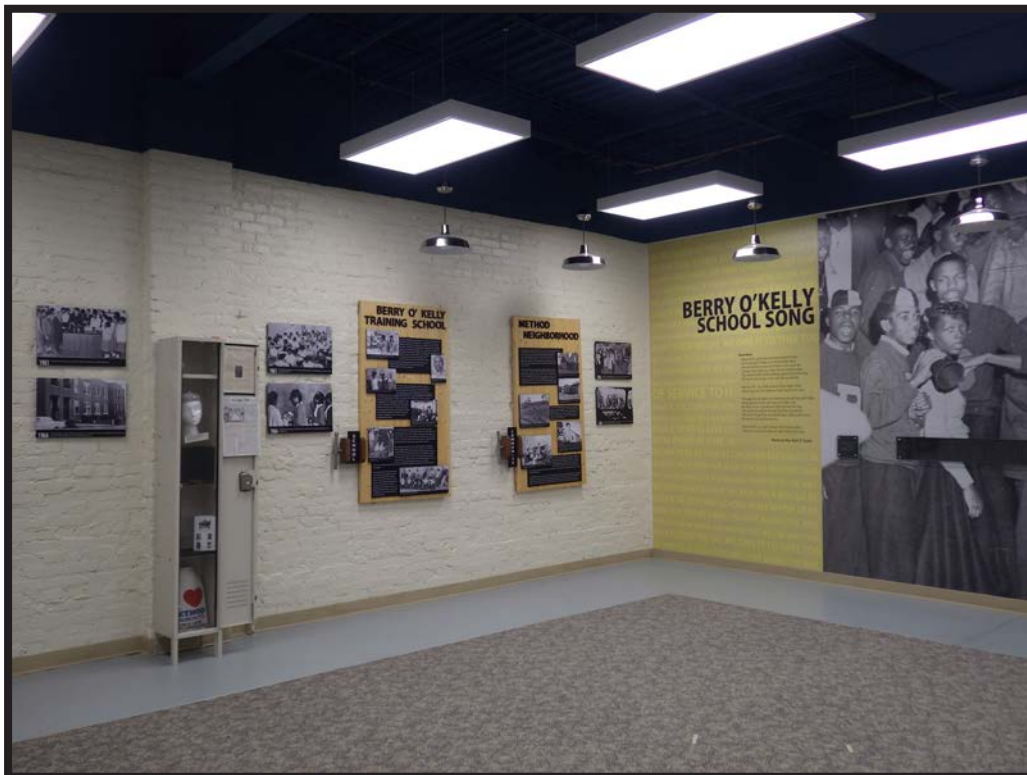
*Figure 28. West Room of 1928 Section, Looking Southeast*

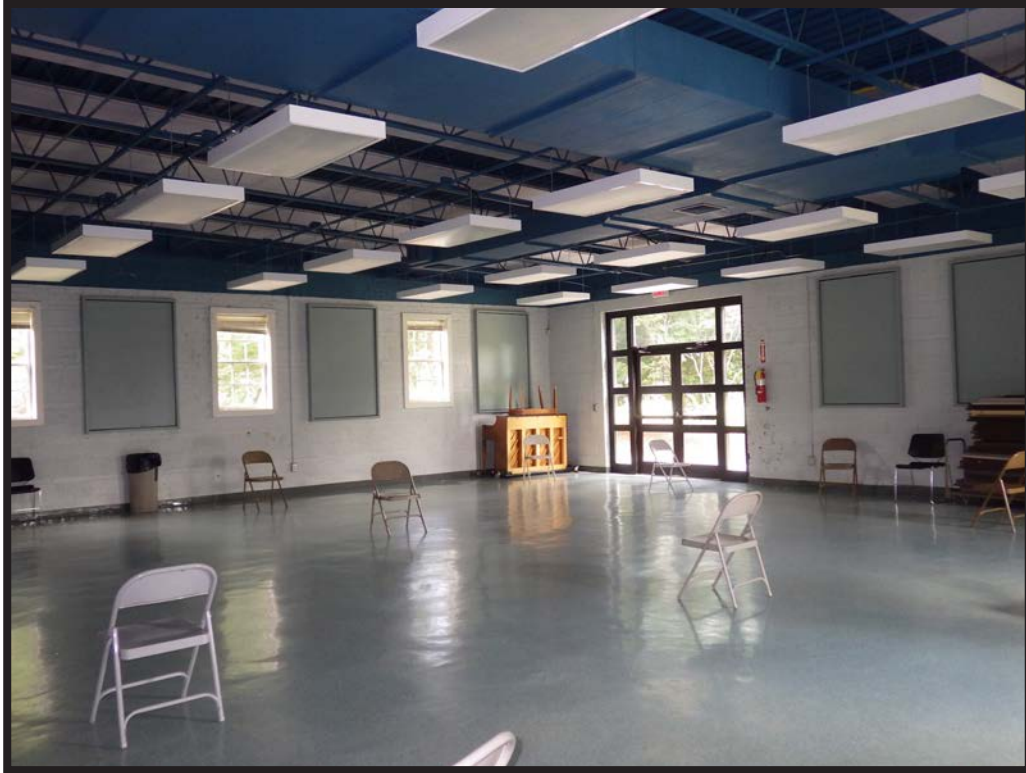
*Figure 29. Interior of Addition, Looking Southeast*

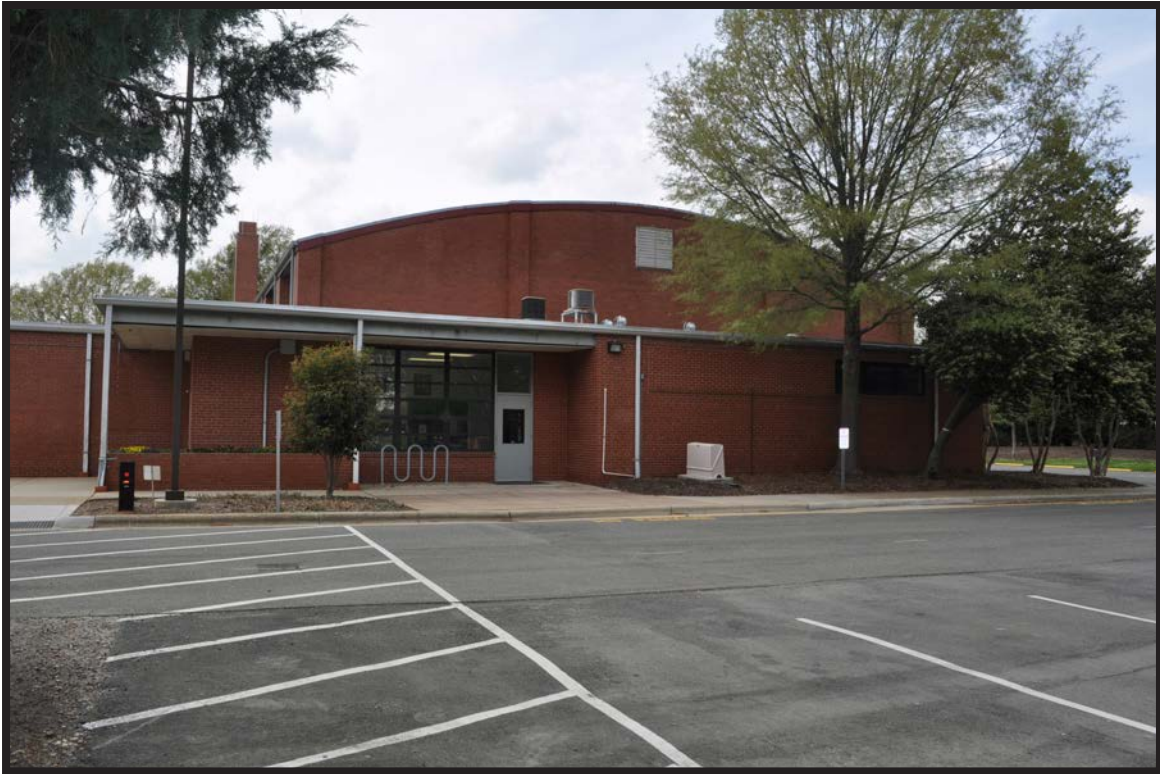
The Berry O'Kelly School Gymnasium was built circa 1950 on the west side of the bus loop, north of the Agriculture Building. The double-height gymnasium is a rectangular building with an arched roof supported by steel roof trusses (Figure 30). It is built of concrete block and faced with brick. Flat-roofed, one-story wings are on the east, south, and west sides. The main entry, consisting of a 15-light window and a glass and metal door with a transom, is located at the southeast corner under a flat-roofed canopy that extends from the south wall of the windowless east wing and wraps around to the east wall of the south wing (Figure 31). Brick pilasters separate the six bays of the side elevations of the main gym block (Figure 32). The upper part of each side bay has a 15-light metal window with operable hopper sashes. The south side wing contains the cafeteria, kitchen, and boiler room (Figure 33). A square brick boiler flue is situated in the fifth bay. A 15-light, an 18-light, and a 30-light metal window are on the south wall of the wing. The rear wing has two 8-light metal windows on the upper wall of the south side (Figure 34).

*Figure 30. Front (East) Side*

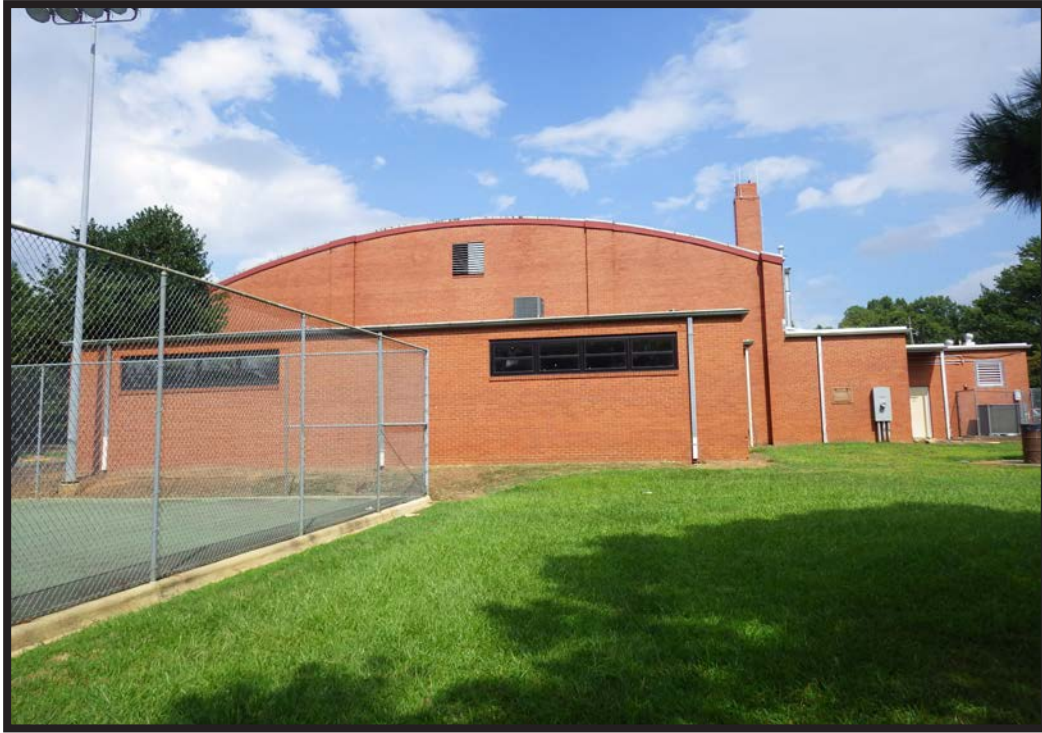
*Figure 34. West Side*

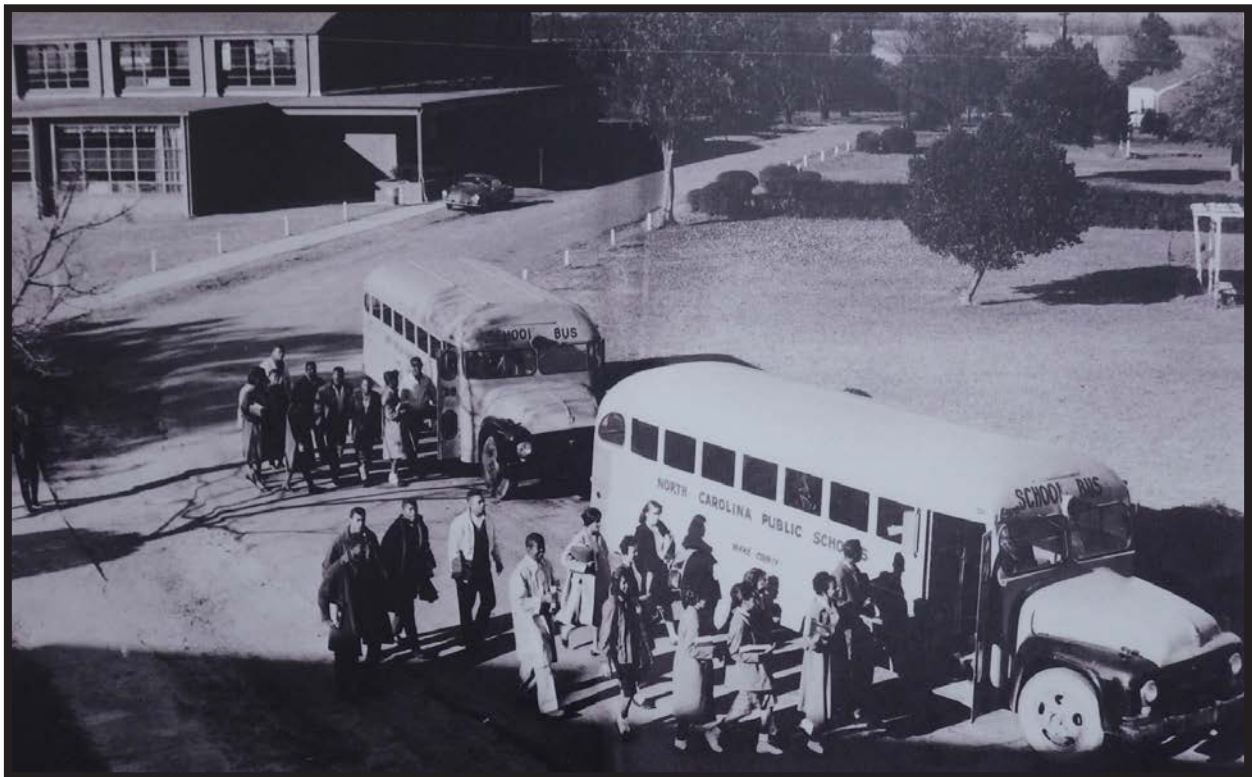
The paved bus loop off Method Road provides access to the campus at the northeast corner and exits just south of St. James AME Church. An unpaved path is visible on the same alignment on the 1938 aerial photograph. The path connected the campus' buildings and provided access for vehicular traffic. Buses are visible at the south end of the loop in the 1959 aerial photograph and in a documentary photograph from 1962 (Figure 35).

*Figure 35. Bus Loop, 1962 with  
Gymnasium in Background*

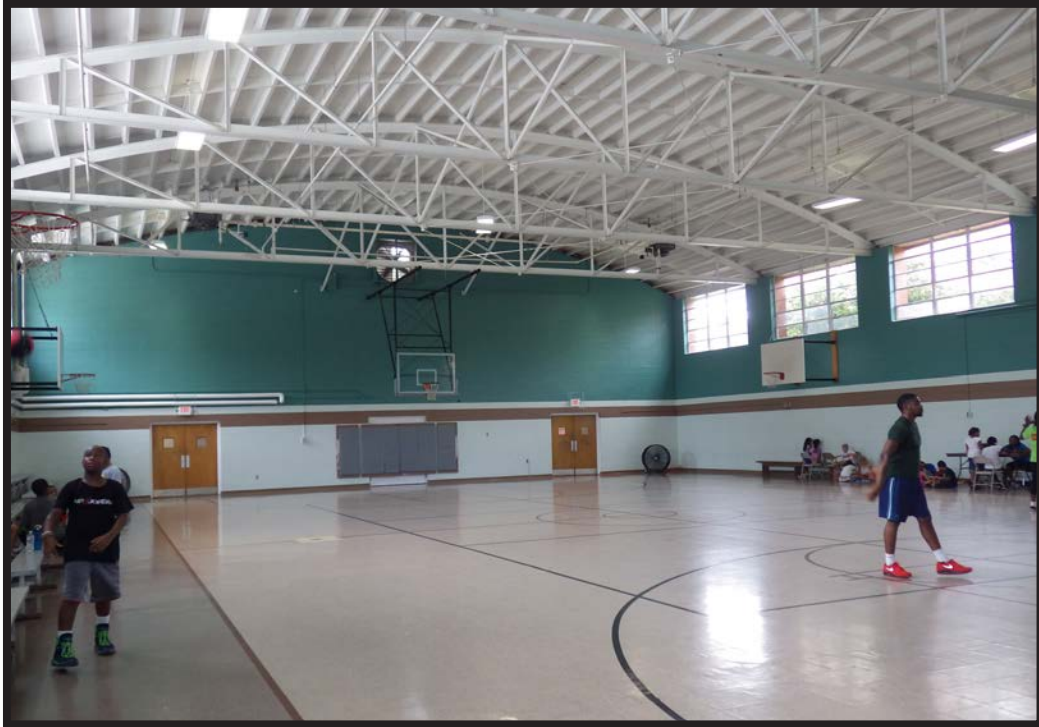
The gymnasium and cafeteria are accessed directly from the rectangular main lobby. Interior walls are made of exposed concrete block and the floors are covered with asbestos-type tiles. The gym, west of the lobby, has exposed metal bow-arched roof trusses (Figure 36). The wood roof rafters and decking are also visible. The cafeteria is a brightly lit rectangular room in the south wing (Figure 37). West of the cafeteria are the kitchen and other mechanical rooms.

*Figure 36. Gym Interior, Looking West*

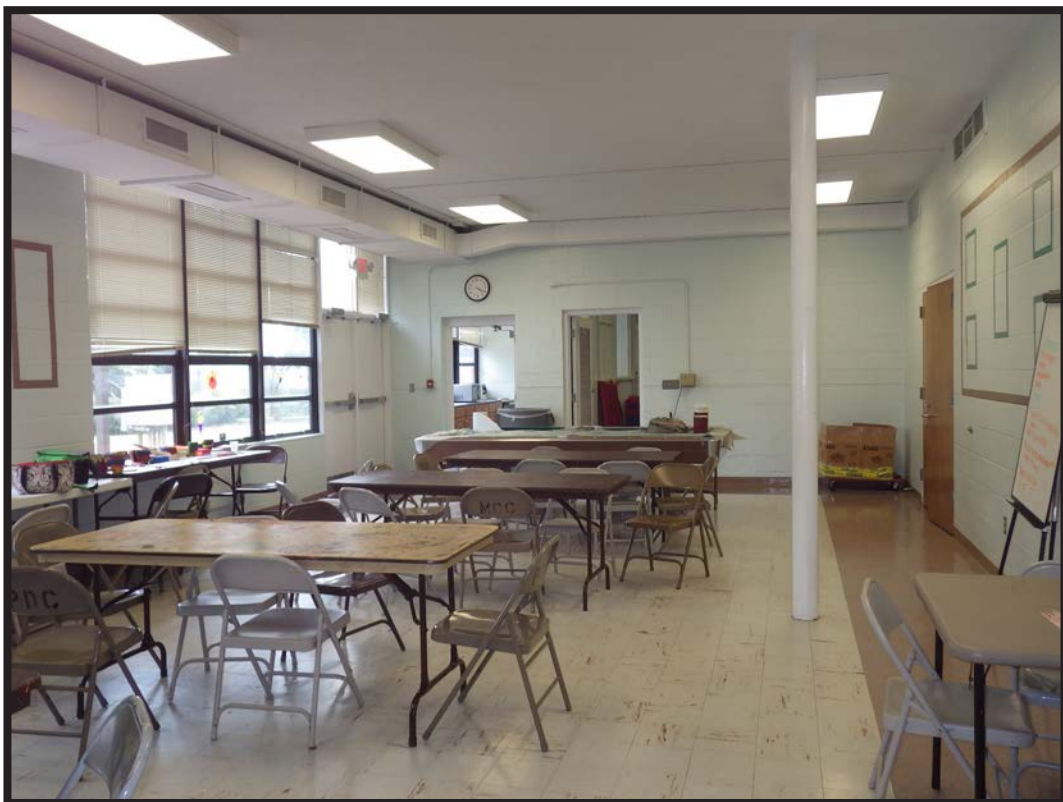
*Figure 37. Cafeteria*

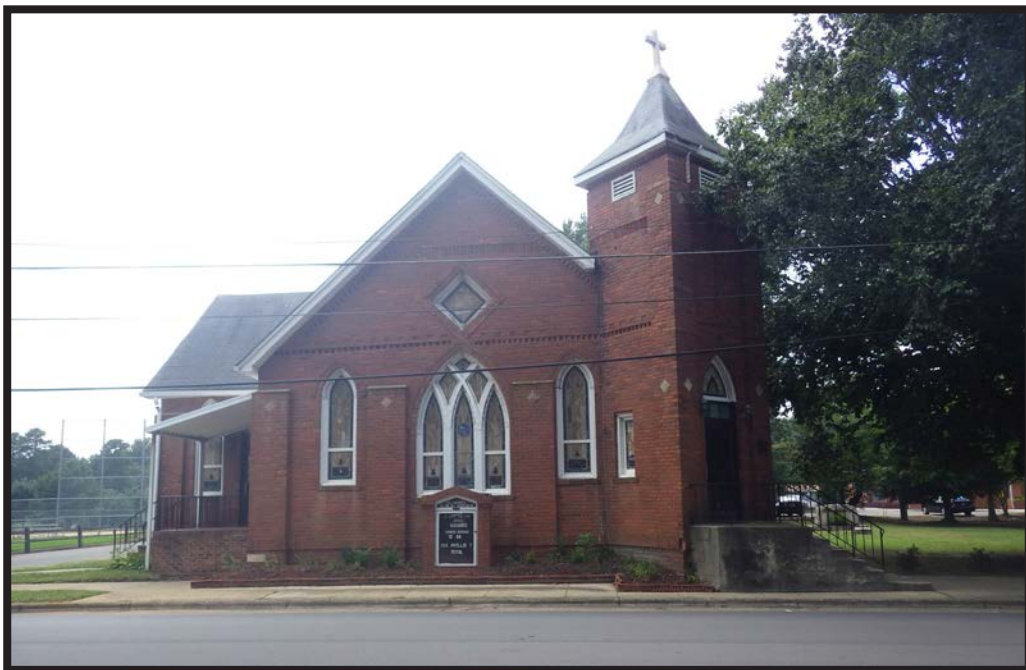
The 1923 St. James AME Church is situated on the east side of the proposed historic district. (Figure 38). The church faces east and its eastern parcel line encroaches on the sidewalk and Method Road right-of-way (ROW). The church's façade wall is approximately five feet from the curb. Between the sidewalk and the façade wall is a mulched planting bed with a brick framed sign. The grassy yard on the church's north side contains a single grave for the community benefactor Berry O'Kelly (Figure 39). His grave is marked with a rusticated, arched-top tablet on a rectangular base and a footstone inscribed with O'Kelly's date of death, March 14, 1931. North of the grave is a polished granite obelisk, a memorial to O'Kelly placed in his honor in 1985 by the Berry O'Kelly School Friends and Alumni (Figure 40).

*Figure 38. St. James AME Church, Front (East) Side*

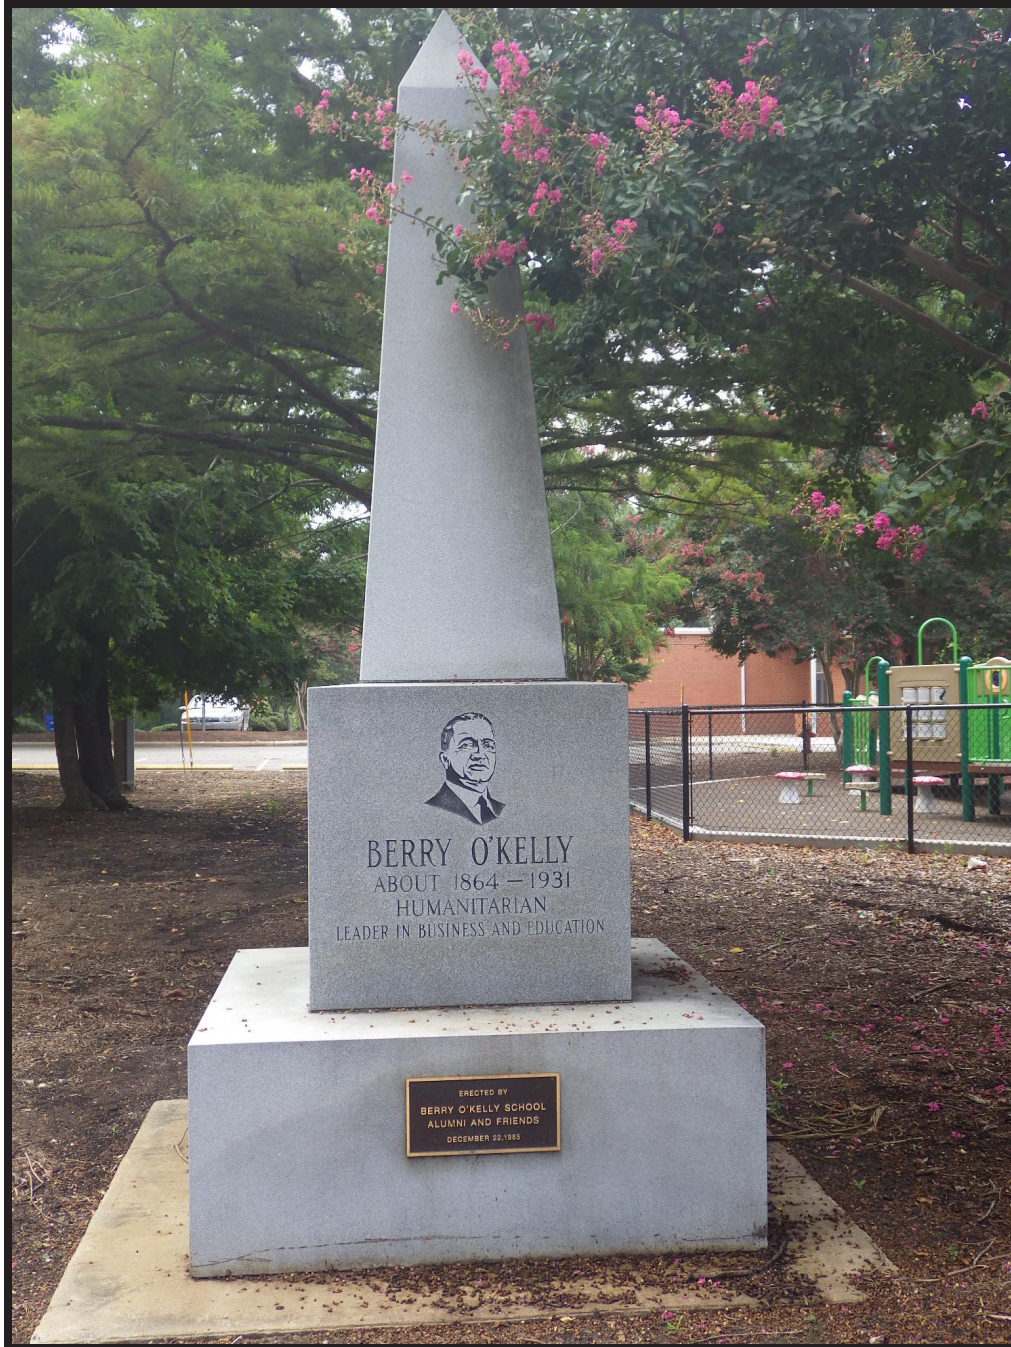
*Figure 40. Memorial Obelisk Honoring Berry O'Kelly*

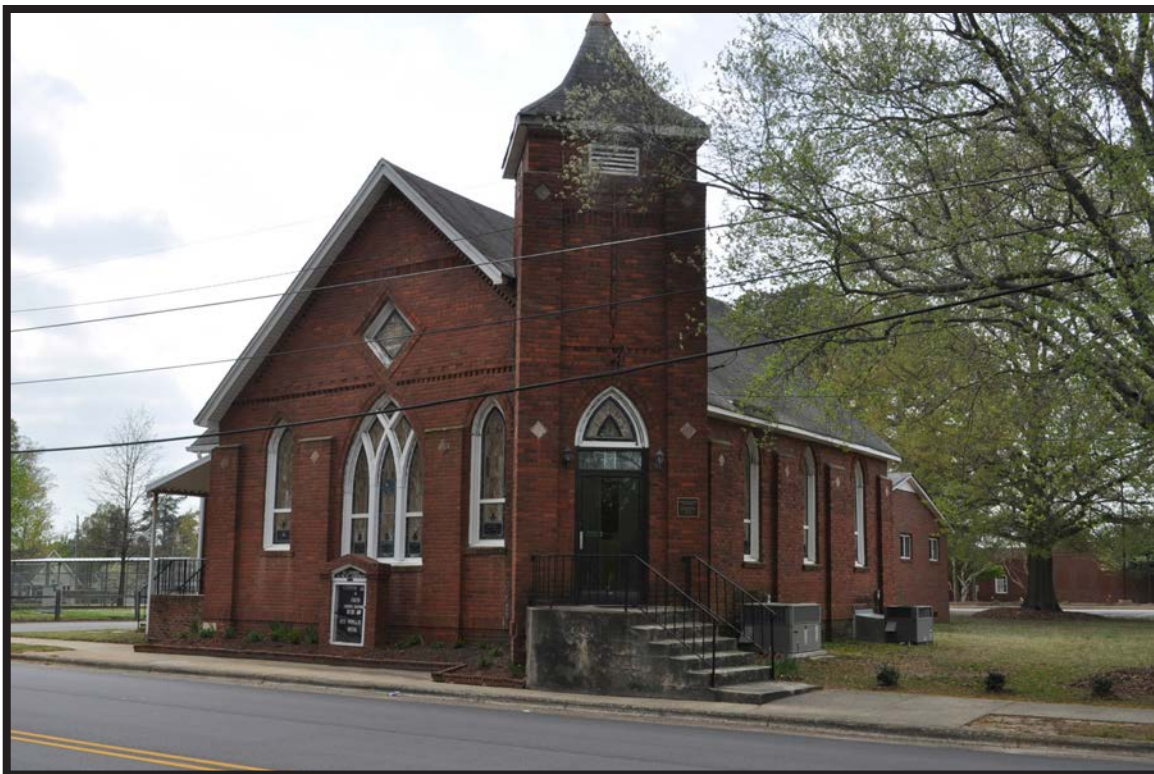
St. James AME Church is an irregularly massed, red-brick Gothic Revival-style structure. The 1923 section is a one-story front-gable building three bays wide and four bays deep, with pointed-arch door and window openings and stained-glass windows typical of the style. At the northeast corner of the church stands a square entry tower with a pyramidal roof with flared eaves (Figure 41). Two brick additions were added to the rear (west side) in the 1990s (Figure 42).

*Figure 41. Oblique View Looking Southwest*

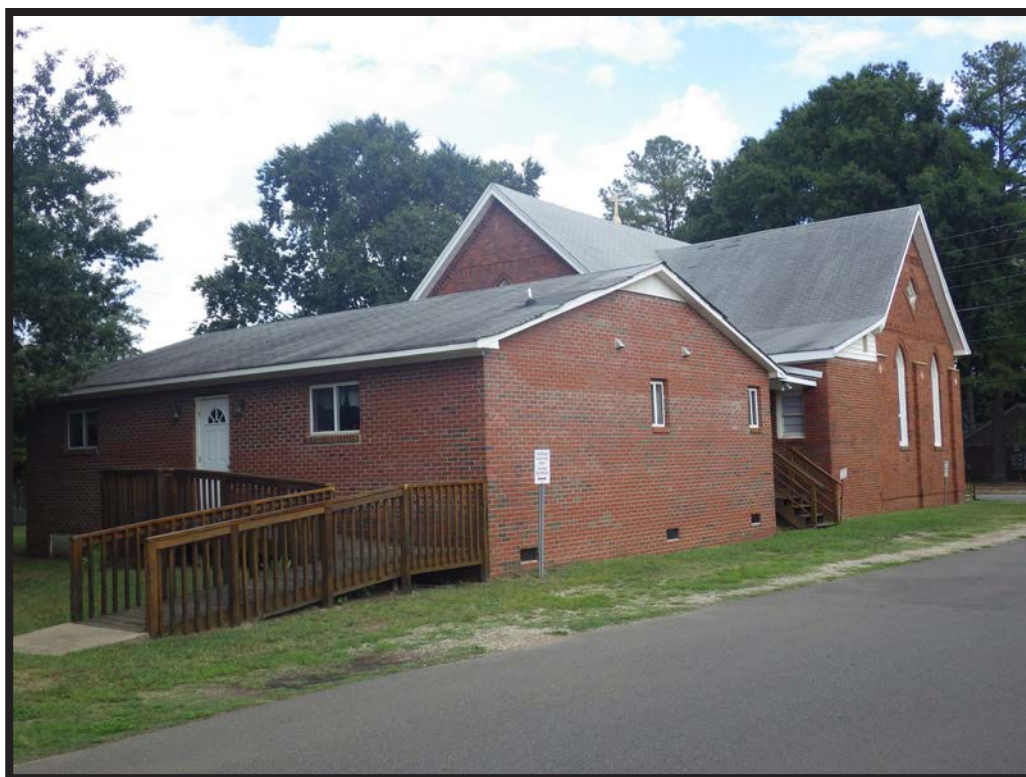
*Figure 42. View of Additions Looking Northeast*

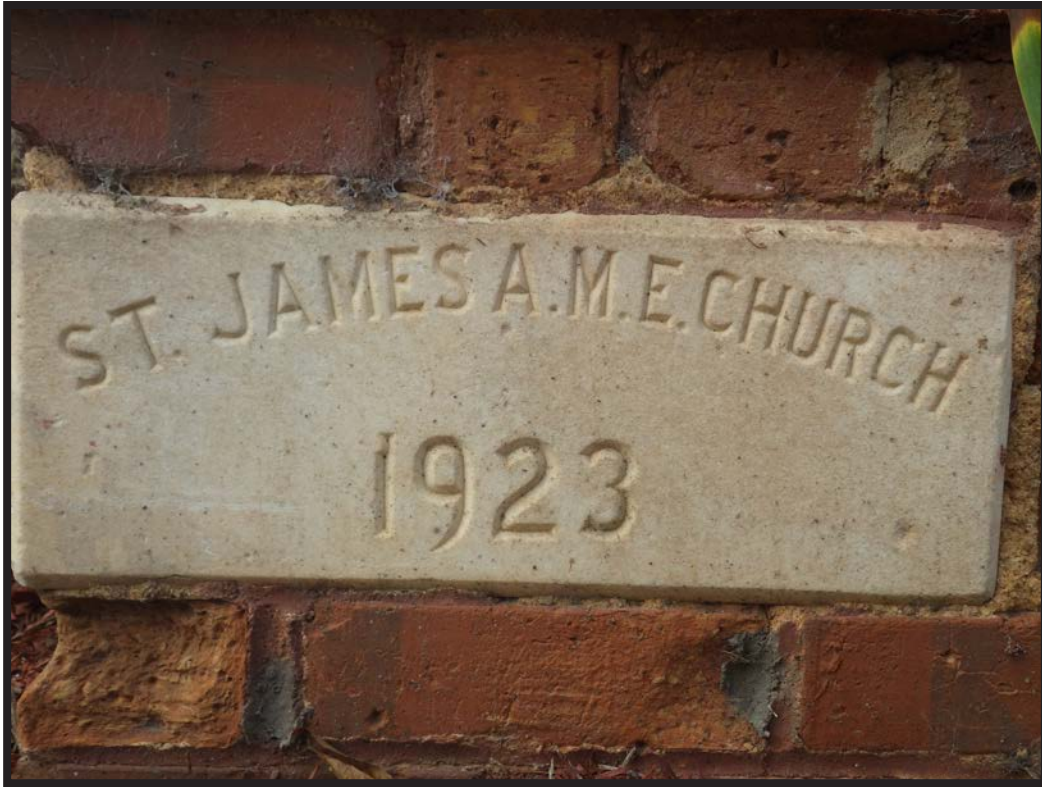
The exterior walls are built of running-bond brick with a soldier course water table and dogtooth header courses above the gable windows and along the cornice. At each corner of the 1923 block, and in between each window opening, are engaged buttresses decorated with concrete caps and lozenges. The door and window surrounds consist of double rows of header courses. The window openings have header-course sills. A granite cornerstone at the southeast corner of the façade is etched with the inscription “St. James A.M.E. Church 1923” (Figure 43).

*Figure 43. Cornerstone at Southeast Corner*

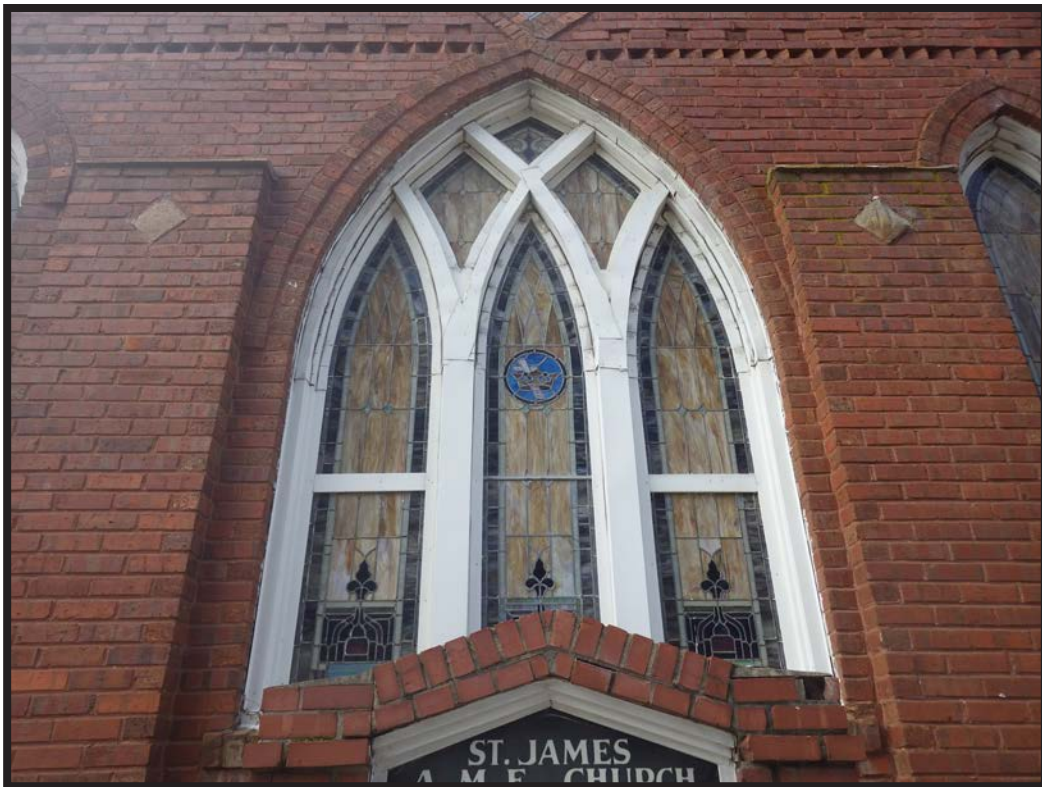
The façade features stained-glass windows: a large center window with single windows in the flanking bays (Figure 44). Above the center triple sash is a diamond-shaped stained-glass window. The main entrance in the northeast corner entry tower consists of a glass and metal replacement door surmounted by a pointed-arch stained-glass transom. The entry is accessed by a set of concrete steps with a metal railing. The north side of the church has four bays of stained-glass windows separated by buttresses (Figure 45). The west side has three stained-glass windows separated by buttresses and a small pointed-arch stained-glass window in the gable (Figure 46). The gabled wing that projects from the south side has two stained-glass windows in the south wall and a window and secondary entry with a glass and metal replacement door on the east side (Figure 47). A plywood panel fills the arched transom above the door; it is unknown why it was placed there. The south entry is accessed by a set of concrete steps and landing underpinned with solid brick. A metal shed roof supported by square posts covers the landing.

*Figure 44. Detail of Triple Center Window on Façade*

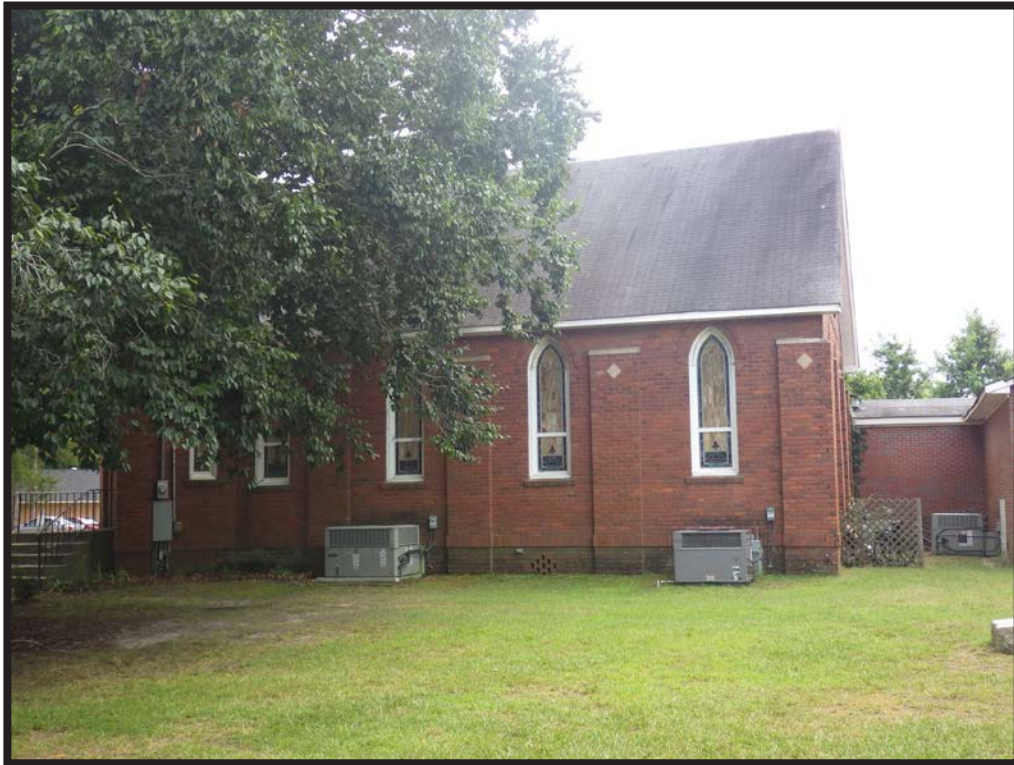
*Figure 45. North Side Showing Buttresses with Concrete Caps*

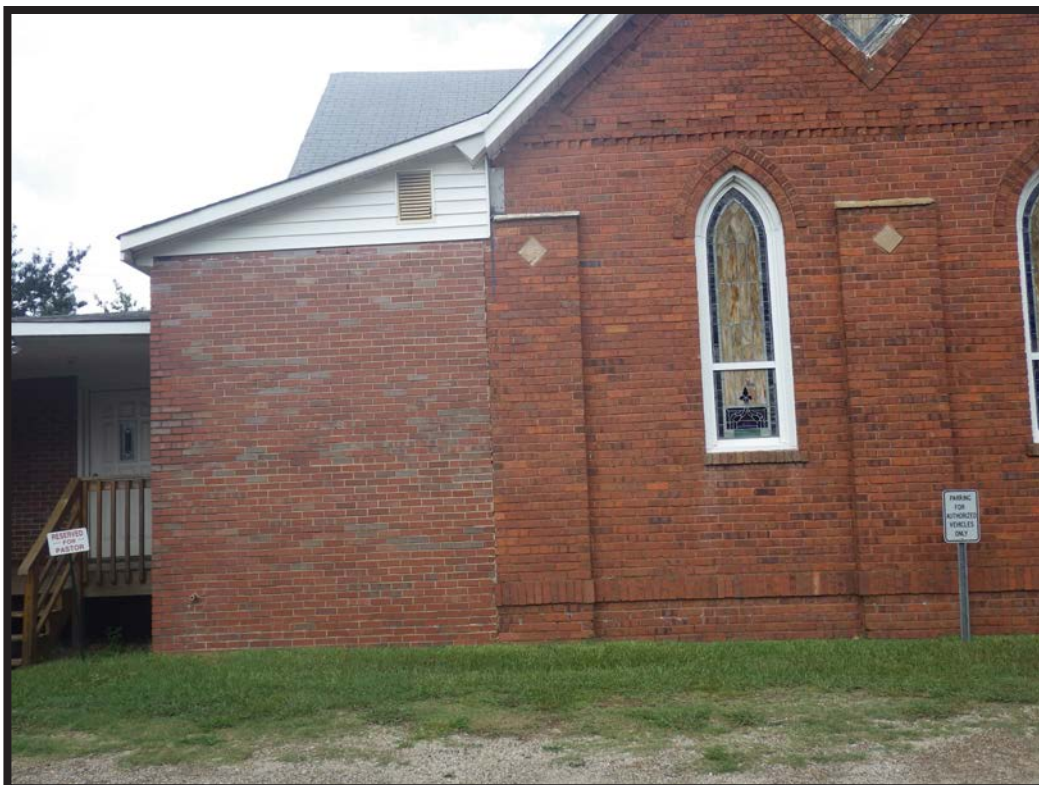
In the 1990s, a brick shed addition was built on the west wall of the south wing (Figure 48). Shortly afterwards, a one-story gabled brick fellowship hall was built behind the church and connected to the shed addition by a hyphen (Figure 49). The fellowship hall has a shallow-pitched roof and two-light slide windows. Vinyl entry doors are situated on the west side, accessed by a wooden wheelchair ramp. The south side of the hyphen is accessed by a set of wood steps. The roofs of the 1923 and circa 1990s sections are covered with grey composite shingles. Both sections rest on foundations of running-bond brick.

*Figure 48. South Side, View of Connection of Shed Addition and 1923 Church*
